Metallurgical Report – Liner Failure

Failure Investigation of Well Casing
from the Salton Sea Scientific Drilling Project

D. van Rooyen and J.R. Weeks
Brookhaven National Laboratory
Upton, New York 11973

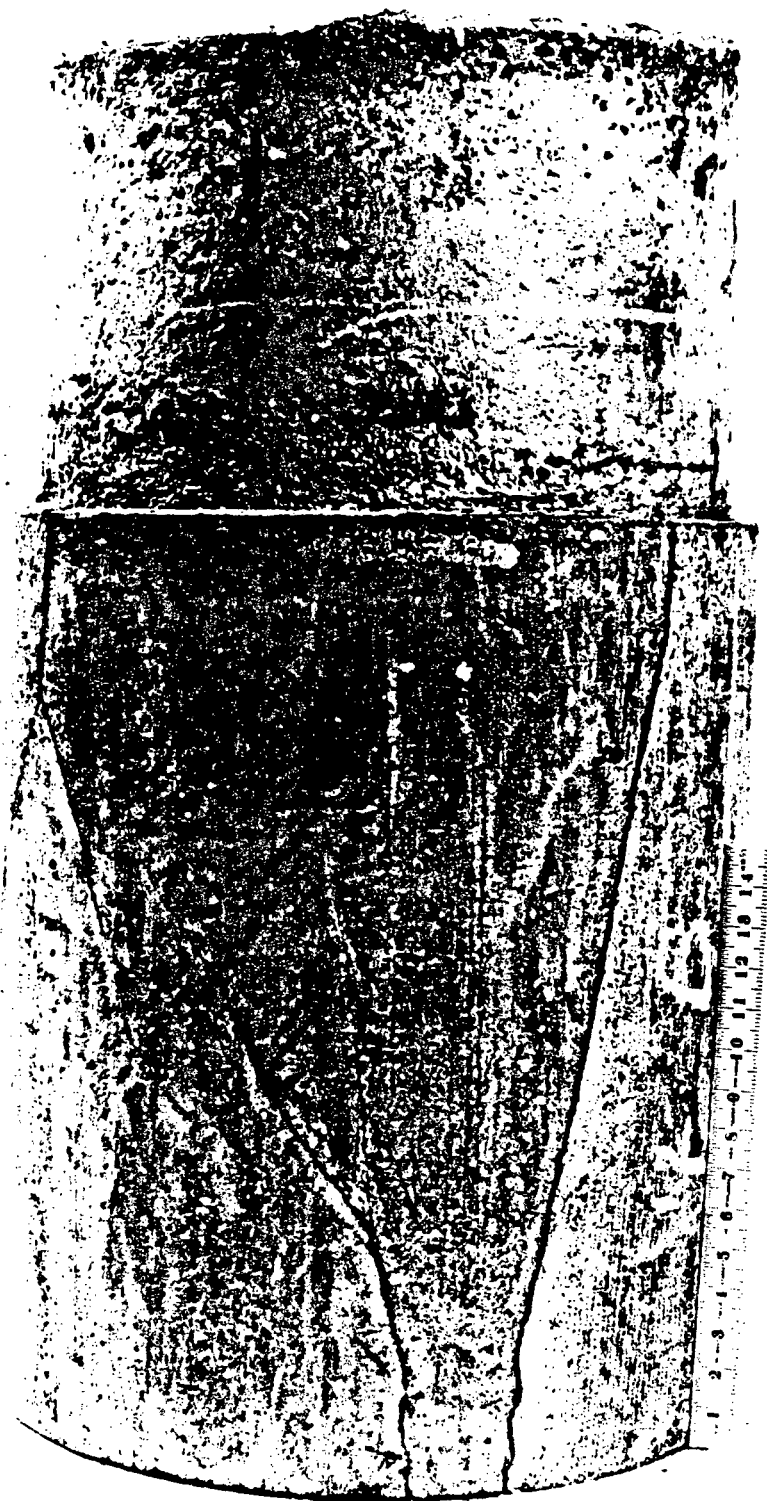
In addition to the through wall crack shown on the collar on specimen two, a second (and possibly third) crack is visible on the photograph (Figure 2). Dye penetrant examination also revealed a short, longitudinal crack on the outer surface of the collar on the first junction. No cracking was seen on any of the casing pipe specimens received. No collar was received on specimen 3. The major failure appears to have occurred on the second collar, although the absence of the collar from section 3 suggests it failed also. The smaller crack in junction number 2 and the part through-wall crack from junction number 1 were selected for further metallographic examination.

Figure 2a. Junction 2, as received at BNL.

Figure 2b. Junction 2, as received at BNL.

Figure 2c. Junction 2, as received at BNL.

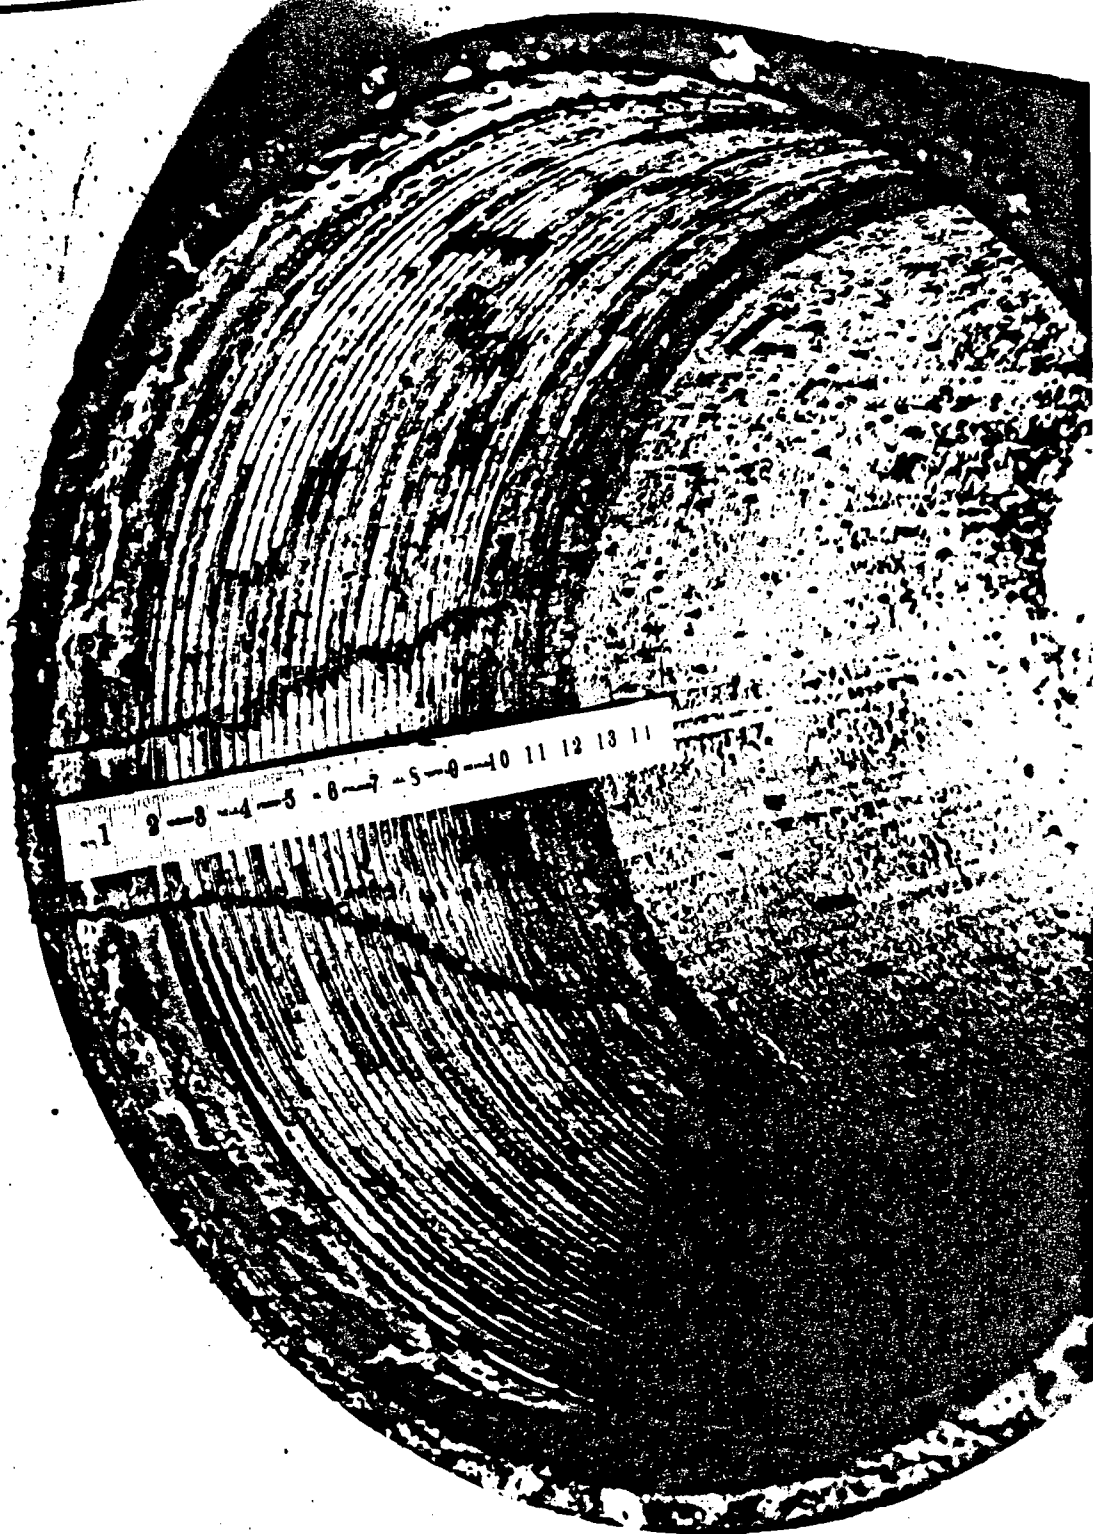
2A

The specimens sent to BNL, as identified by the sender (Bechtel) are listed in Appendix A. The origin of the heavily corroded specimen 4 is not clear. The piping received was 7" diameter, 29 #N-80 LT&C R3 seamless steel casing. Photographs of the sections of the pipe and collars, as received at BNL, are shown in Figures 1 through 4 (Junction numbers 1,2,3, and the unknown specimen 4 respectively). As can be seen, the extent of general corrosion appears to increase with depth (from 1 through 4). Also, specimen number 4 was so severely corroded that identification of any significant features in the vicinity of the failure was impossible. A major branched crack is also visible in the crack in the collar of section 2.

Figure 2d. Inside of cracked collar.

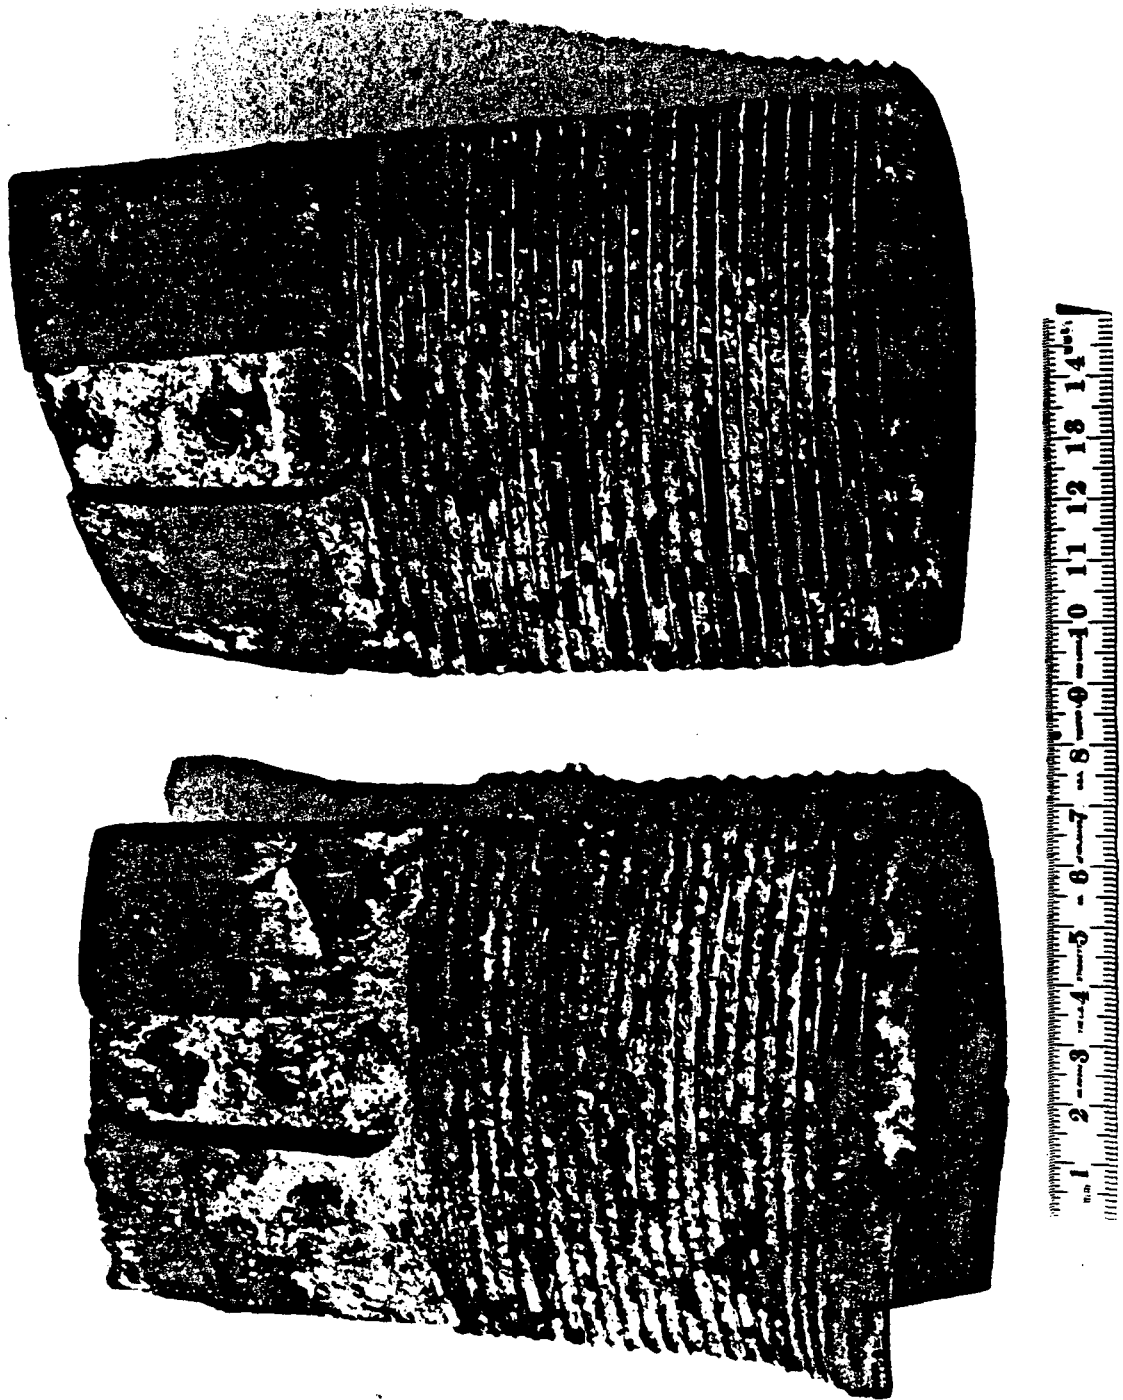
Figure 4a. Junction 4, two segments of the casing pipe outer surface.

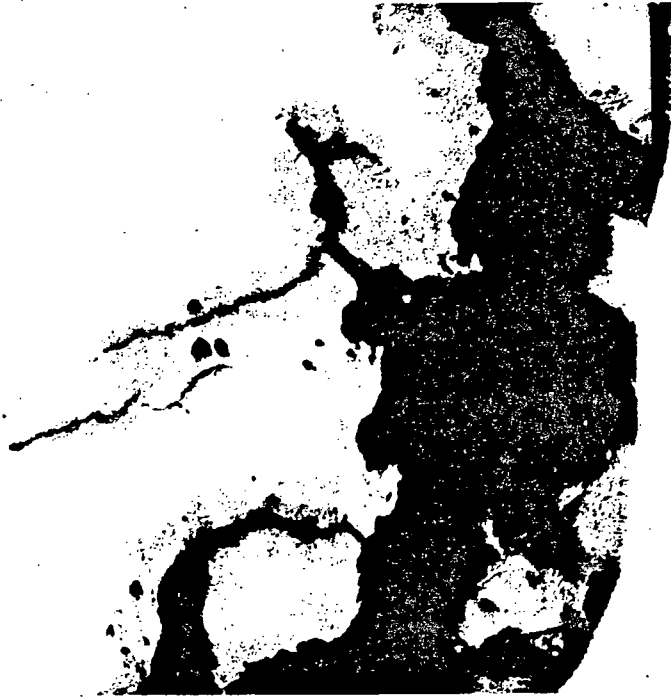
The cross sections of the secondary crack from collar number 2 are shown in Figures 5 through 7. The surface of the main crack is seen to be heavily corroded and a number of secondary cracks emitting from the primary crack are evident. The structure of the alloy is heavily martensitic, with no tendency for the crack to follow any of the martensite grain boundaries. Attempts to etch the specimens to try to bring out the original austenitic grain boundaries were unsuccessful. However, the micrographs of these cracks in the unetched condition show some of the martensitic grain structure in the vicinity of the cracks, suggesting that some penetration along the martensite grains may have occurred. Figures 8 and 9 show the fracture surface (in scanning electron micrographs) of two of these cracks after they were opened up in the laboratory. On the first, a through wall crack, one can see deposited crystals which from the EDS charts appear to be high in silicon, suggesting these crystals grew from the brine solution as it flowed through the crack. An EDS spectrum of the second crack showed significant amounts of calcium and silicon present on the crack surface. There is no strong evidence of an intergranular type cracking phenomenon, however, or of any ductile rupture occurring in these cracks.

Figure 5a. Branching cracks departing from main crack, collar #2 (on left). 50 X, unetched.

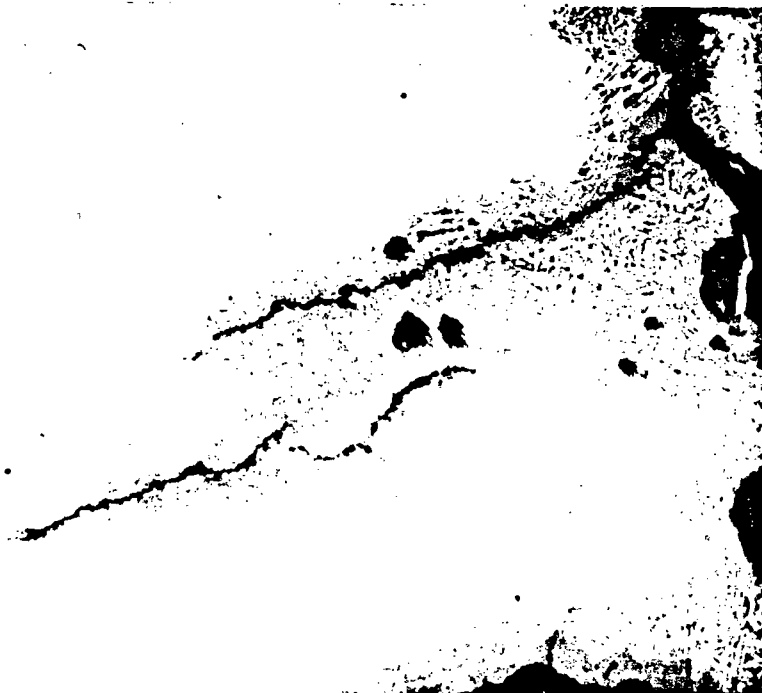
Figure 5b. Branching cracks departing from main crack, collar #2 (on left). 100 X, unetched.

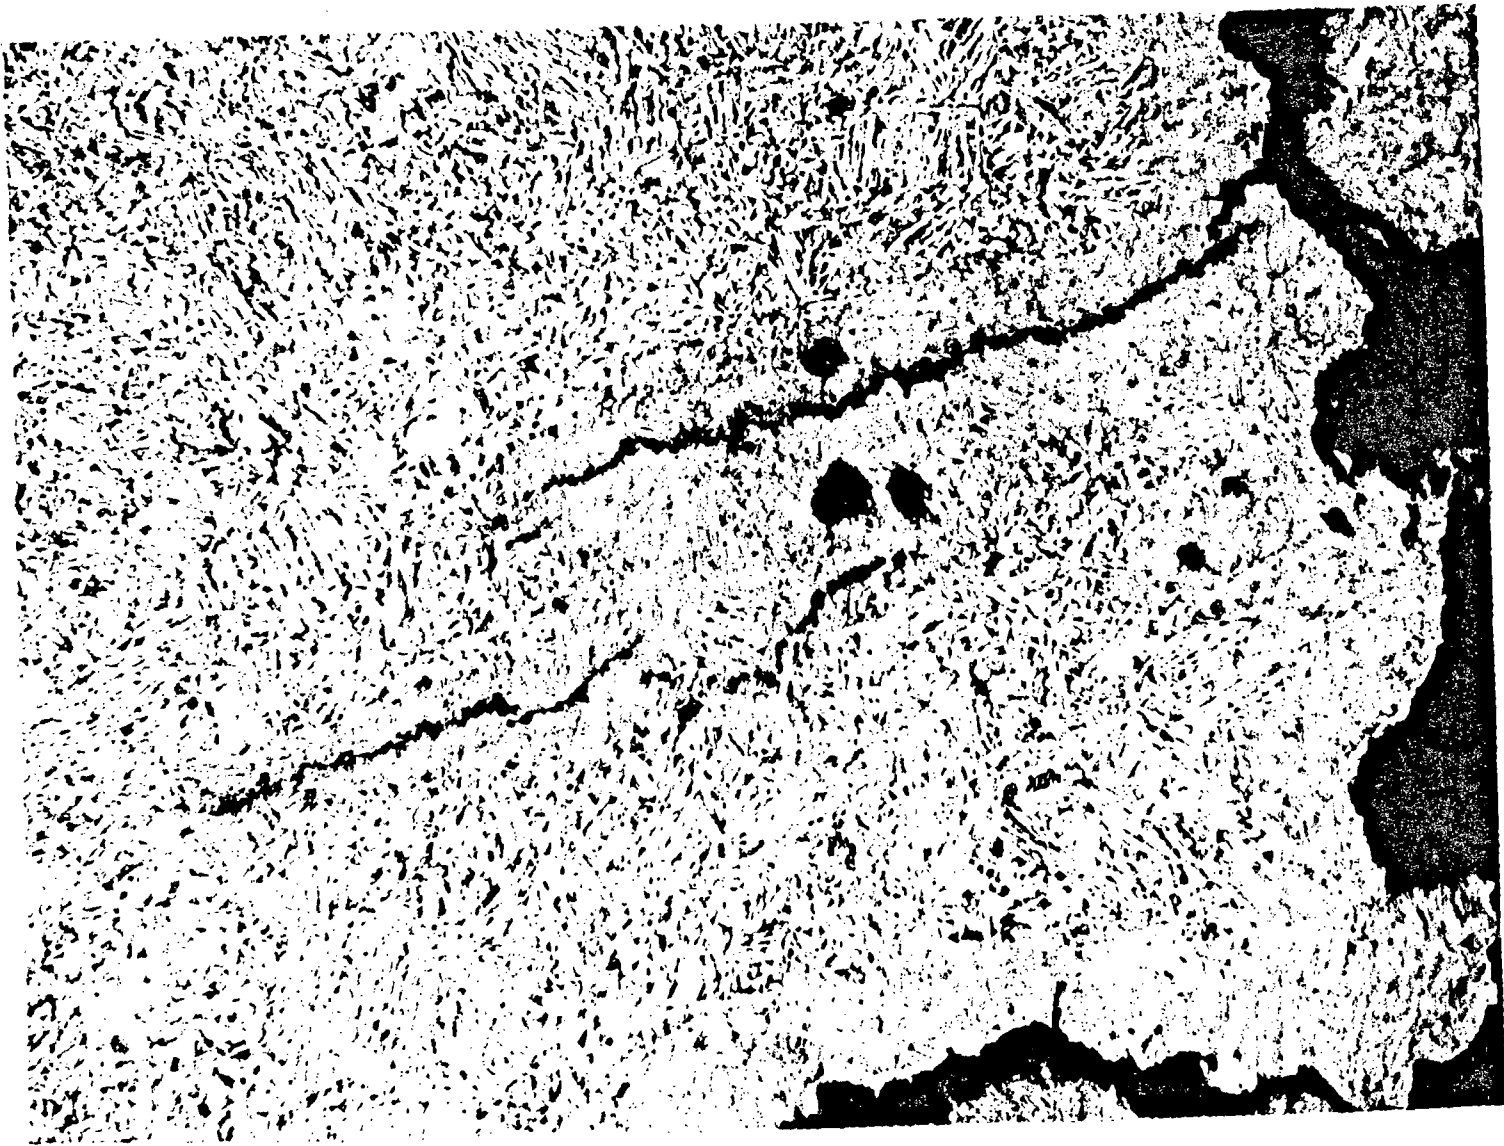
Figure 6. Cracks shown in Figure 5b, 100 X, etched.

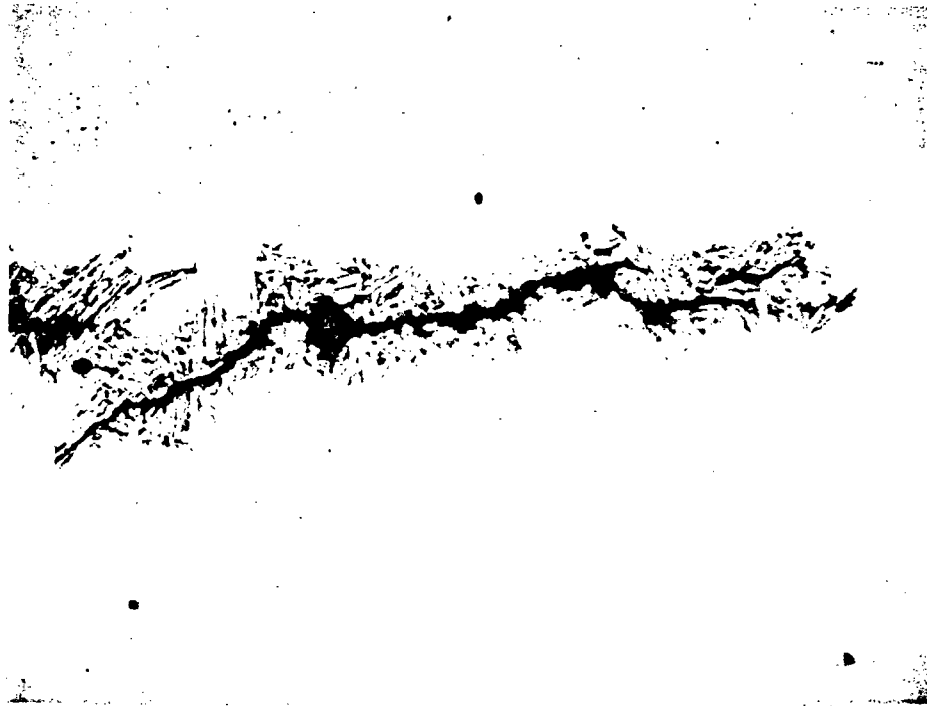
Figure 7a. Crack tip, 200 X, unetched.

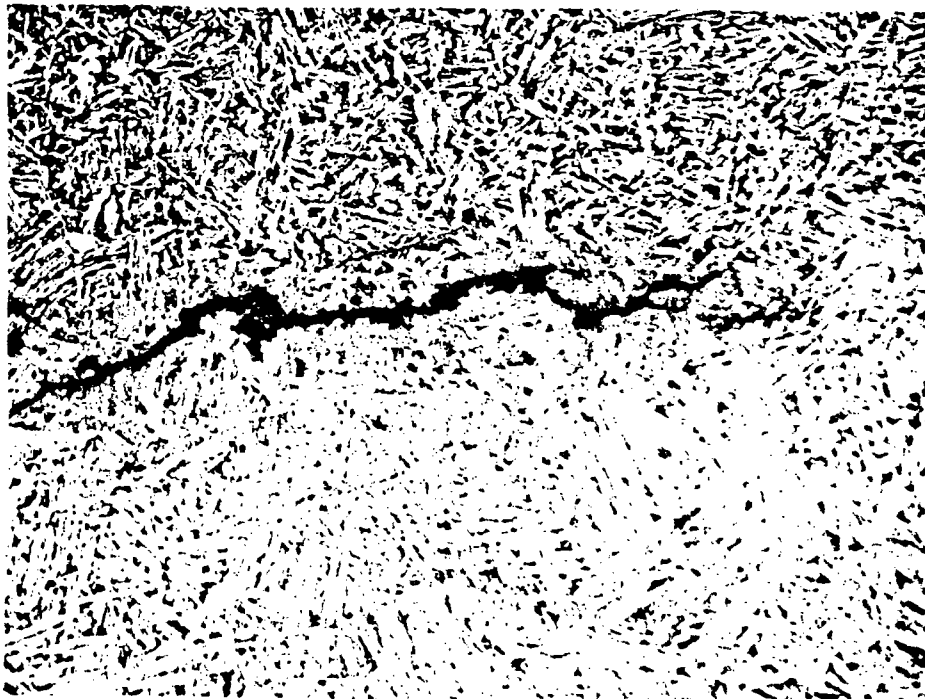
Figure 7b. Crack tip, 200 X, etched.

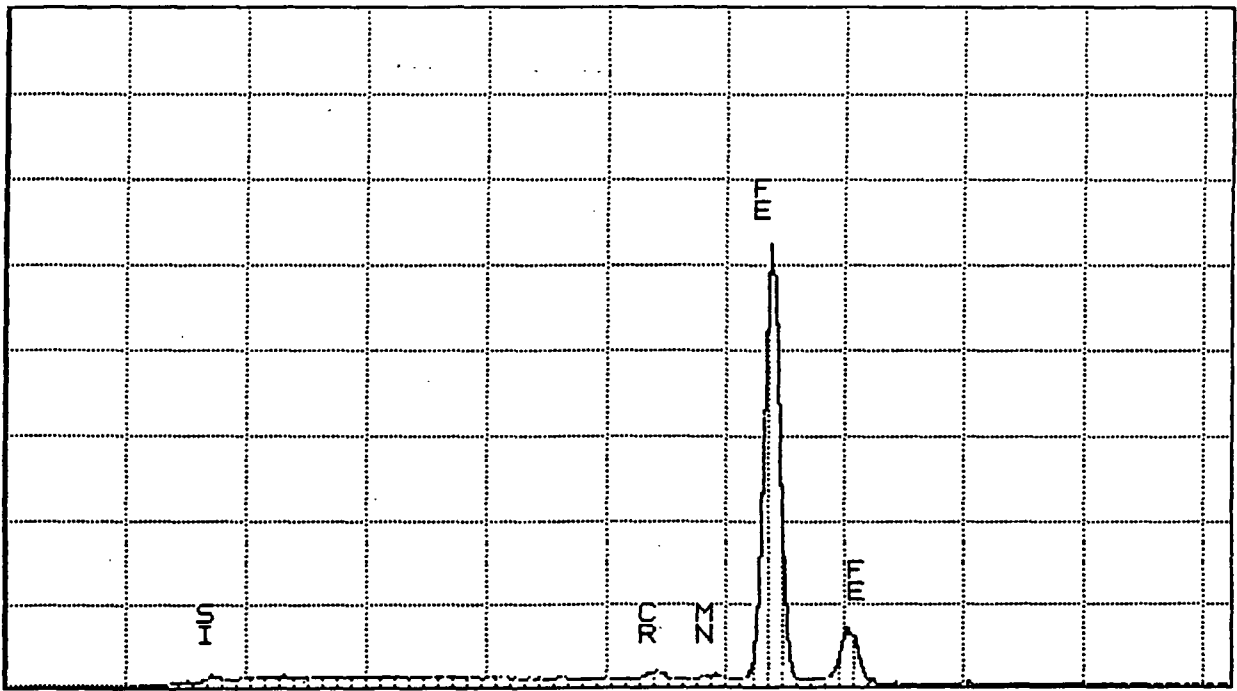
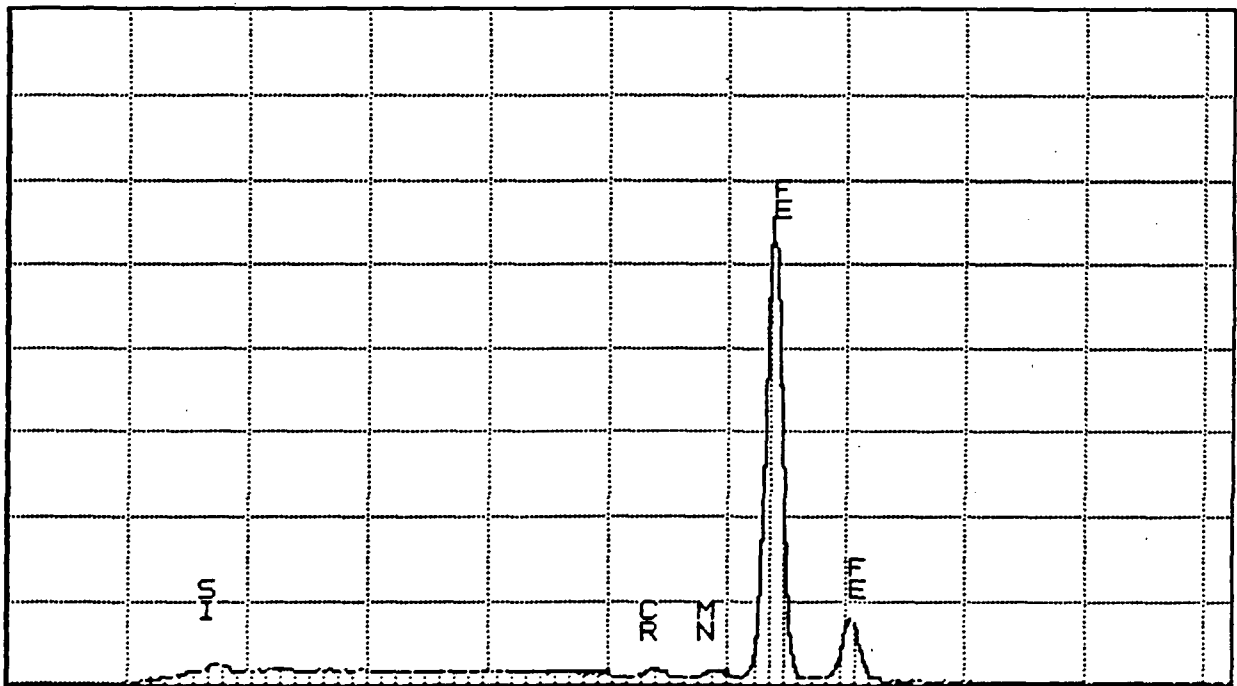
A sample from each alloy was examined in the EDAX. The patterns received are shown in Figure 11 A and B. It is apparent these EDAX scans are essentially identical and indicate no major differences in alloying constituents between the collar and casing materials.

Figure 11a. EDAX scan of casing alloy.

Figure 11b. EDAX scan of collar alloy.

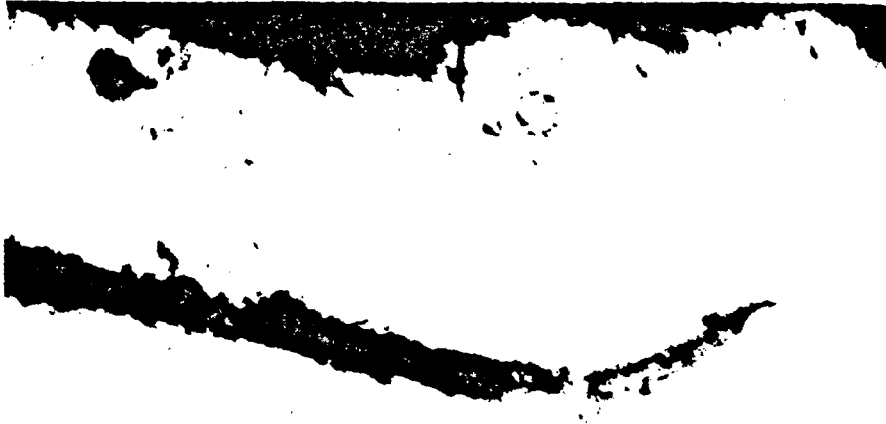
As noted above, during dye penetrant examination a small, longitudinal, part through-wall crack was identified in collar number 1. A portion of this collar including the crack was examined metallographically. The results are shown in Figure 12 A and B. It can be seen that this is a shallow crack that propagated at an acute angle to the surface and not in a direction in which it would have tended to penetrate the piping. The appearance of this crack is entirely consistent with that described by Parkins (1) as "hydrogen blistering" although whether it was actually due to this phenomenon or to other stress corrosion phenomena cannot be determined at present.

It was not possible to tell whether the cracks in the collar number 2 originated from the inner or outer surface of the collar. The crack on the first collar, however, was definitely shallow and only on the exterior surface. The nature of this crack is quite suggestive of that for hydrogen blistering as described by others, as cited above. It is interesting to note that the highest hardness was consistently observed on the outer surface of the collar and that it consistently exceeded the (nominal) borderline (Rc22) suggested for oil industry applications.

Figure 12a. Surface crack found near collar #1
or casing, 200 X, unetched.

Figure 12b. Surface crack found near collar #1
or casing, 200 X, etched.
