FAILURE INVESTIGATION OF WELL CASING
FROM THE SALTON SEA SCIENTIFIC DRILLING PROJECT (SSSDP)

D. van Rooyen and J. R. Weeks
Department of Applied Science
Brookhaven National Laboratory
Upton, New York 11973

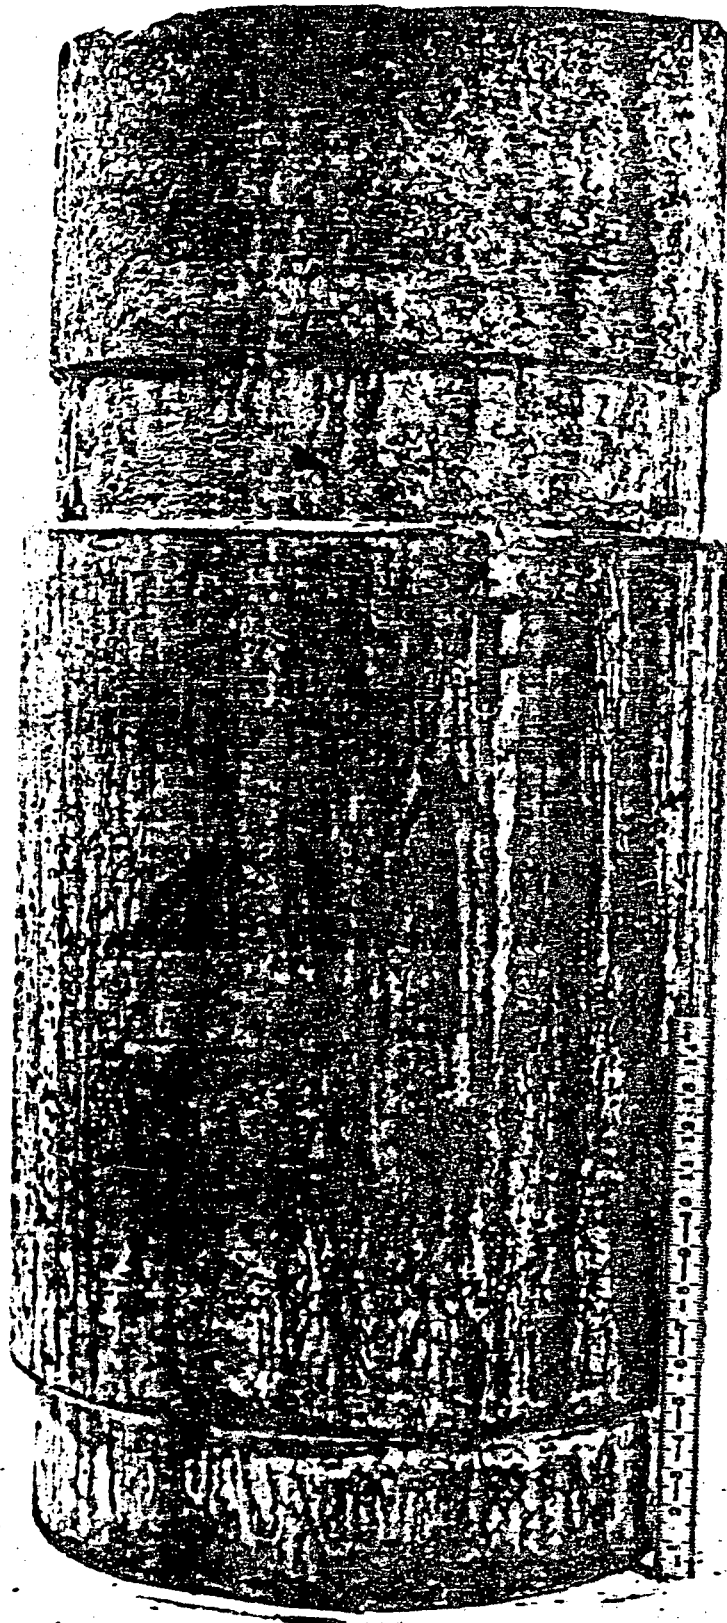
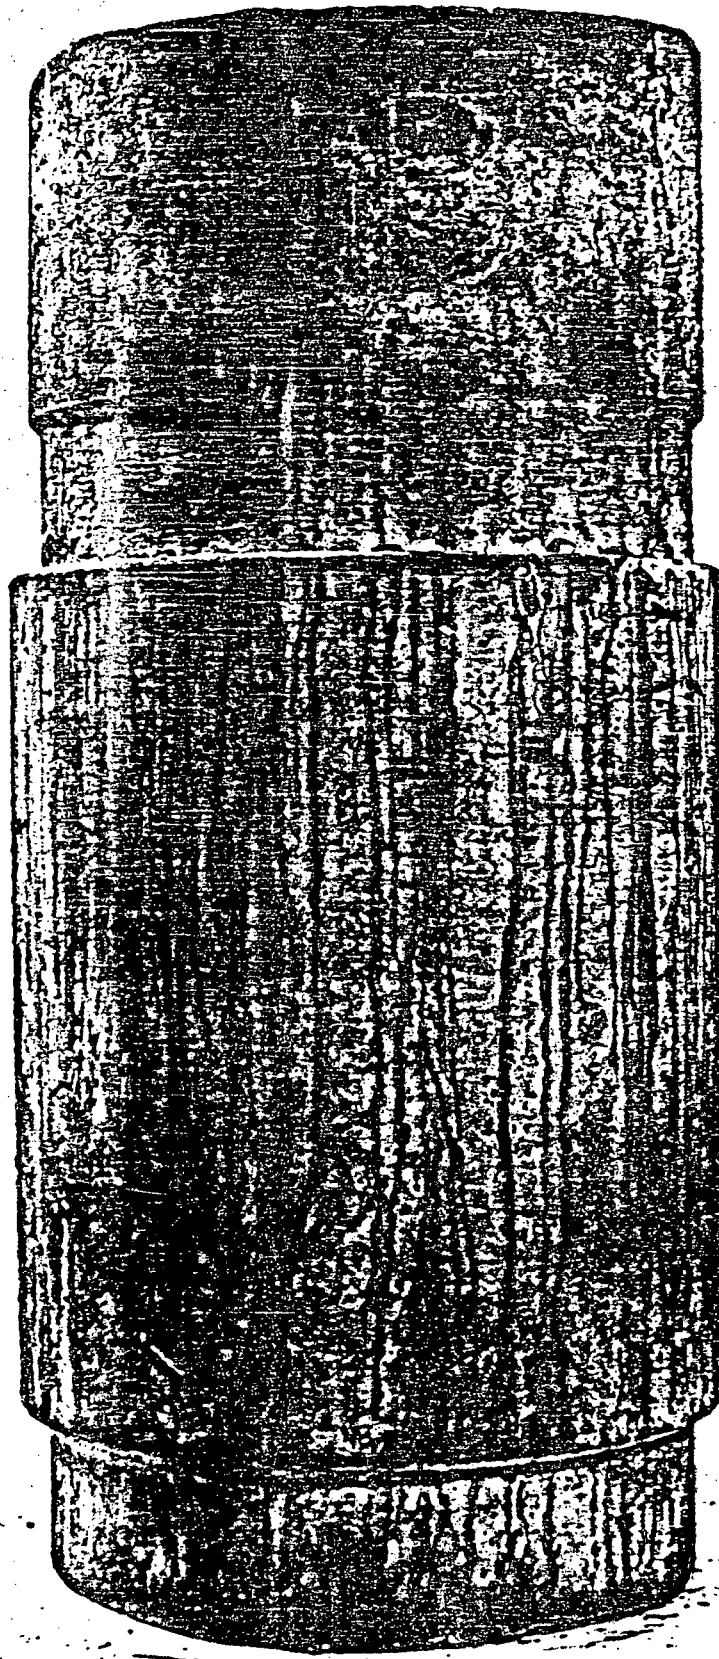
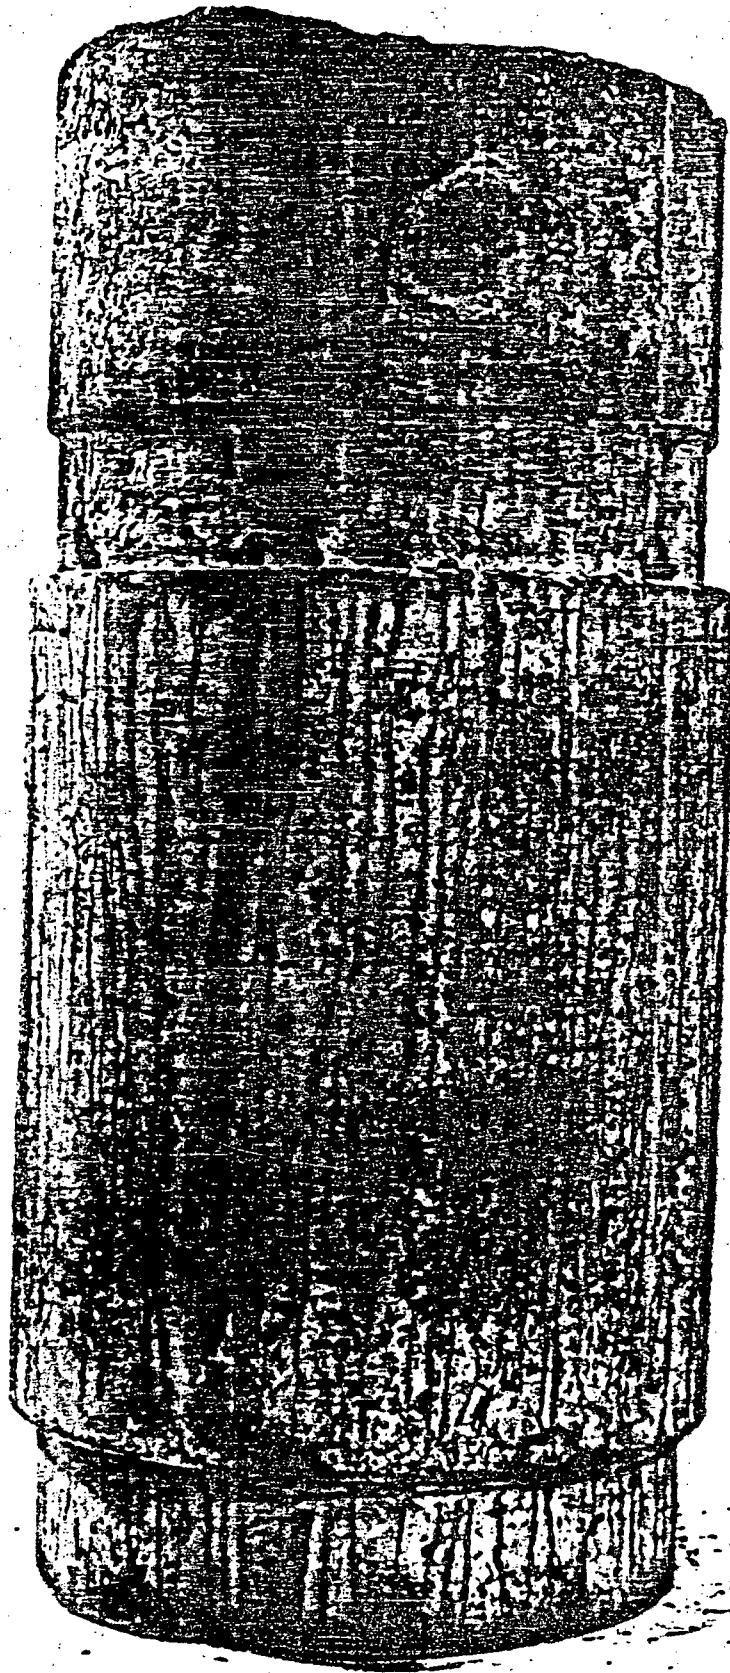
In addition to the through wall crack shown on the collar on specimen two, a second (and possibly third) crack is visible on the photograph (Figure 2). Dye penetrant examination also revealed a short, longitudinal crack on the outer surface of the collar on the first junction. No cracking was seen on any of the casing pipe specimens received. No collar was received on specimen 3. The second major failure appears to have occurred on the second collar, the first being the collar from section 3, which was the original problem since the liner parted at this collar. The smaller crack in junction number 2 and the part through-wall crack from junction number 1 were selected for further metallographic examination.

Figure 1. Junction 1, as received at BNL.

Figure 1a. Junction 1, as received at BNL.

Figure 1b. Junction 1, as received at BNL.

Figure 1c. Junction 1, as received at BNL.

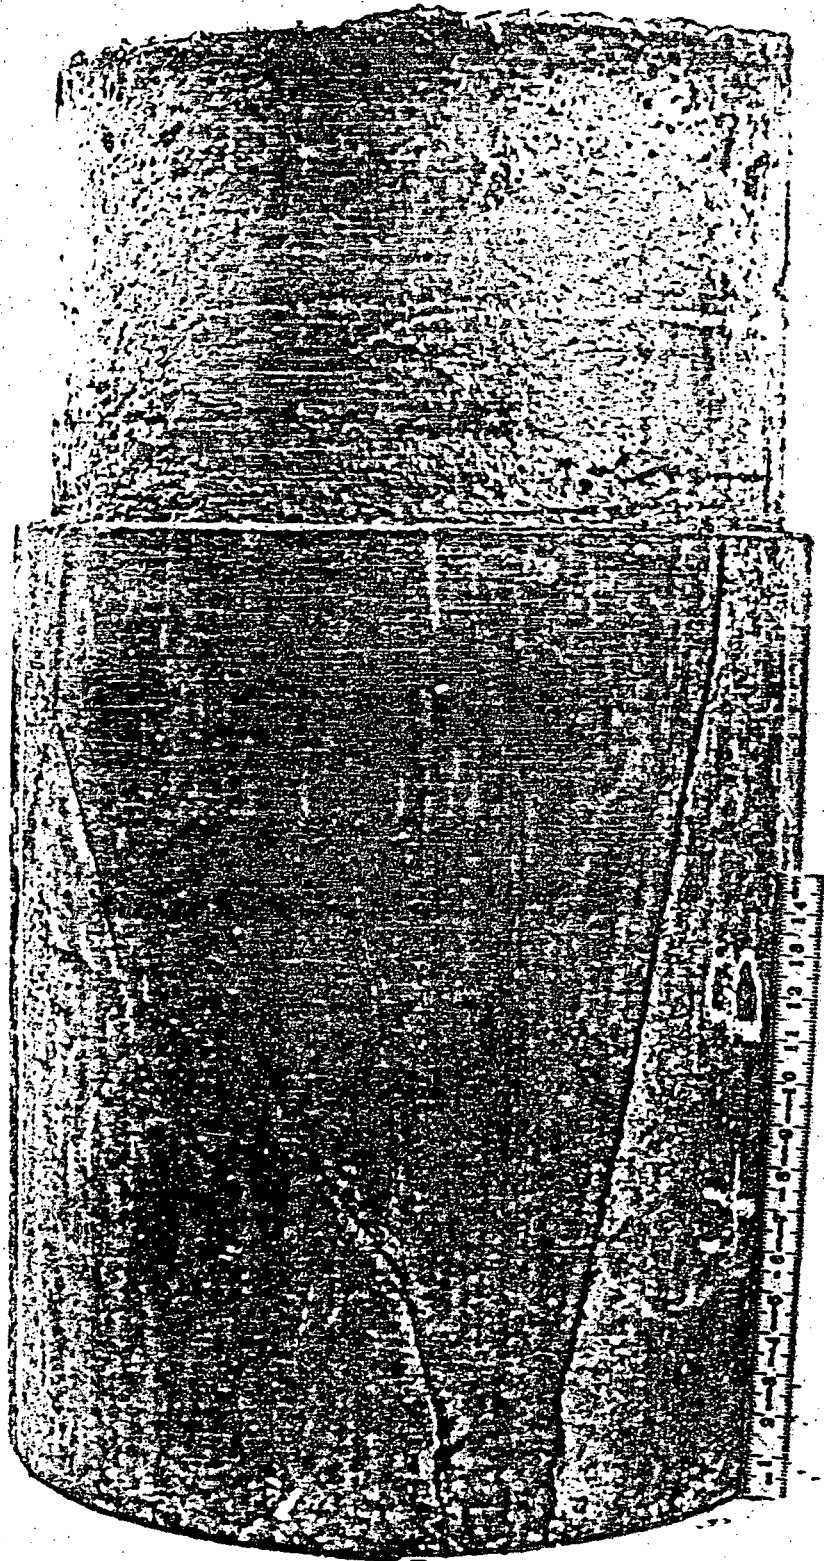
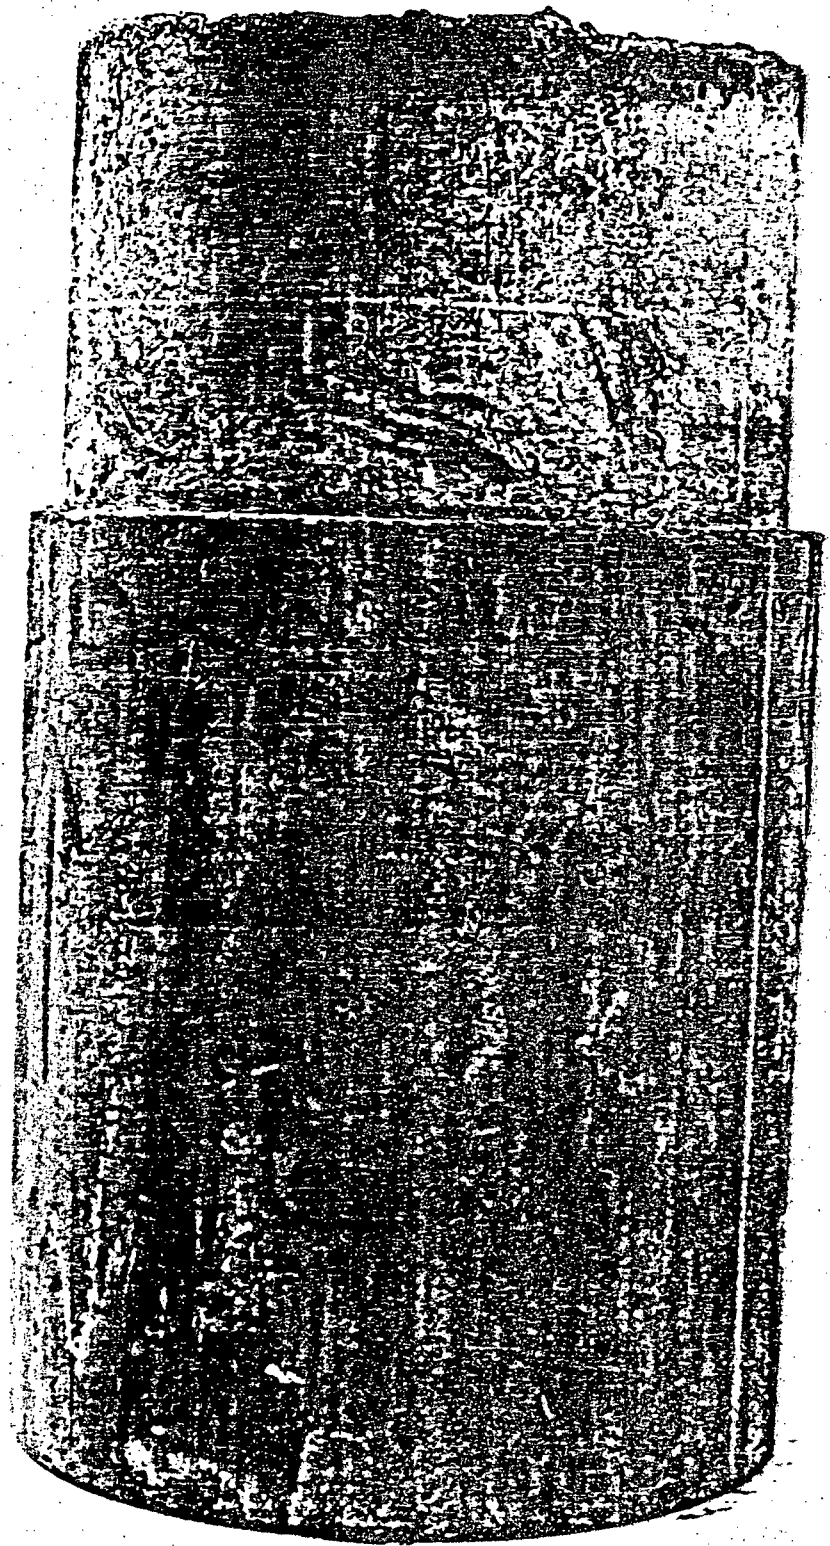
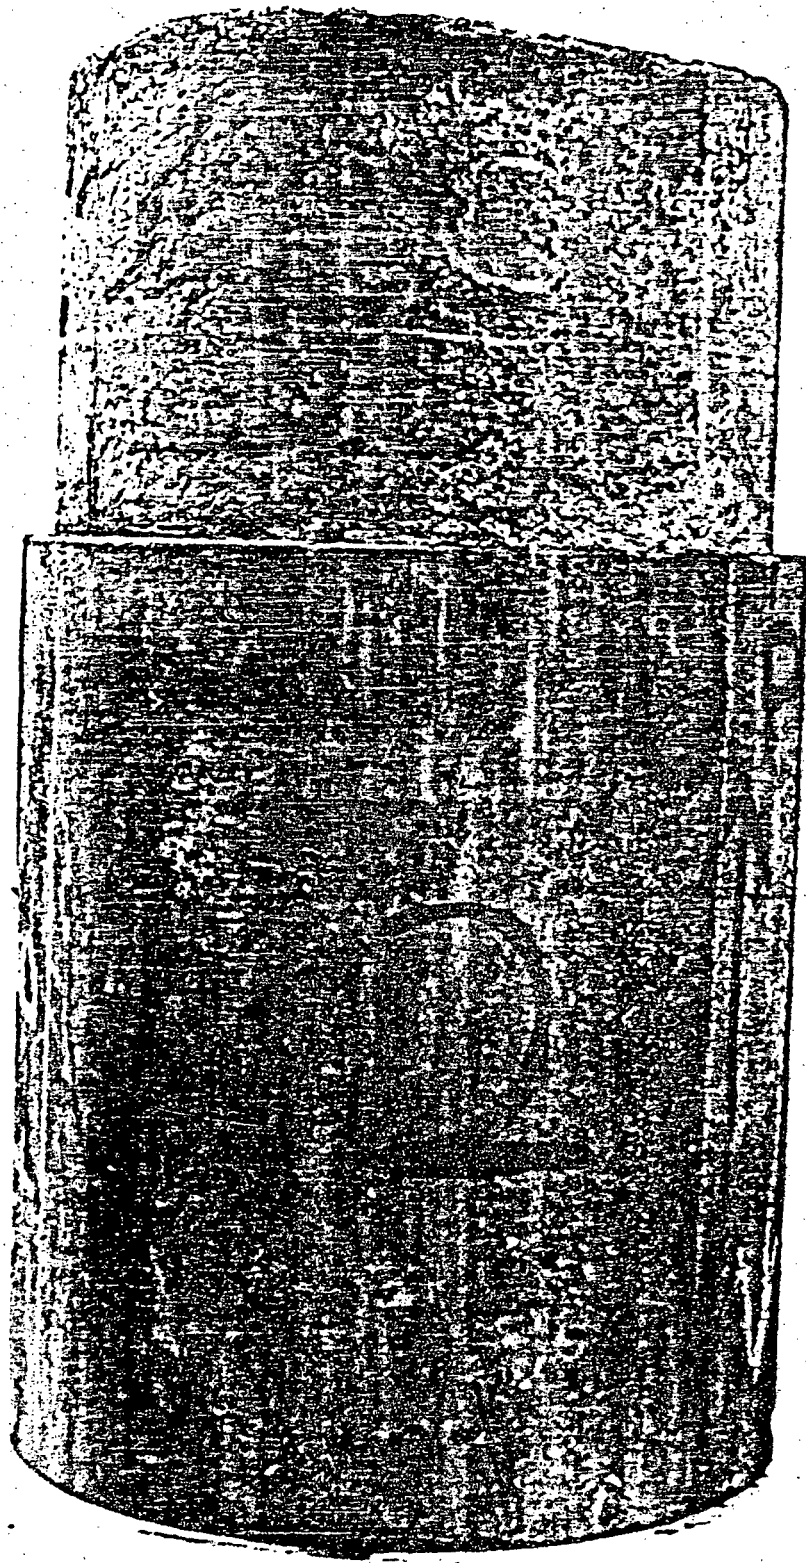
The specimens sent to BNL as identified by the sender (Bechtel) are listed in Appendix A. The piping received as 7-in. diameter, 29 #N-80 LT&C R3 seamless steel casing. Photographs of the sections of the pipe and collars, as received at BNL, are shown in Figures 1 through 4 (Junction numbers 1, 2, and 3, together with specimen 4 which is from a jaw assembly located above items 1, 2, and 3. As can be seen, the extent of general corrosion on 1, 2, and 3 appears to increase with depth. Note, however, that specimen number 4 was also severely corroded. A major branched crack is also visible in the crack in the collar of section 2.

Figure 2. Junction 2, as received at BNL.

Figure 2a. Junction 2, as received at BNL.

Figure 2b. Junction 2, as received at BNL.

Figure 2c. Junction 2, as received at BNL.

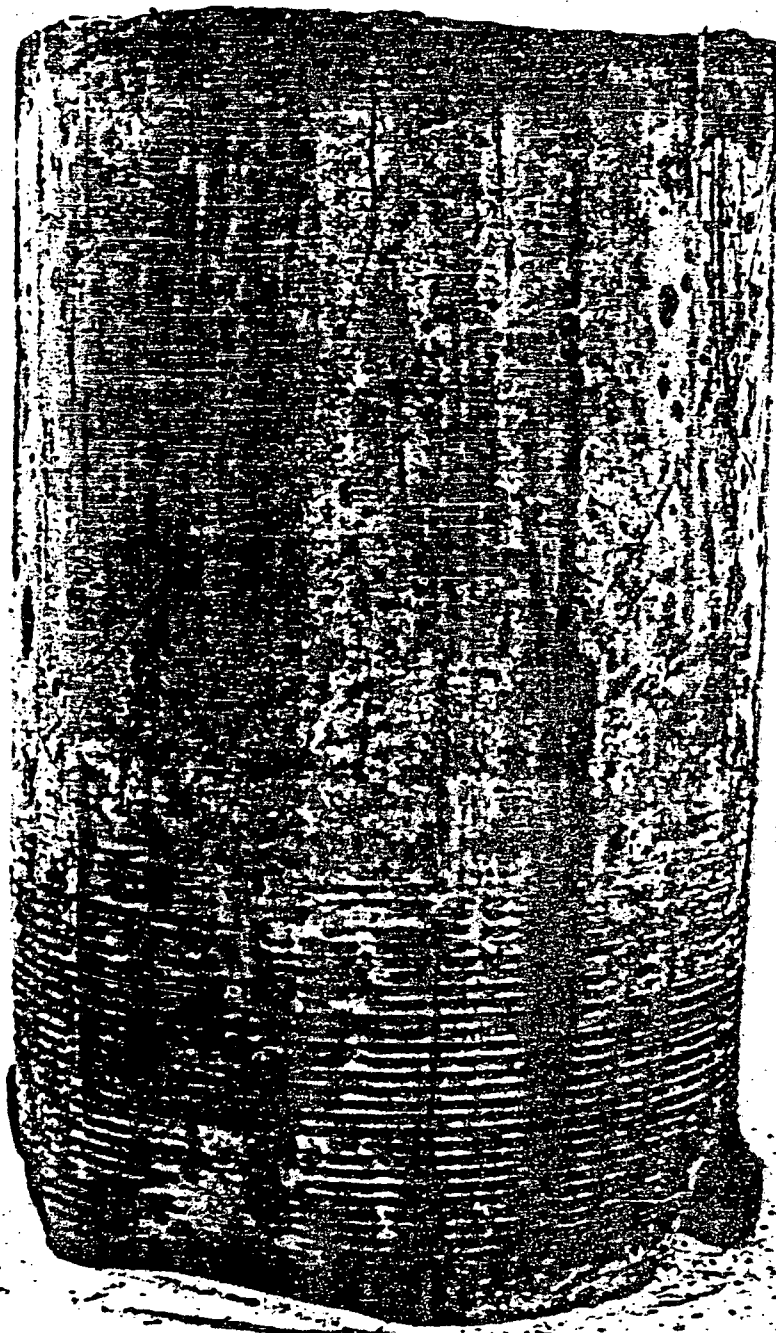
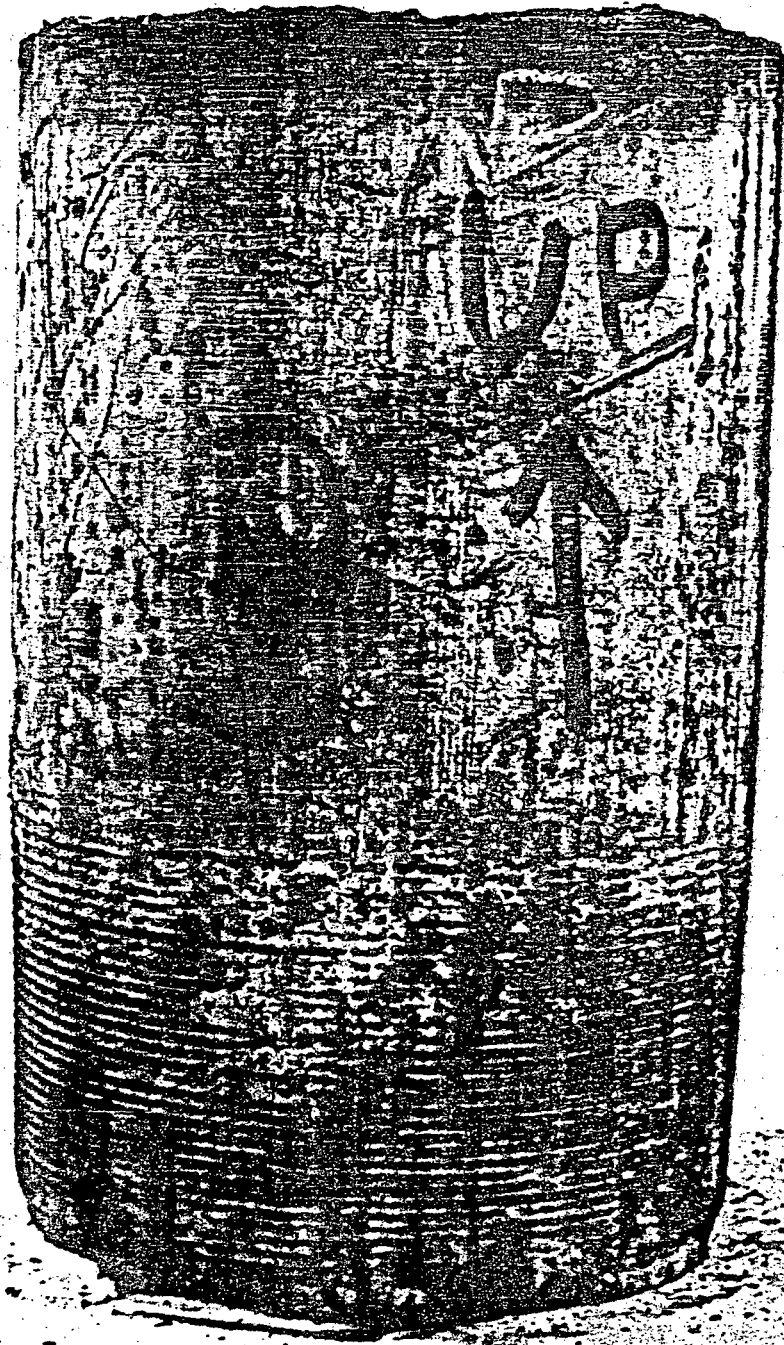
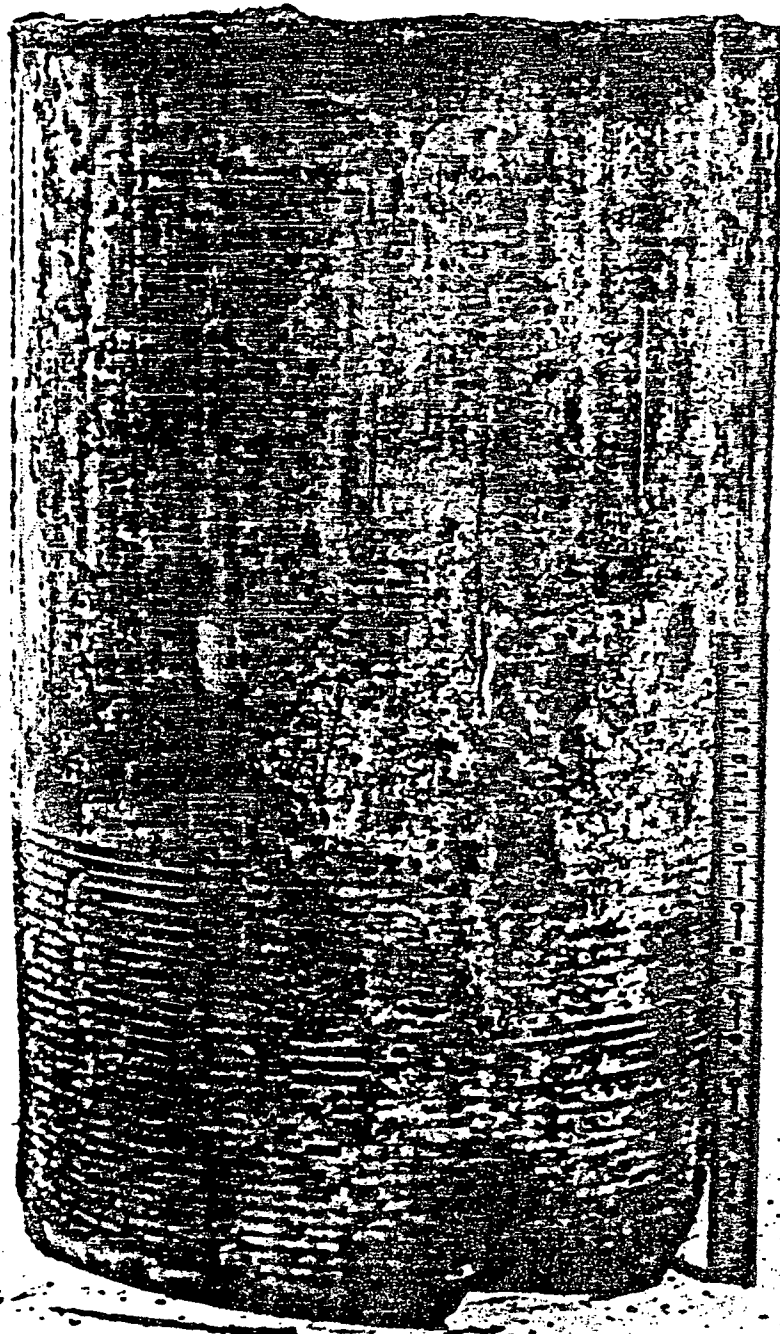
Figure 3. Junction 3, as received at BNL. Casing only - no collar. Bottom end damaged by falling 330 feet and impacting 7" liner at the bottom of the hole.

Figure 3a. Junction 3, as received at BNL. Casing only - no collar. Bottom end damaged by falling 330 feet and impacting 7" liner at the bottom of the hole.

Figure 3b. Junction 3, as received at BNL. Casing only - no collar. Bottom end damaged by falling 330 feet and impacting 7" liner at the bottom of the hole.

Figure 3c. Junction 3, as received at BNL. Casing only - no collar. Bottom end damaged by falling 330 feet and impacting 7" liner at the bottom of the hole.

Damage to pin #3 was caused by falling 330' and impacting 7" liner at the bottom of the hole

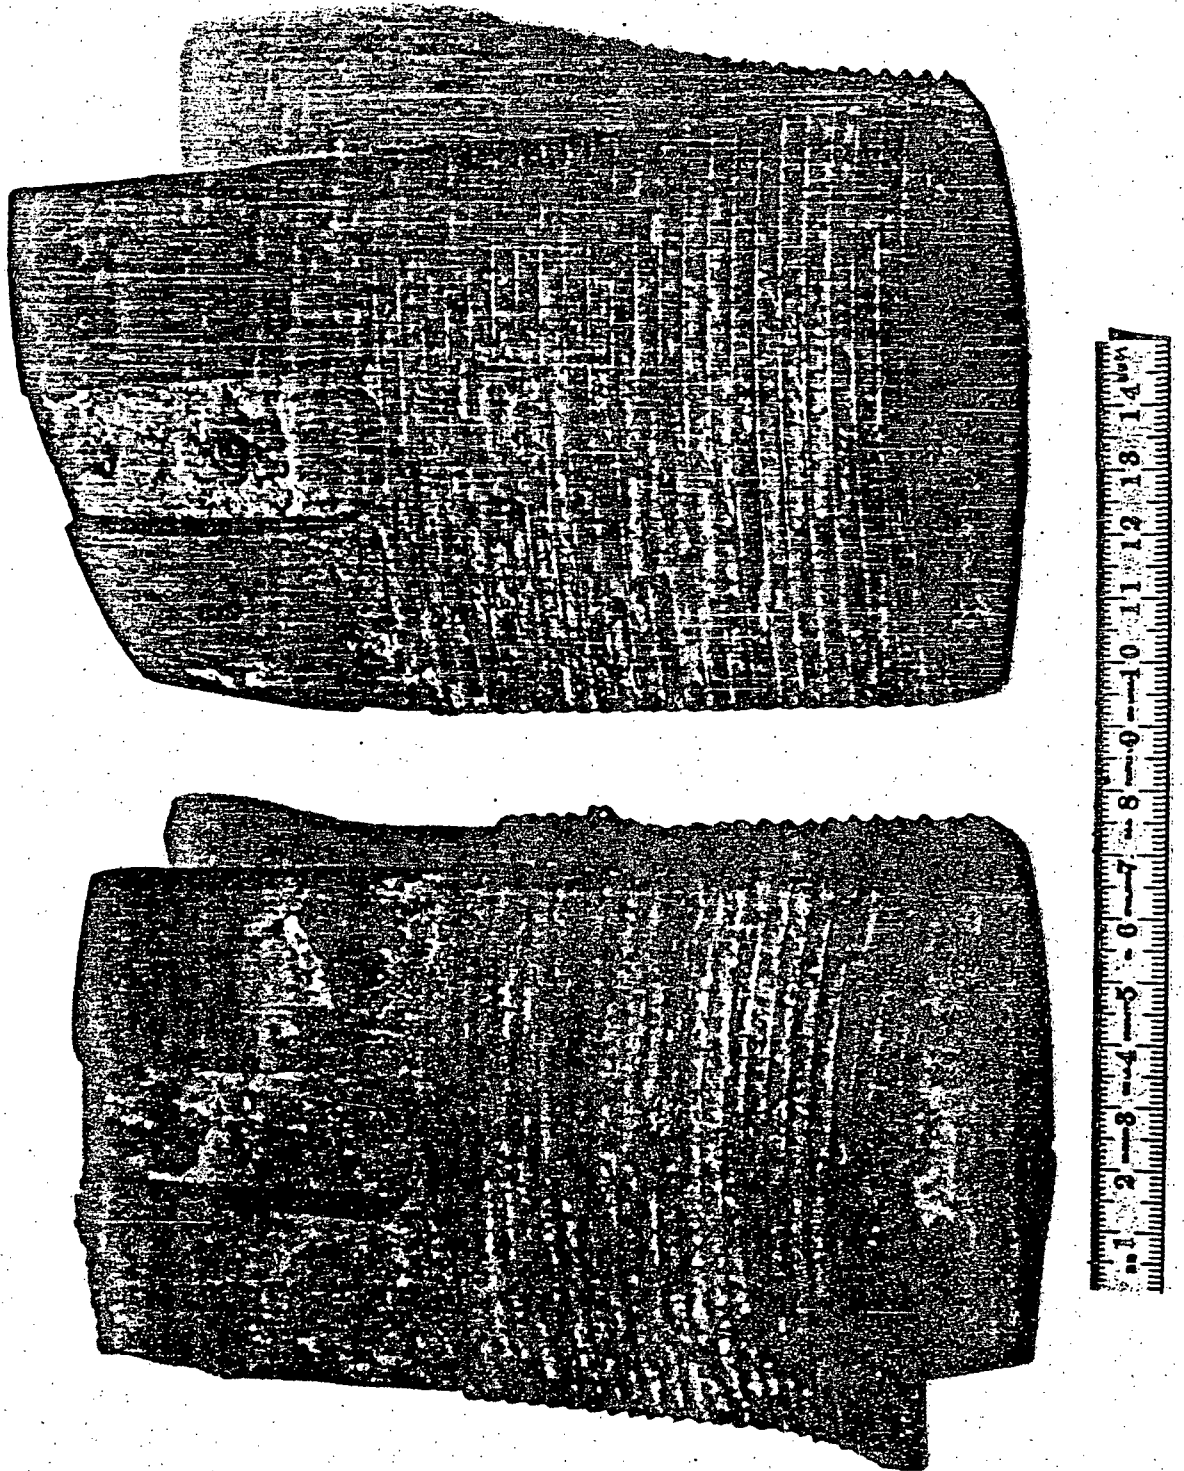
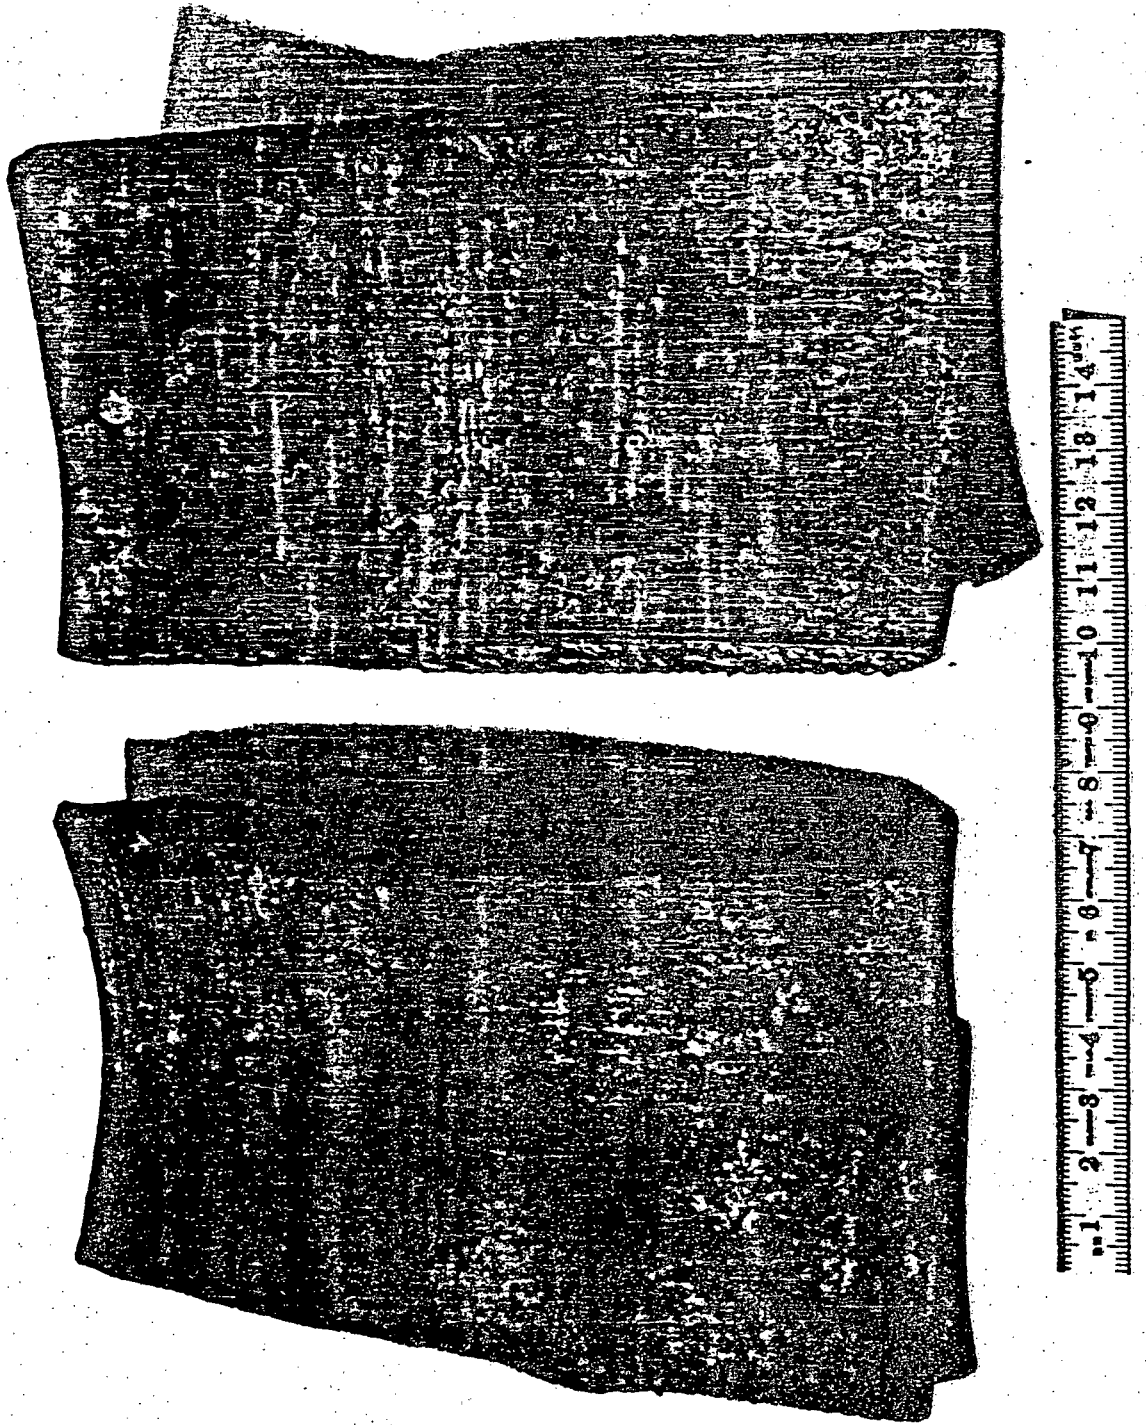
Figure 4. Junction 4, two segments of the casing pipe.

Figure 4a. Junction 4, two segments of the casing pipe outer surface.

Figure 4b. Junction 4, two segments of the casing pipe inner surface.

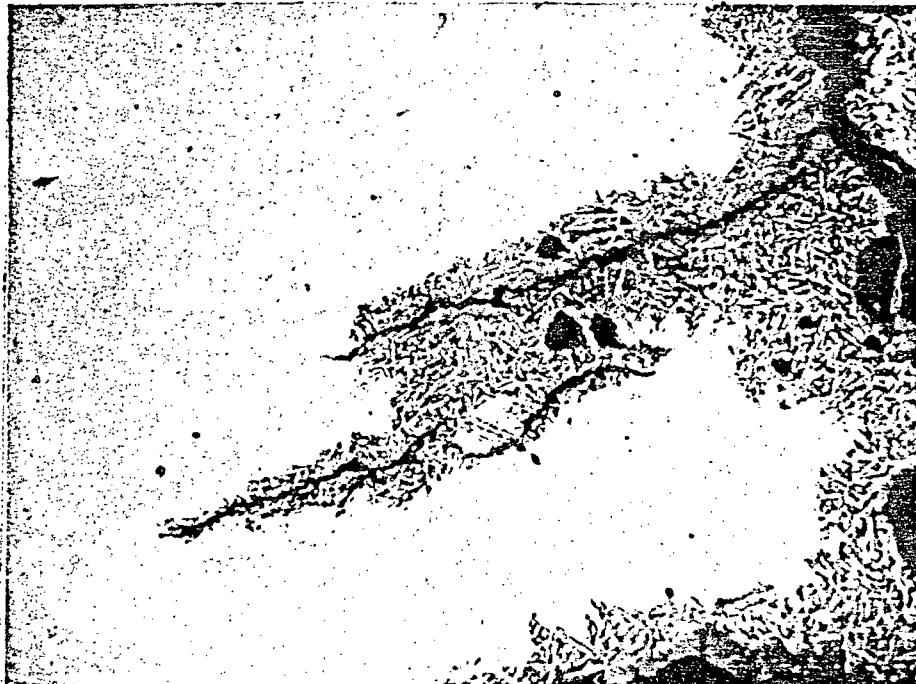
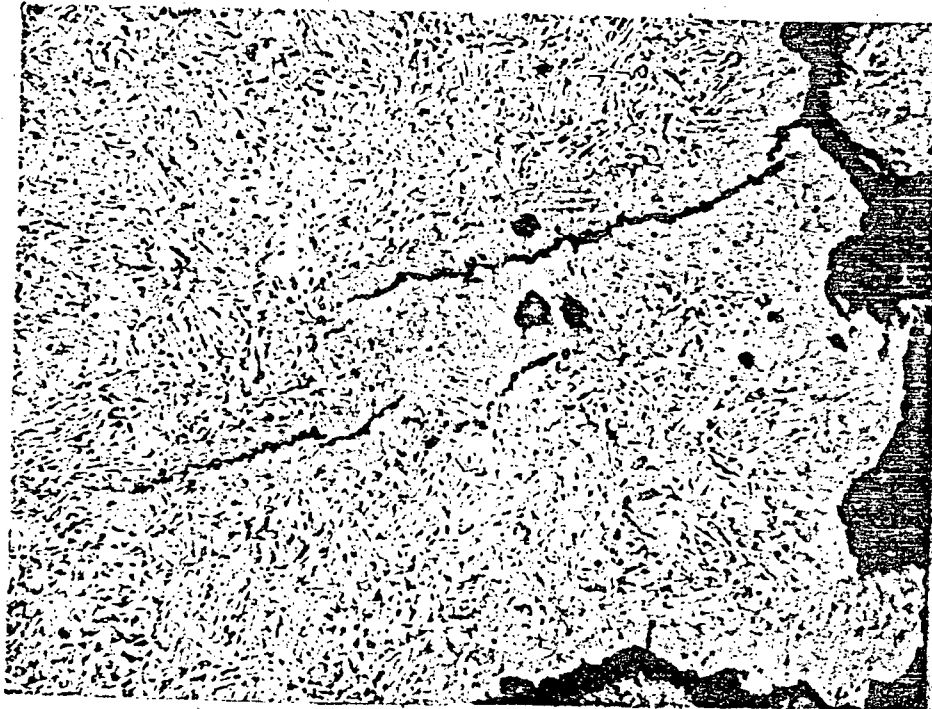
The cross sections of the secondary crack from collar number 2 are shown in Figures 2 through 7. The surface of the main crack is seen to be heavily corroded and a number of secondary cracks emitting from the primary crack are evident. The structure of the alloy is heavily martensitic, with no tendency for the crack to follow any of the martensite grain boundaries. Attempts to etch the specimens to try to bring out the original austenitic grain boundaries

Figure 5. Branching cracks departing from main crack, collar #2 (on left).

Figure 5a. Branching cracks departing from main crack, collar #2 (on left). 50 X, unetched.

Figure 5b. Branching cracks departing from main crack, collar #2 (on left). 100 X, unetched.

Figure 6. Cracks shown in Figure 5b, 100 X, etched.

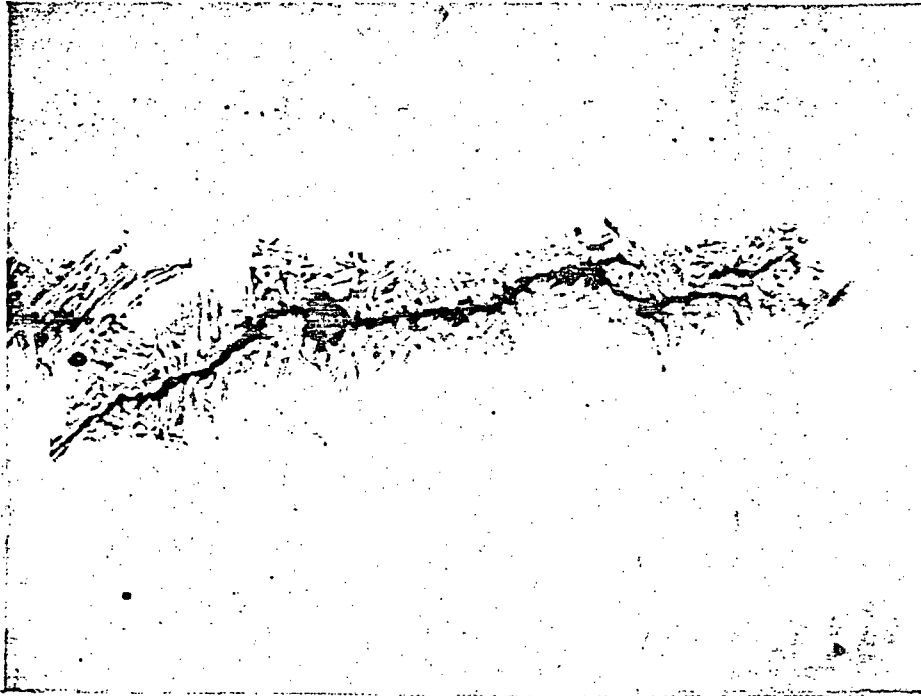
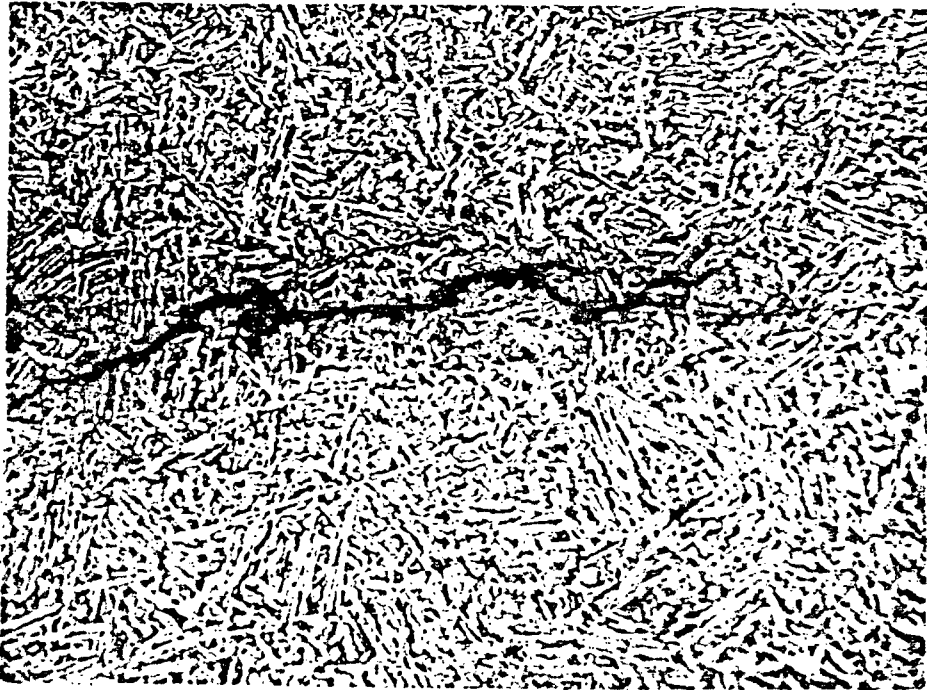
were unsuccessful. However, the micrographs of these cracks in the unetched condition show some of the martensitic grain structure in the vicinity of the cracks, suggesting that some penetration along the martensite grains may have occurred. Figures 8 and 9 show the fracture surface (in scanning electron micrographs) of two of these cracks after they were opened up in the laboratory. On the first, a through wall crack, one can see deposited crystals which from the EDS charts appear to be high in silicon, suggesting these crystals grew from the brine solution either during evaporation of the brine or as it flowed through the crack. An EDS spectrum of the second crack showed significant amounts of calcium and silicon present on the crack surface. There is no strong evidence of an intergranular type cracking phenomenon, however, or of any ductile rupture occurring in these cracks.

Figure 7. Crack tip, 200 X, unetched.

Figure 7a. Crack tip, 200 X, unetched.

Figure 7b. Crack tip, 200 X, etched.

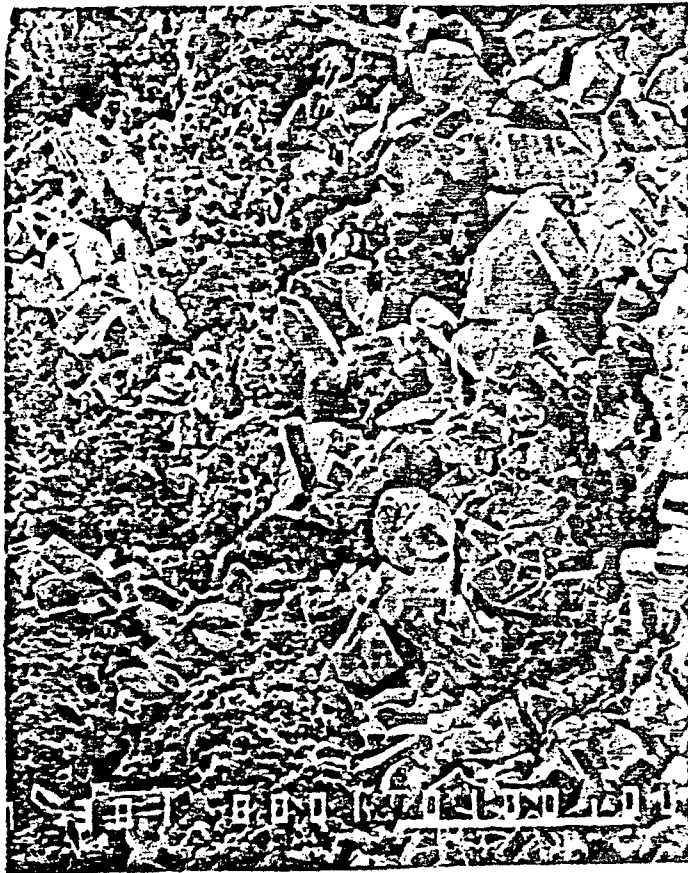
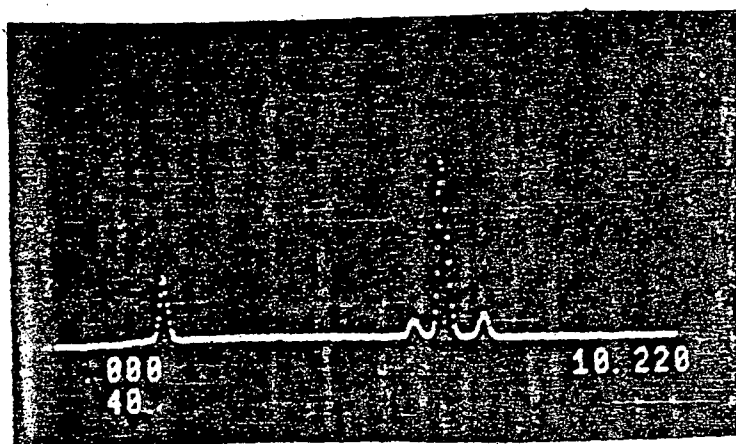
Figure 8. SEM picture of crack surface, showing crystals grown from geothermal brine.

Figure 8a. SEM picture of crack surface, showing crystals grown from geothermal brine.

Figure 8b. EDAX of crystals.

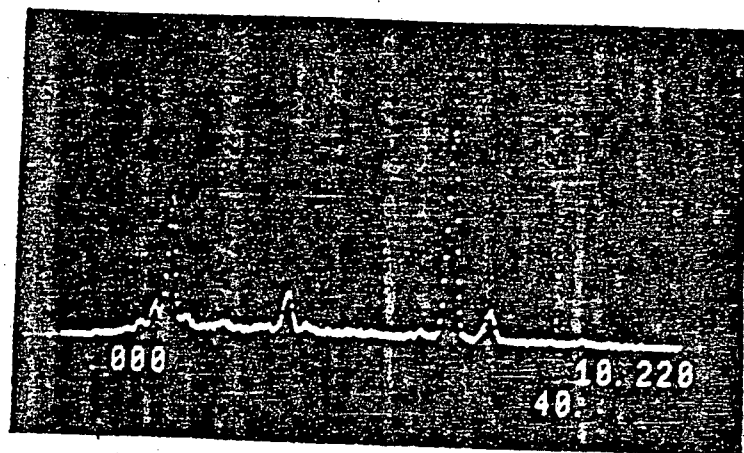
Figure 9. SEM picture of fracture surface of secondary crack.

Figure 9a. SEM picture of fracture surface of secondary crack.

Figure 9b. EDAX of corrosion product.

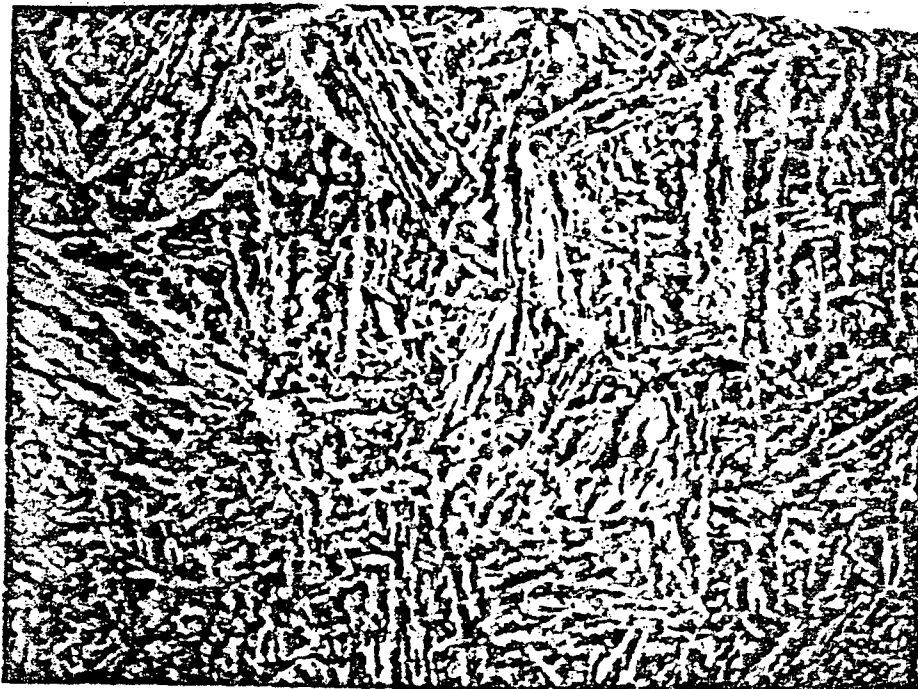
The microstructure of the casing and collar materials are shown in Figure 10 at 400 x magnification; by comparison with the coarse-grained acicular structure of the collar, the casing is seen to be finer grained, but still martensitic. The slight rounding of the particles, however, suggests that some tempering of the martensitic had occurred.

Figure 10. Casing material

Figure 10a. Casing material 400 X 5% nital etched.

Figure 10b. Collar material 400 X 2% nital etched.

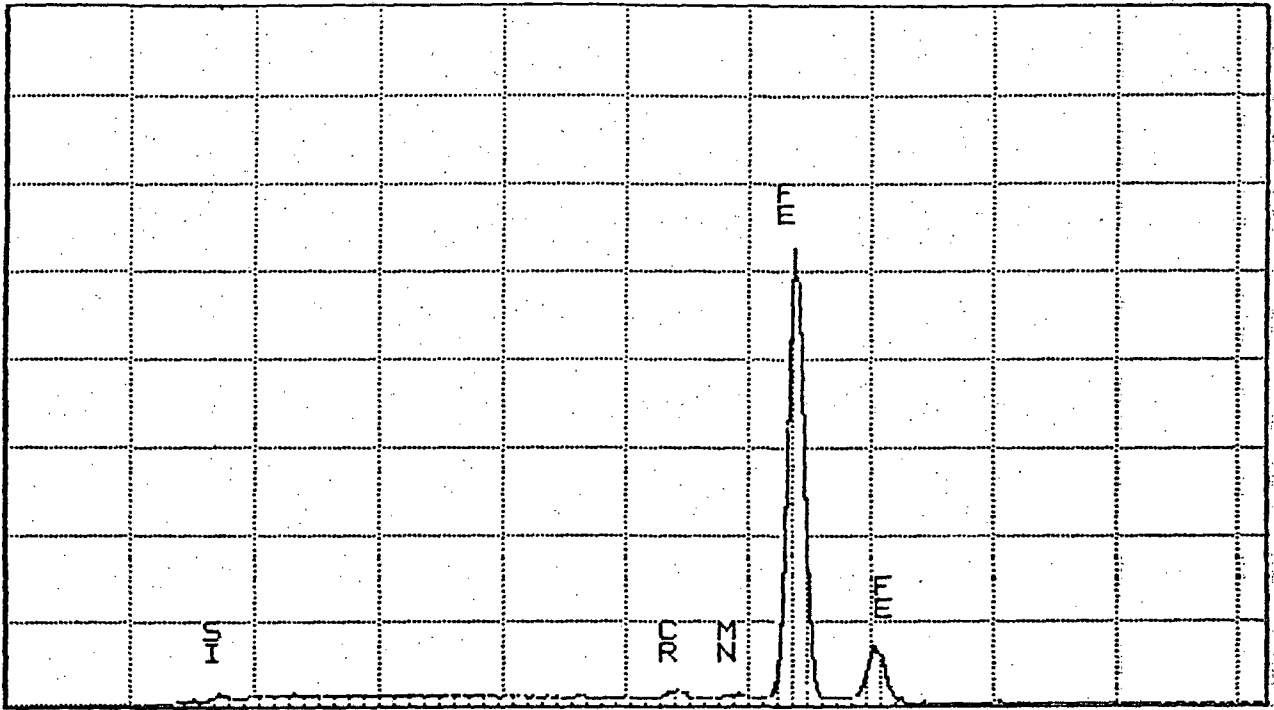
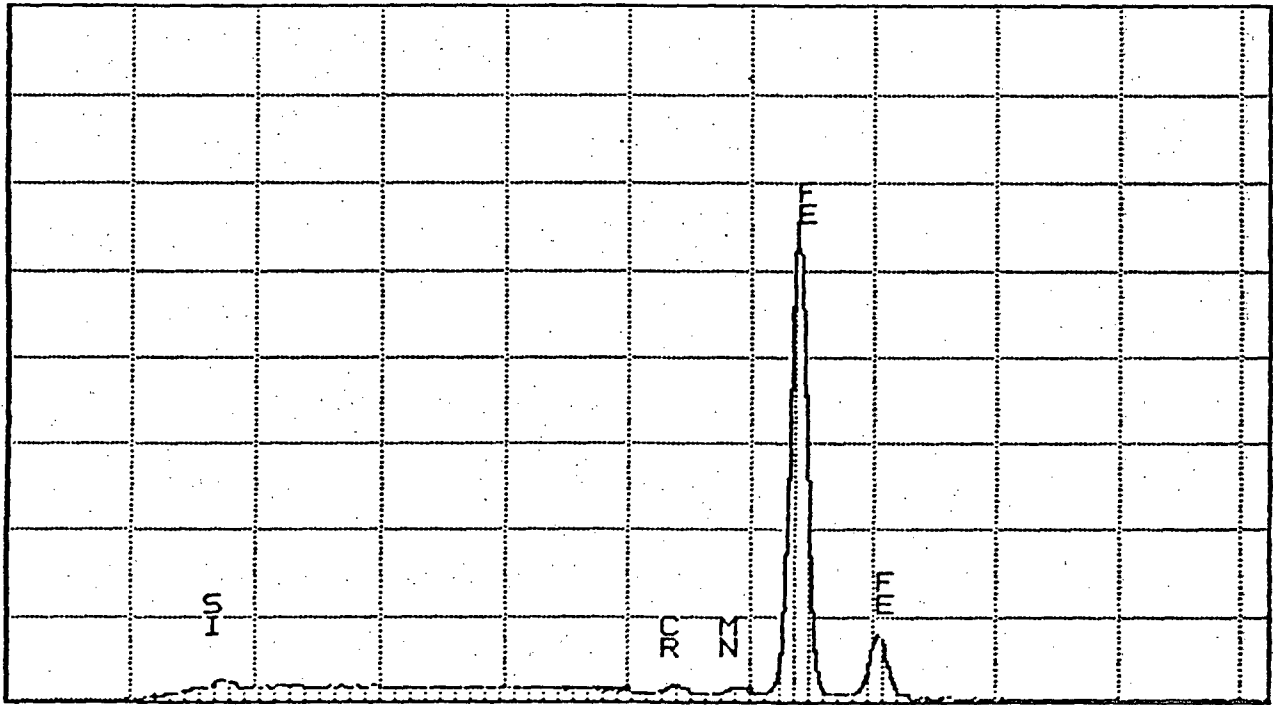
A sample from each alloy was examined in the EDAX. The patterns received are shown in Figure 11 A and B. It is apparent these EDAX scans are essentially identical and indicate no major differences in alloying constituents between the collar and casing materials.

Figure 11a. EDAX scan of casing alloy.

Figure 11b. EDAX scan of collar alloy.
