FAILURE INVESTIGATION OF WELL CASING
FROM THE SALTON SEA SCIENTIFIC DRILLING PROJECT (SSSDP)

D. van Rooyen and J. R. Weeks
Department of Applied Science
Brookhaven National Laboratory
Upton, New York 11973

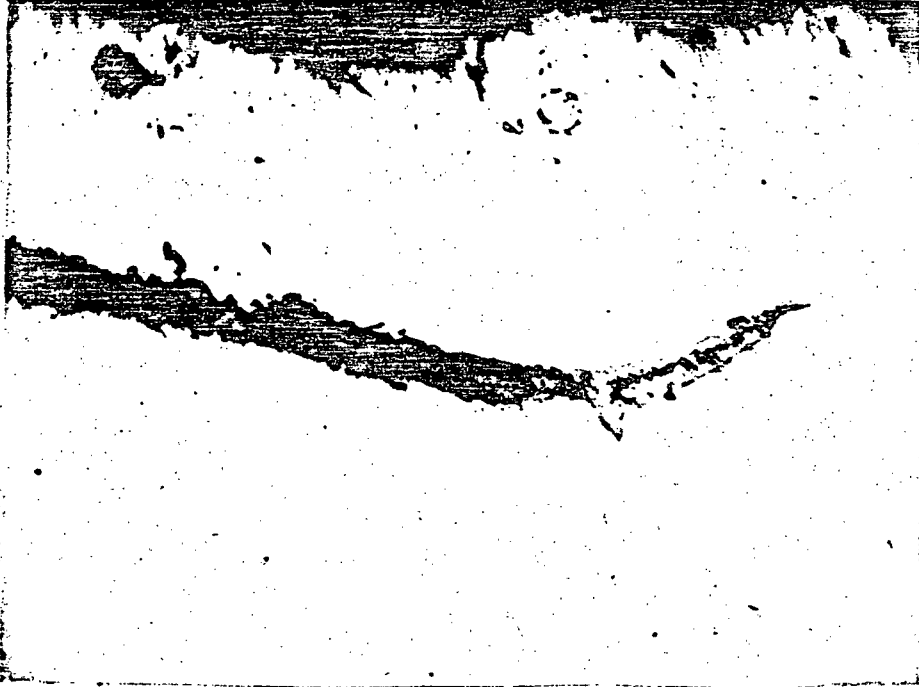
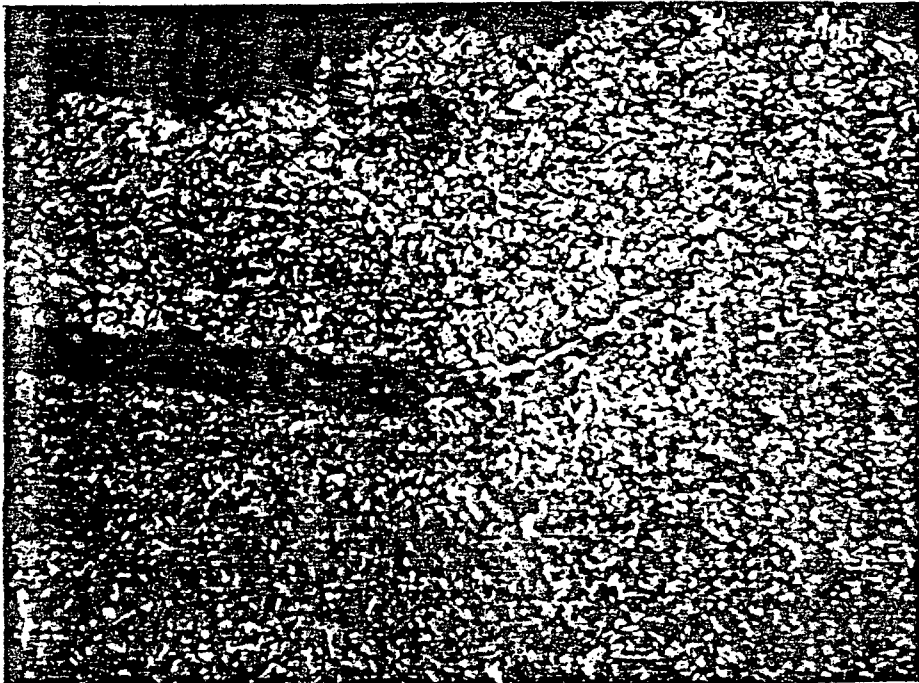
As noted above, during dye penetrant examination, a small, longitudinal, part through-wall crack was identified in collar number 1. A portion of this collar including the crack was examined metallographically. The results are shown in Figure 12 A and B. It can be seen that this is a shallow crack that propagated at an acute angle to the surface and not in a direction in which it would have tended to penetrate the piping. The appearance of this crack is entirely consistent with "hydrogen blistering" although whether it was actually due to this phenomenon or to another stress corrosion phenomenon cannot be determined at present.

It was not possible to tell whether the cracks in the collar number 2 originated from the inner or outer surface of the collar. The crack on the first collar, however, was definitely shallow and only on the exterior surface. The nature of this crack is quite suggestive of that for hydrogen blistering as described by others, as cited above. It is interesting to note that the highest hardness was consistently observed on the outer surface of the collar and that it consistently exceeded the (nominal) borderline (Rc22) associated with oil industry applications.

Figure 12. Surface crack found near collar #1
or casing, 200 X, unetched.

Figure 12a. Surface crack found near collar #1
or casing, 200 X, unetched.

Figure 12b. Surface crack found near collar #1
or casing, 200 X, etched.
