LACKLAND AIR FORCE BASE

SAN ANTONIO, TEXAS

GEOLOGICAL AND FOUNDATION INVESTIGATION

APRIL 1967

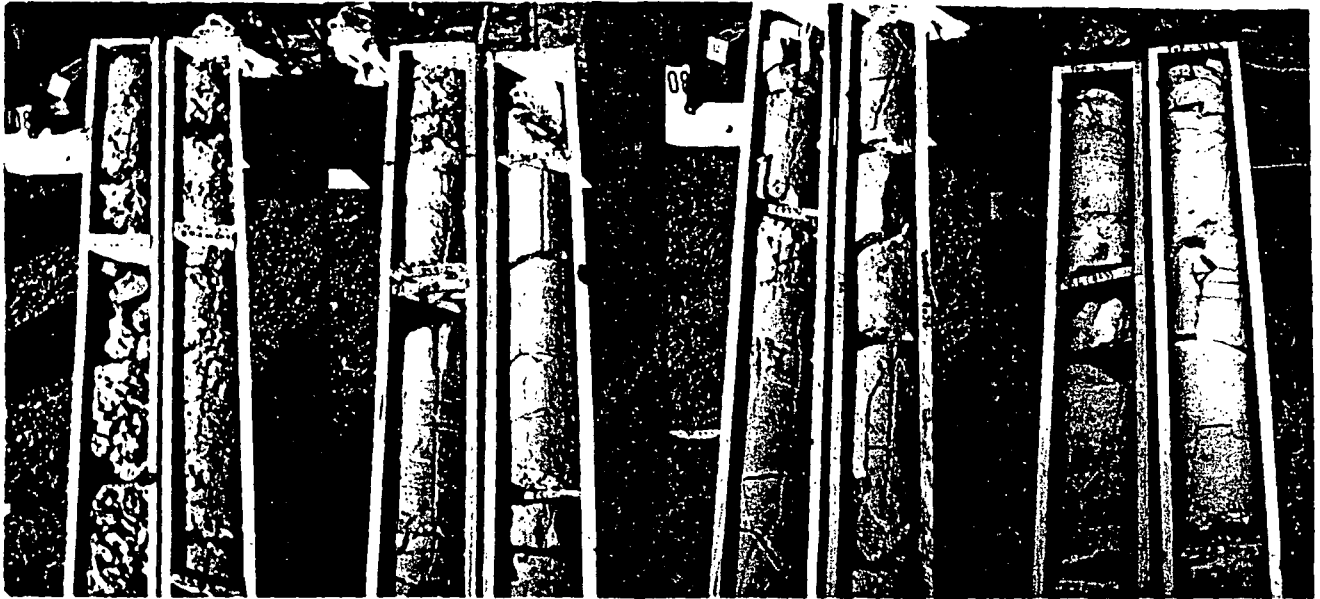
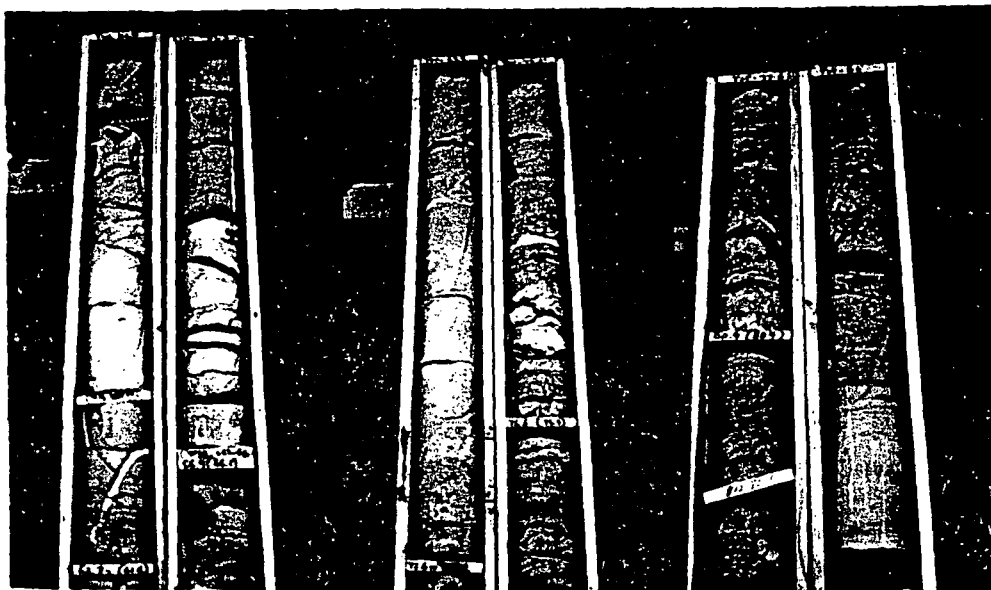
FIGURE 1

The Navarro group is a sandy, silty clay shale and, in most cases, exhibits jointing, fracturing, and weathering features to a depth of 70 to 80 feet below the ground surface (Figure 1). The Navarro immediately underlies the overburden in the southern one-third of the Study Area, within a small portion of the Hospital Complex area, and beneath almost all of Kelly AFB. The maximum thickness of the Navarro within the Study Area is approximately 450 feet.
