BLOWOUT OF A

GEOHERMAL WELL

THE GEYSERS GEOHERMAL FIELD,

SONOMA COUNTY, CALIFORNIA

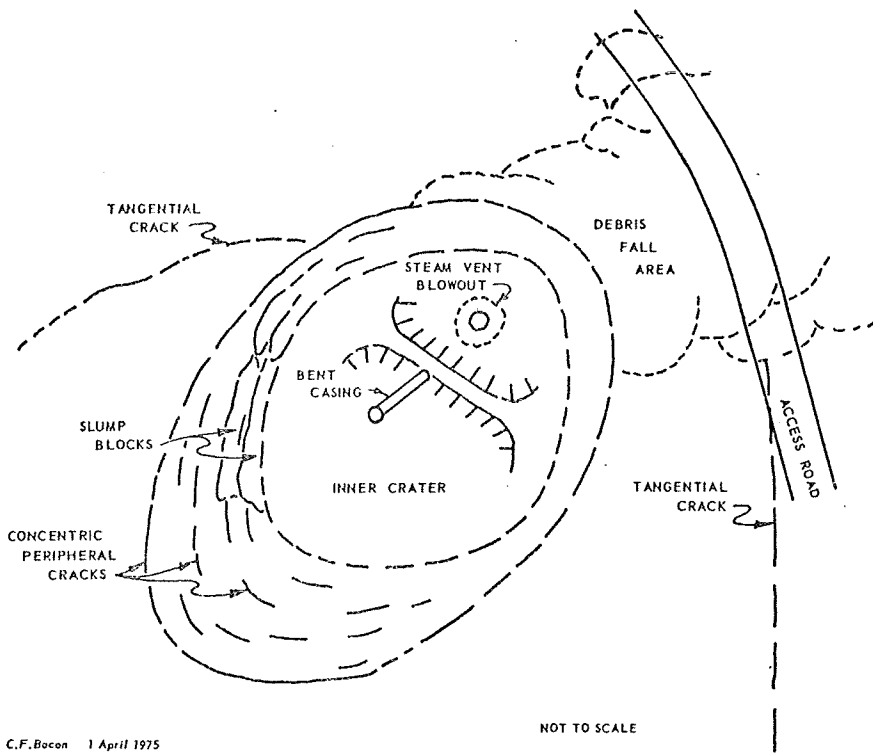
Steam was issuing from two sources within the crater: (1) from a 3 inch

bleeder valve nipple opening on the bent-over well head, and (2) from an open hole well head and 20 inch surface casing. A mixture of sand, dust, and rock fragments accompanied the steam venting from the open hole, but mostly clean, dry steam issued from the well head which was bent 35° to the southwest (down slope). At intervals small rock fragments were thrown as high as 150 to 200 feet in the air; 6-inch to 10-inch fragments were found scattered over much of the drill site.

Diagrammatic sketch map of blowout crater, well "G.D.C." 65-28 prior to excavation and abandoning.

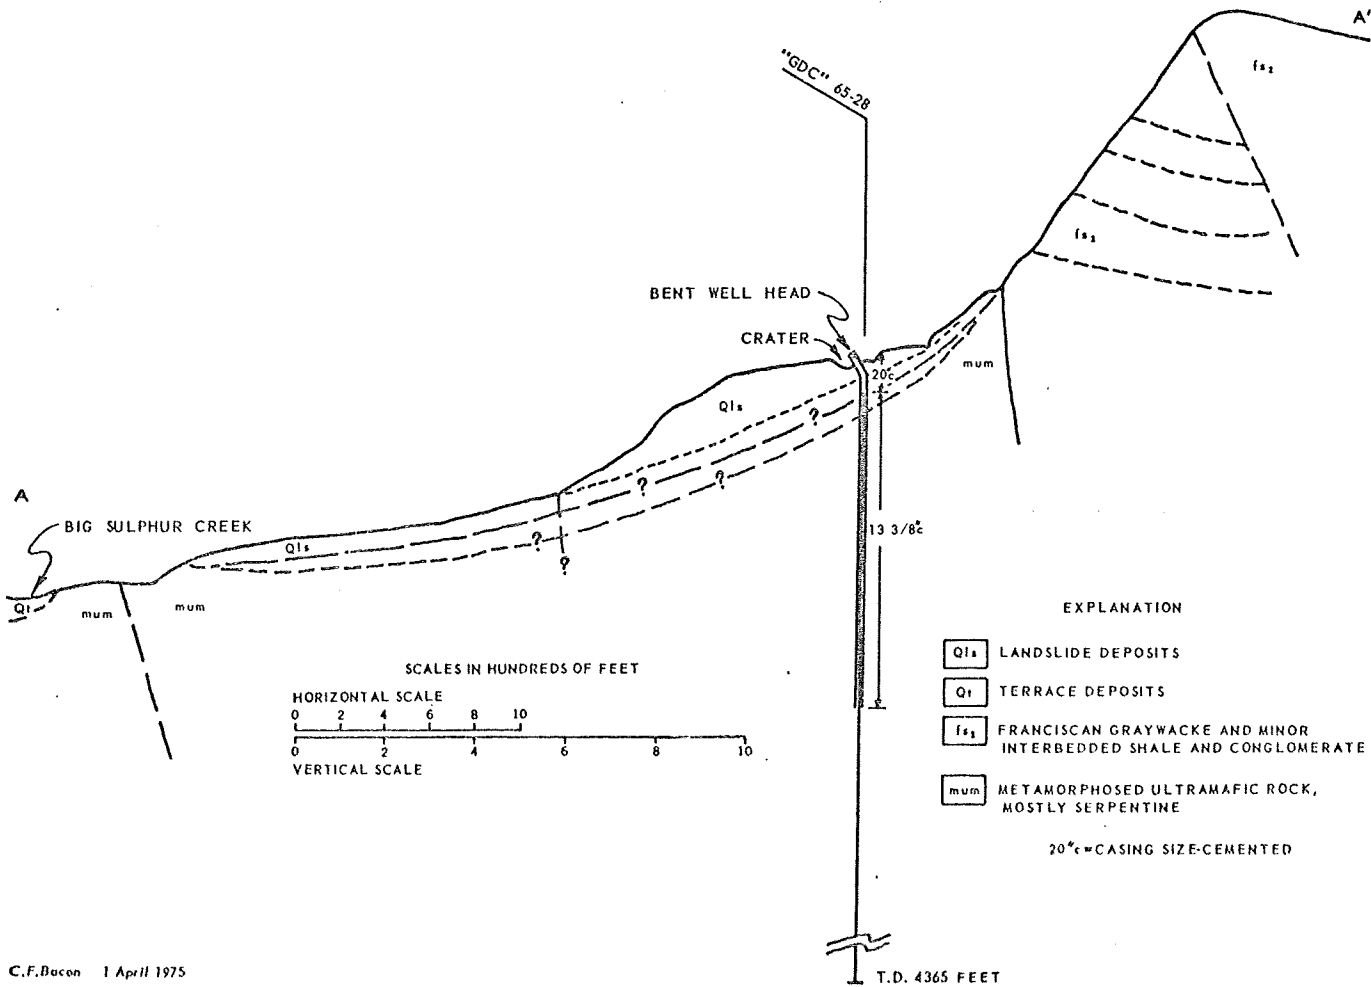
Diagrammatic geologic section showing possible relationships to blown-out geothermal well "G.D.C." 65-28.

A preliminary geologic section drawn through the "G.D.C." 65-28 well site revealed that the 20-inch surface casing, which was set 80 feet deep, might have just barely reached in-place rock—or possibly might have been cemented in slide material. However, subsequent examination of the materials encountered in the excavation that was made around the well in the efforts to regain control, together with other evidence, indicates that the slide is at least 125 feet deep.

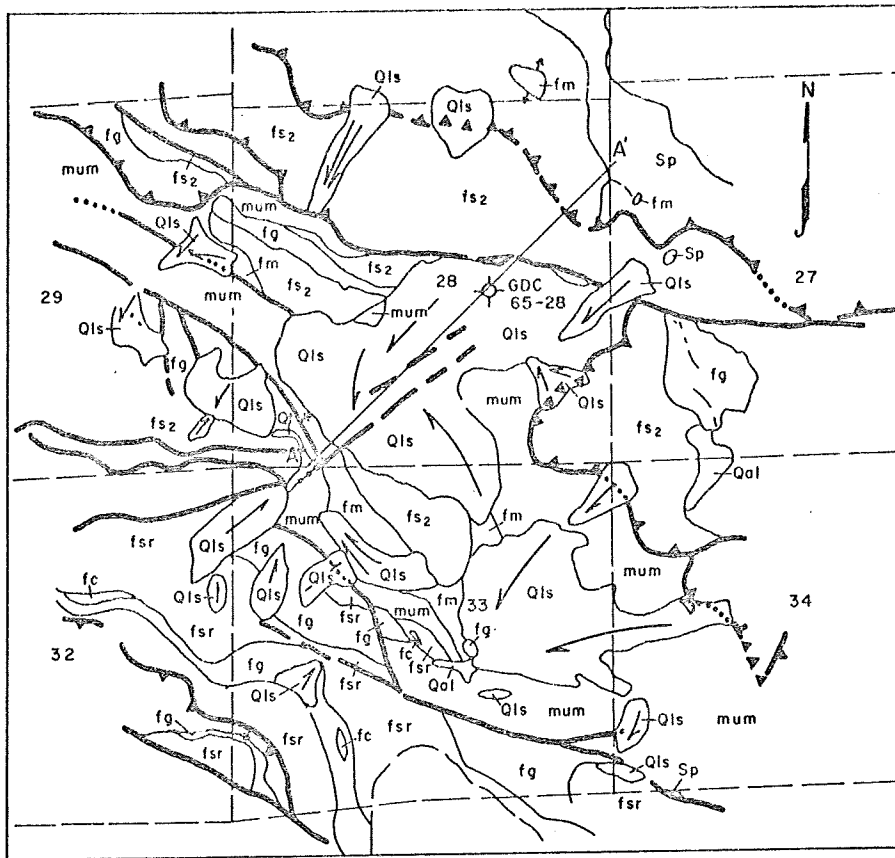
Geologic map, vicinity of Union Oil Co. Well "G.D.C." 65-28. Adapted from USGS Open-file map 74-238, *Preliminary geologic map of The Geysers steam field and vicinity, Sonoma County, California* by Robert J. McLaughlin, 1974.

Geologic mapping recently completed by McLaughlin (1974) indicates that geothermal well "G.D.C." 65-28 is situated on the upper part of a large landslide nearly 1 mile long. Two other wells are sited on this same slide area and the nearest one, "Little Geysers" 2, which was drilled in 1964, was plugged and abandoned with much difficulty in 1971. Additional work is still needed to seal small steam vents and a bubbling pool located in a hole on the site. A count of geothermal wells located within The Geysers area and within the bounds of McLaughlin's map area, showed that over 90 wells are located on landslides.

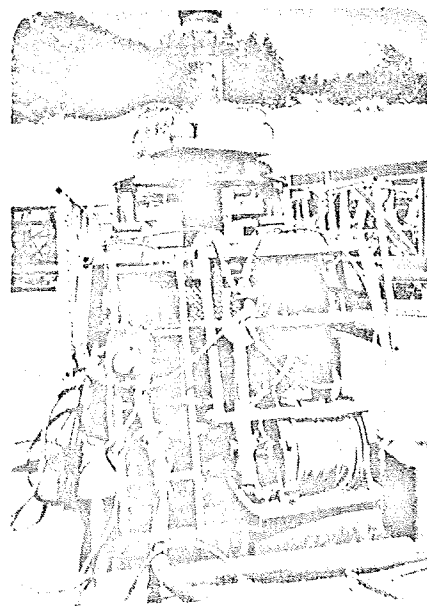
almost certainly indicate slippage of earth materials in the old slide mass—probably moving along a plane similar to those exposed higher up in the excavation walls. On 28 July 1975 an unsuccessful attempt using hydraulic jacks was made to retrieve the damaged portion of the casing for metallurgical tests. Similar tests run on damaged portions of casing retrieved from higher up have disclosed a low resistance to impact but no other unusual conditions.

The heavy duty hydraulic jacking equipment used to bring the remaining broken off segment of casing to the surface after completion of the excavation and backfill (see text).
