CASING FAILURE - RR&E #1

The following is an analysis of the probable cause of the production (13-5/8") casing ^{failure} in RR&E #1 which occurred on 2/24/75 during cementing of the production casing. Zone of collapse occurred ^{at 3,315-3,338 ft.} and 3,584-3,591 ft.

CASING FAILURE AT RRGE-1

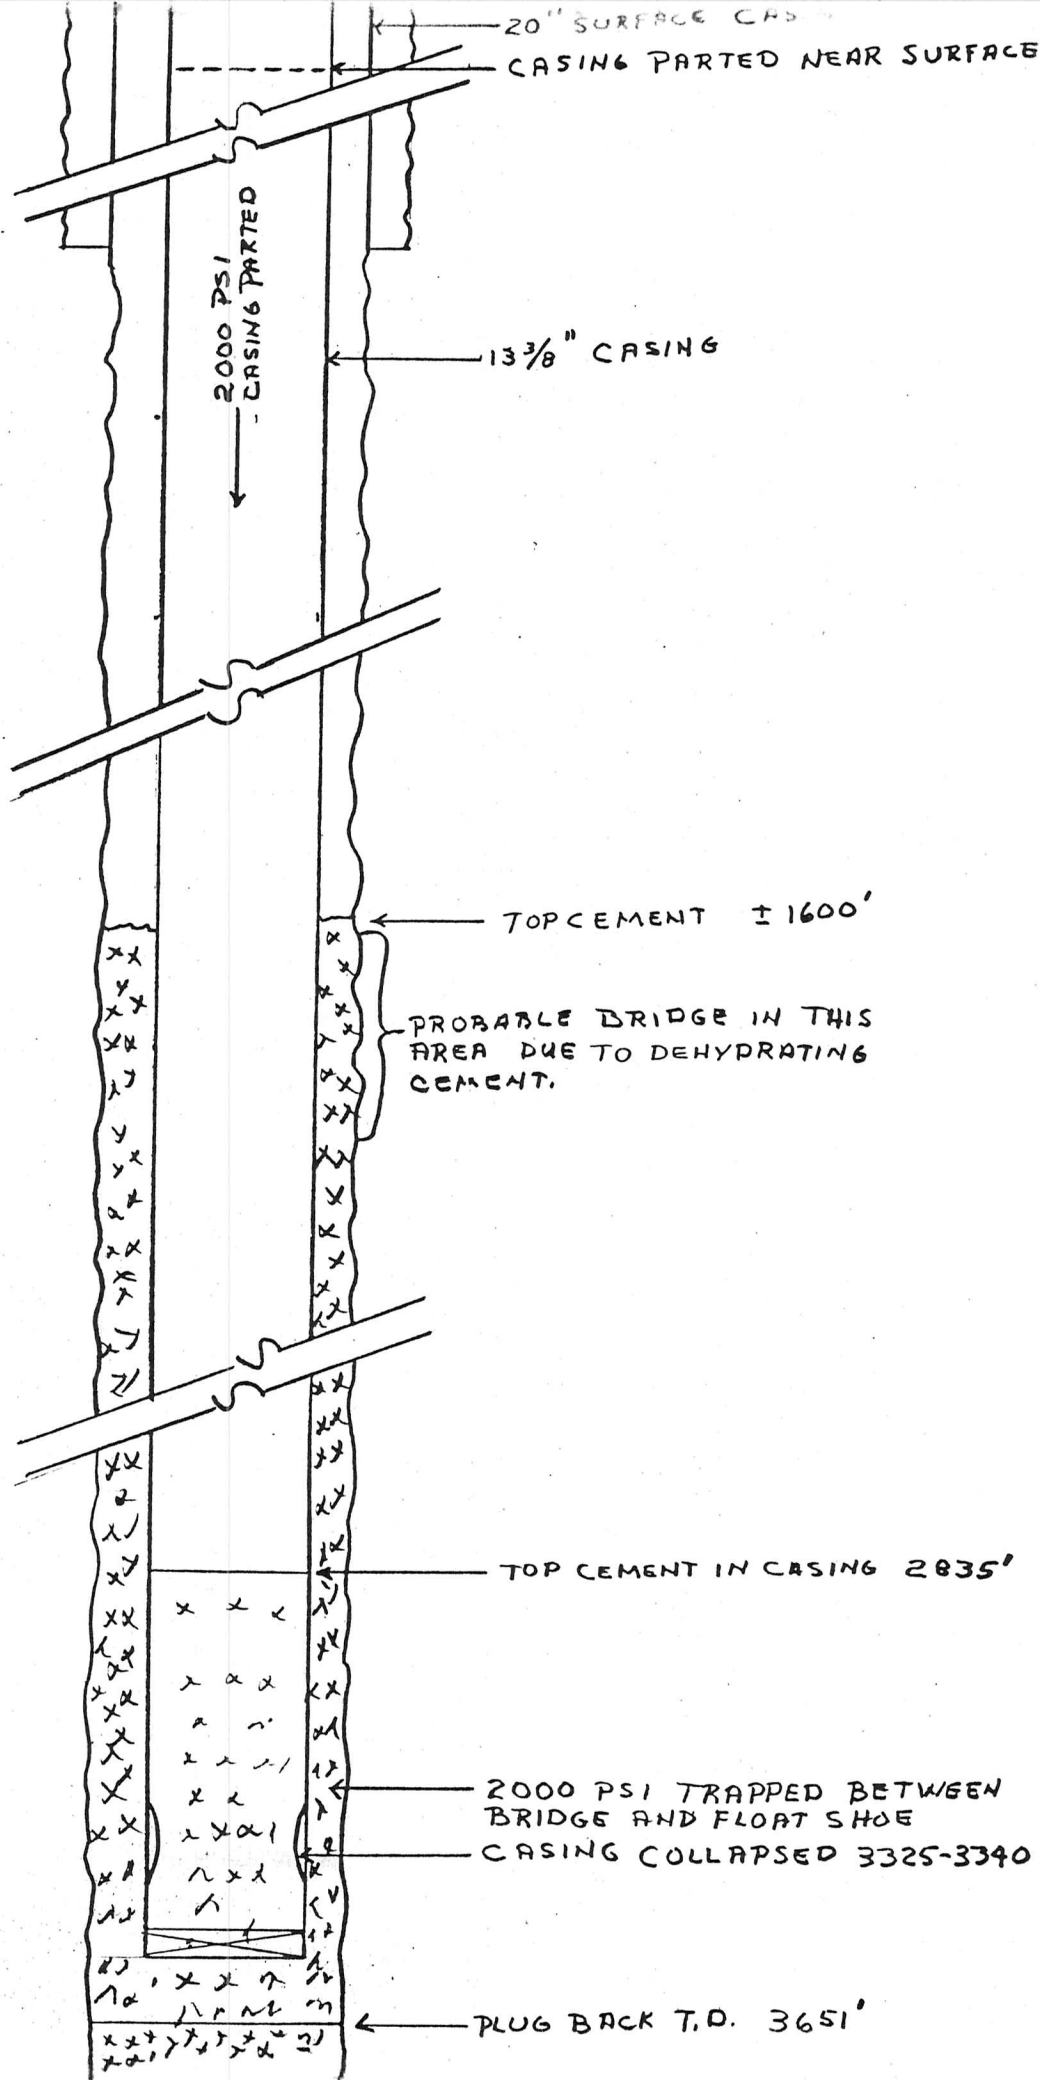
The increasing pressure during displacement was

probably due in a small part to the changing hydrostatic head and the most part to thickening of the cement slurry due to loss of water into the formation. The first portion of the slurry would thicken to the point of non-pumpability because it had the longer contact time with the formation. When the lead slurry was no longer pumpable at 2000 psi, movement ceased. The 2000 psi was trapped inside the casing and also in the annulus between the thickened slurry at the top and the float shoe at the bottom. When the casing parted, the pressure inside the pipe was relieved to hydrostatic instantly while the pressure in the annulus, trapped between the thickened cement and the float shoe, could not be relieved. At this point the 2000 psi trapped exceeded the 1,540 psi collapse of 13 3/8", 61# casing. This excess pressure collapsed the casing from 3,325' to 3,340'.

The attached diagram shows graphically the probable cause of the collapsed casing.

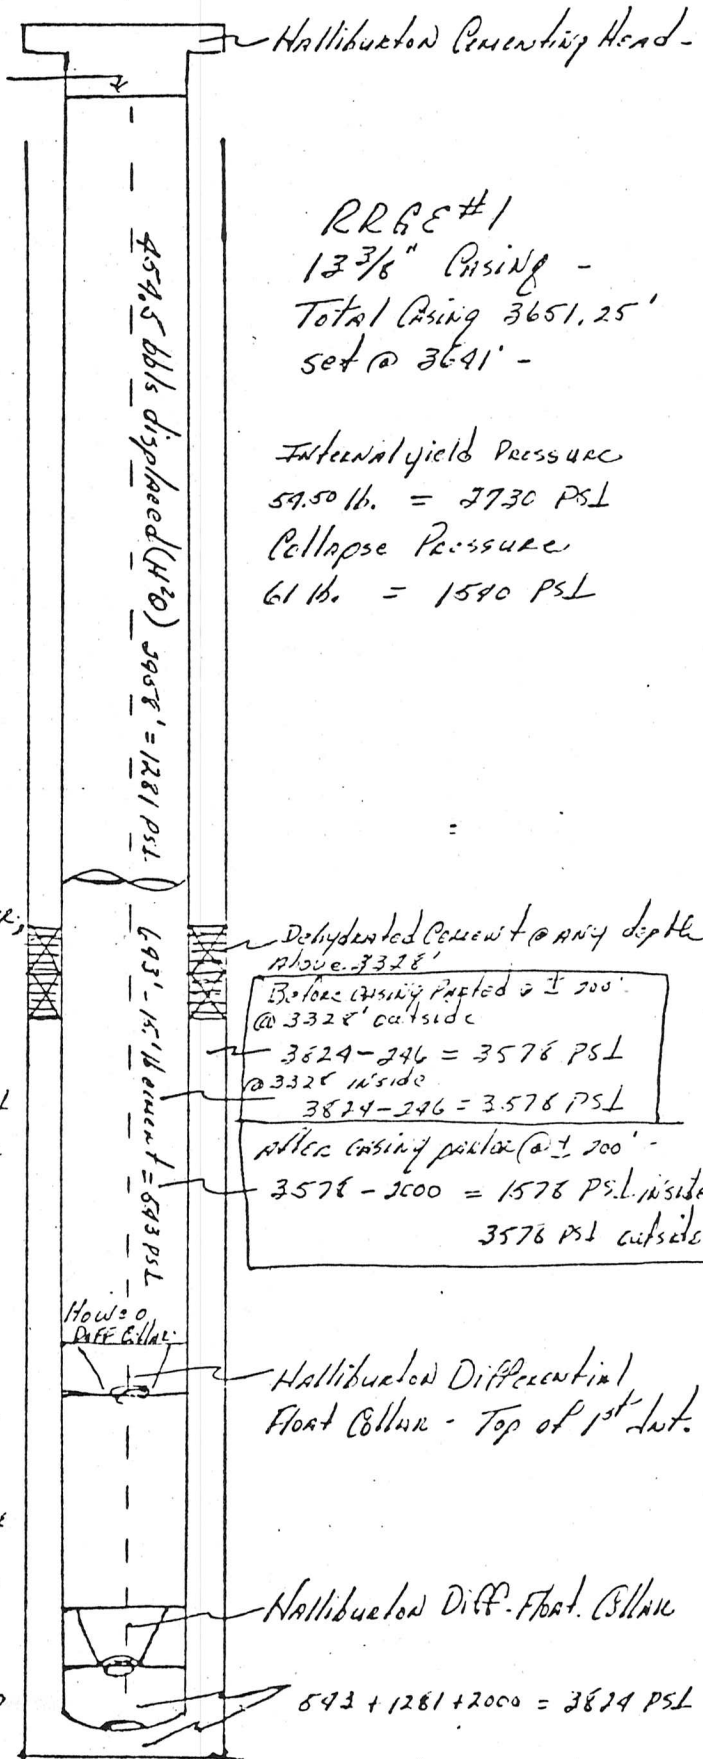
RRGE #1
13 3/8" Casing -
Total Casing 3651.25'
set @ 3641' -

3000 PSI applied to head by Howco

Halliburton had displaced 454.5 bbls of cement out of casing - Pressure climbed to 3000 PSI - Howco shut down - Approx. 45 sec's later, casing parted @ ± 200' down from top of casing.

Top ± 200' of casing was "distorted" up against hook as a result of the 3000 PSI inside the casing - As the pressure bled off, then existing open 2" lines below the 13 3/8" casing stripper, the top ± 200' started to fall back down toward the elevators -

Simultaneously, the second Halliburton was holding on the casing before it parted was bled off @ the 3328' ft. level - leaving a 2000 PSI differential on the outside of the casing - due to the Diff. Float Collar - the casing collapsed @ 3328' causing a second surge of pressure against the top ± 200' of casing - resulting in it again being distorted up to the hook - before falling face to the elevators -

Internal yield Pressure
59.50 lb. = 2730 PSI
Collapse Pressure
61 lb. = 1580 PSI

Dehydrated Cement @ any depth above 3328'
Before casing parted @ ± 200' @ 3328' outside
3824 - 246 = 3578 PSI @ 3328' inside
3824 - 246 = 3578 PSI
After casing parted @ ± 200' -
3578 - 2000 = 1578 PSI inside
3578 PSI outside

Halliburton Differential Float Collar - Top of 1st Int.

Halliburton Diff. Float Collar

593 + 1281 + 2000 = 3874 PSI

It is recommended by the undersigned that future holes, if not drilled using normal oil well drilling techniques, be "mudded up" before running casing and the hole be conditioned to run and cement casing. It is also recommended that

the JAM System on the joint "make up" be used. The "Joint Analyzed Make Up" system integrates the number of turns with the torque. The "wear" coupling would have been rejected by the JAM System.
