STRUCTURE OF THE REDONDO CREEK AREA,
BACA PROJECT, NEW MEXICO: IMPLICATIONS
CONCERNING THE NATURE OF PERMEABILITY/PRODUCTION
AND RECOMMENDATIONS FOR FUTURE DRILLING

Summary and Recommendations

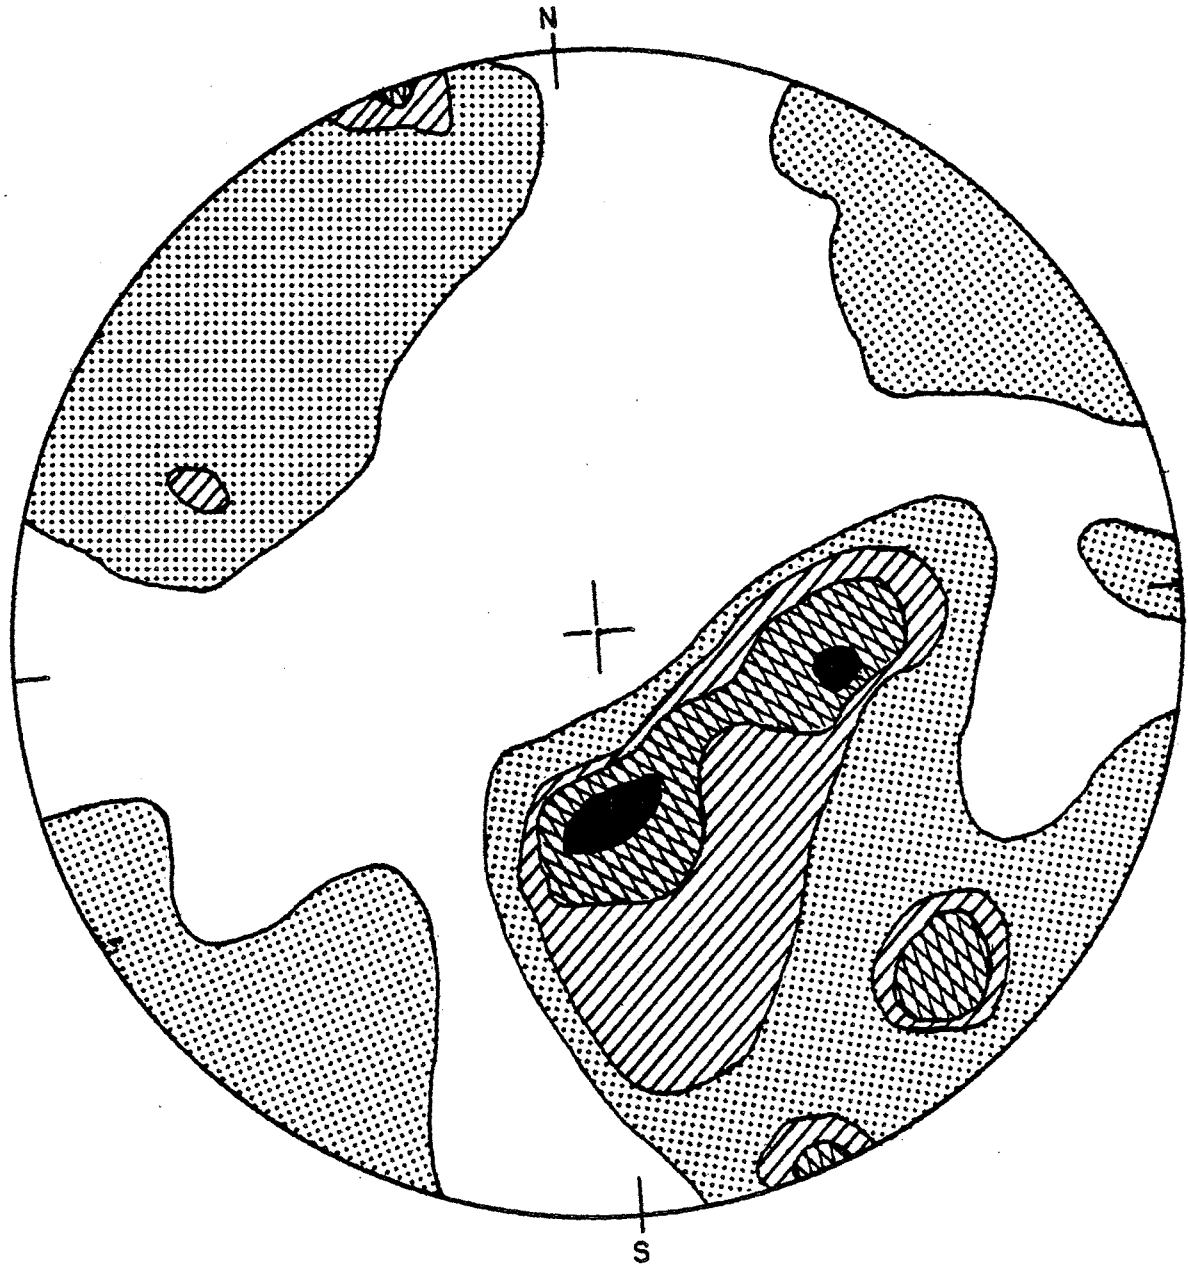
Shallow-dipping joints are characterized by a northeasterly strike and a 30± 10° dip (Figure 3) which roughly coincide

Figure 3. Density of Poles to Fracture Planes Measured in the Bandelier Tuff. Poles are projected to the lower hemisphere, and density is in the units of percent abundance - number of fractures per 10^4 - per 1% of total stereonet area. The more densely patterned areas depict the more abundant fracture orientations. The fractures predominantly strike northeasterly and dip westwardly $30^\circ \pm 10^\circ$. This orientation parallels the orientation of the northwestern side of the resurgent dome. Fracture abundances were measured at 72 stations.

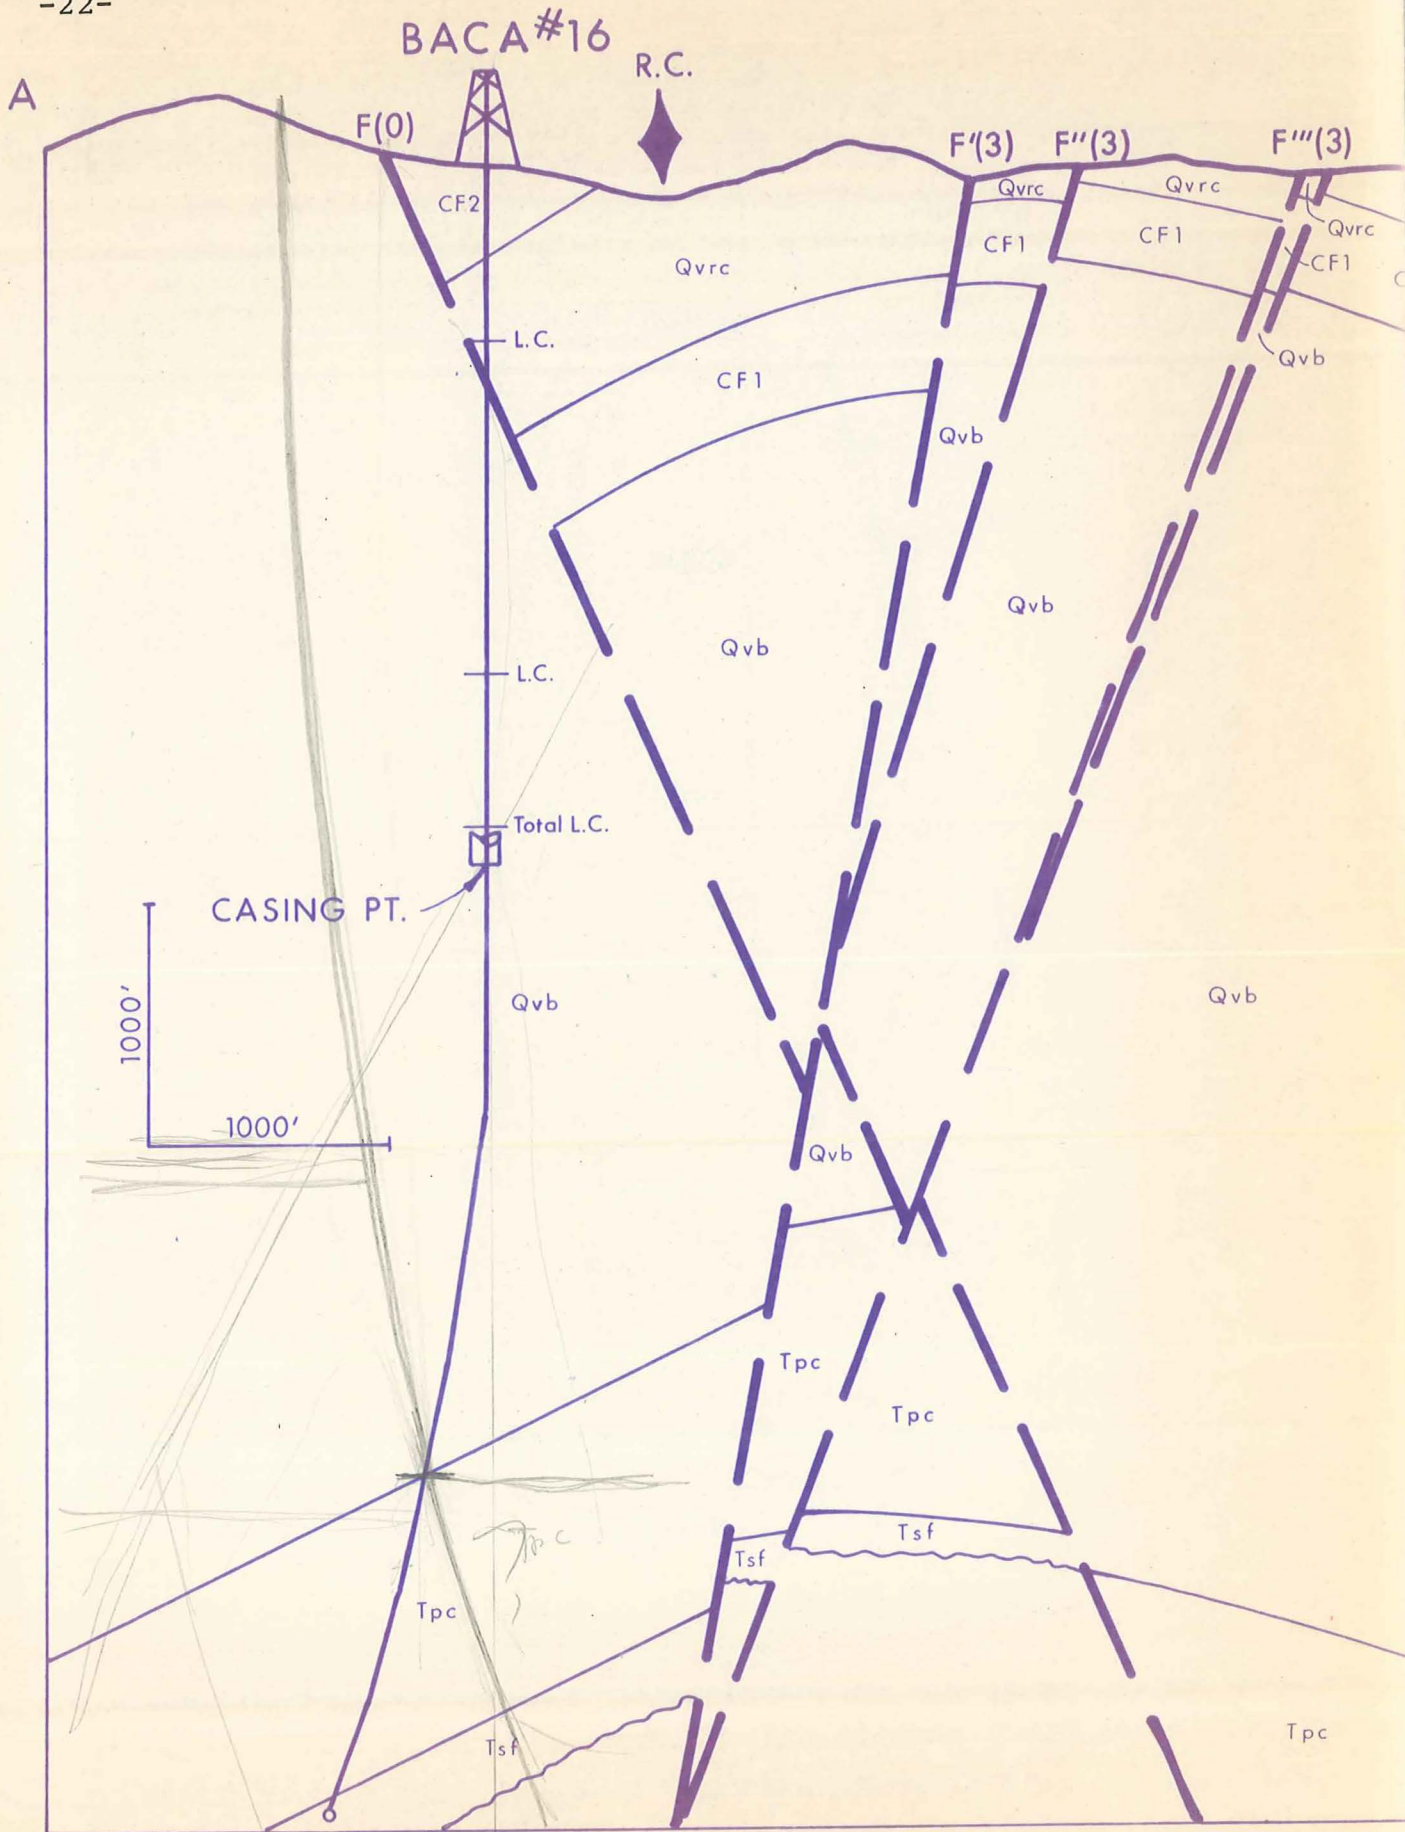
FIGURE 6.. Cross Section through Baca 16;
A-A' on Figure 1.

Baca 16 penetrated Caldera Fill (2), Redondo Creek Rhyolite, Bandelier Tuff, Paliza Canyon Andesite, and Santa Fe Formation (Fig. 6). The absence of Caldera Fill (1) below the Redondo Creek Rhyolite, together with the presence of Caldera Fill (1) in all adjacent wells and the close proximity of F(0), indicate that Baca 16 crossed F(0) at an elevation of 8742 ft. above sea level. The location of the intersection of F(0) with Baca 16, combined with the approximate surface trace of fault, unequivocally determines the dip on F(0) between 65° to 70°. Lost circulation was encountered above and below the casing point. A zone of complete lost circulation above the casing point may correspond to the intersection of an adjacent northwest trending cross-fault

with the well course. The remaining lost circulation zones in the Bandelier Tuff probably correspond to areas characterized by a high density of cooling joints. Despite the presence of lost circulation below the casing point, this well did not produce. We interpret the lack of productivity in Baca 16 to the absence of steeply-dipping faults intersecting the well trend below the casing point. The high temperatures recorded in Baca 16 indicate that additional wells should be drilled in this area but targeted towards the intersection of F(0) with the base of the Bandelier Tuff.

4. Baca 16. The high temperatures encountered in Baca 16 and the presence of adjacent steeply-dipping structures suggest that a redrill of this well is warranted. F(0) was crossed at a very shallow level, but this fault could be penetrated again or even F(3) could be intersected if Baca 16 were plugged to ~ 7500 ft. (elevation) and the redrill targeted to the southeast at a 30° deviation from vertical (Figure 6).

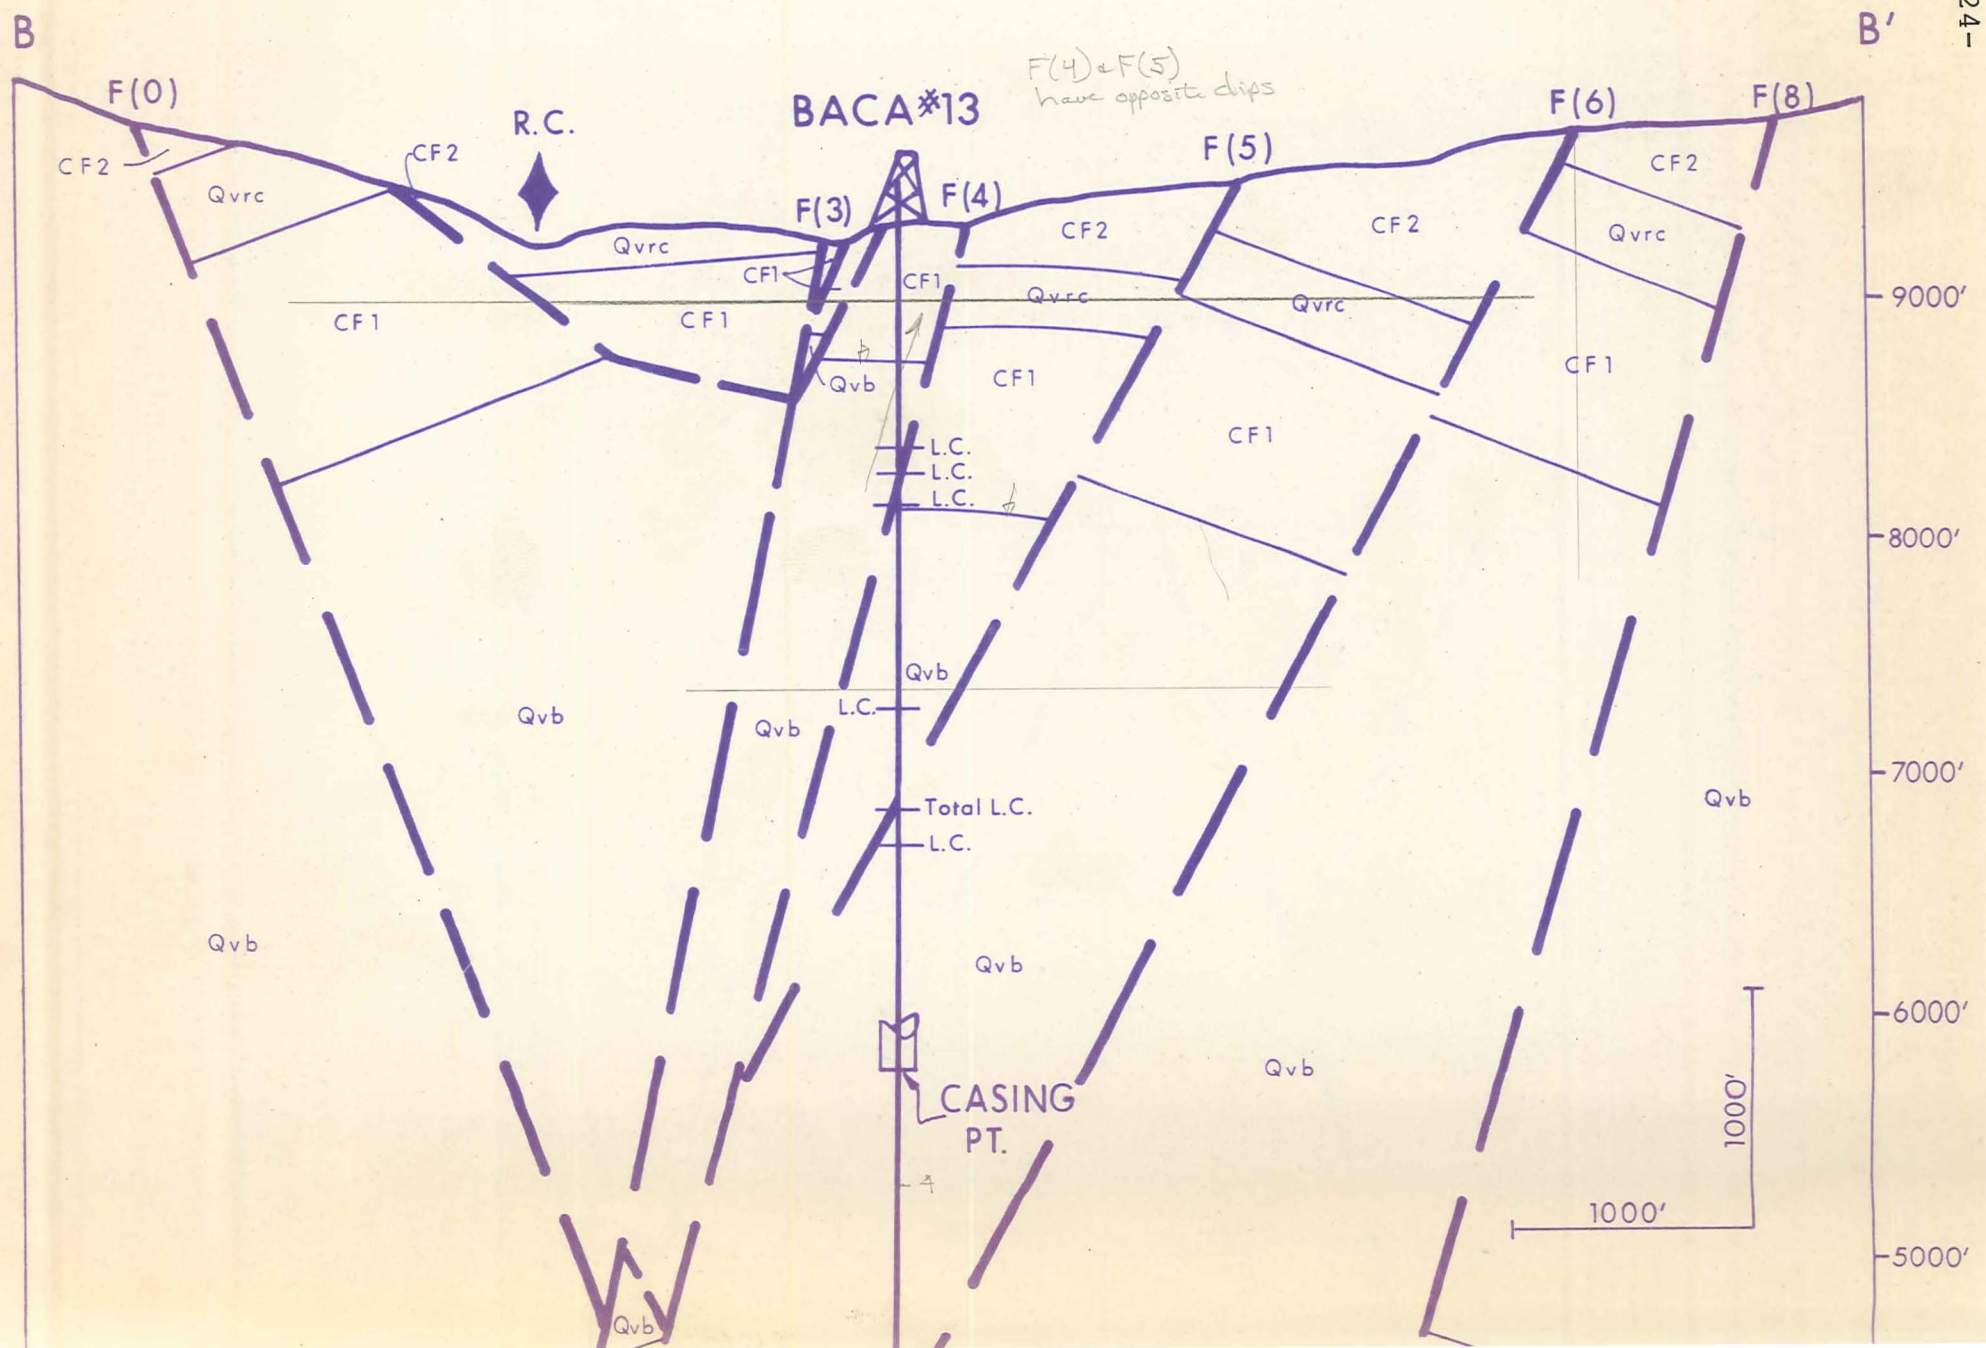
A cross-section through Baca 13 (Fig. 7) depicts the two distinct fault orientations (low-angle and high-angle structures), as well as the lithologies encountered in this well. The projected flattening of the low-angle fault in Fig. 7 is the result of the curvature of this structure into the plane of the cross-section. Several zones of lost circulation in the upper portion of this well appear to correspond to the projections of F(4) and F(5). Below the casing point Baca 13 intersected F(6) and F(0). The intersection of F(6) in the well course also corresponds to a zone of lost circulation. An additional zone of lost circulation which was encountered below the casing point cannot be related to fault zones and may be the result of high joint density.

We interpret the moderate productivity of this well to the intersection of F(6) and F(0) with the well course.

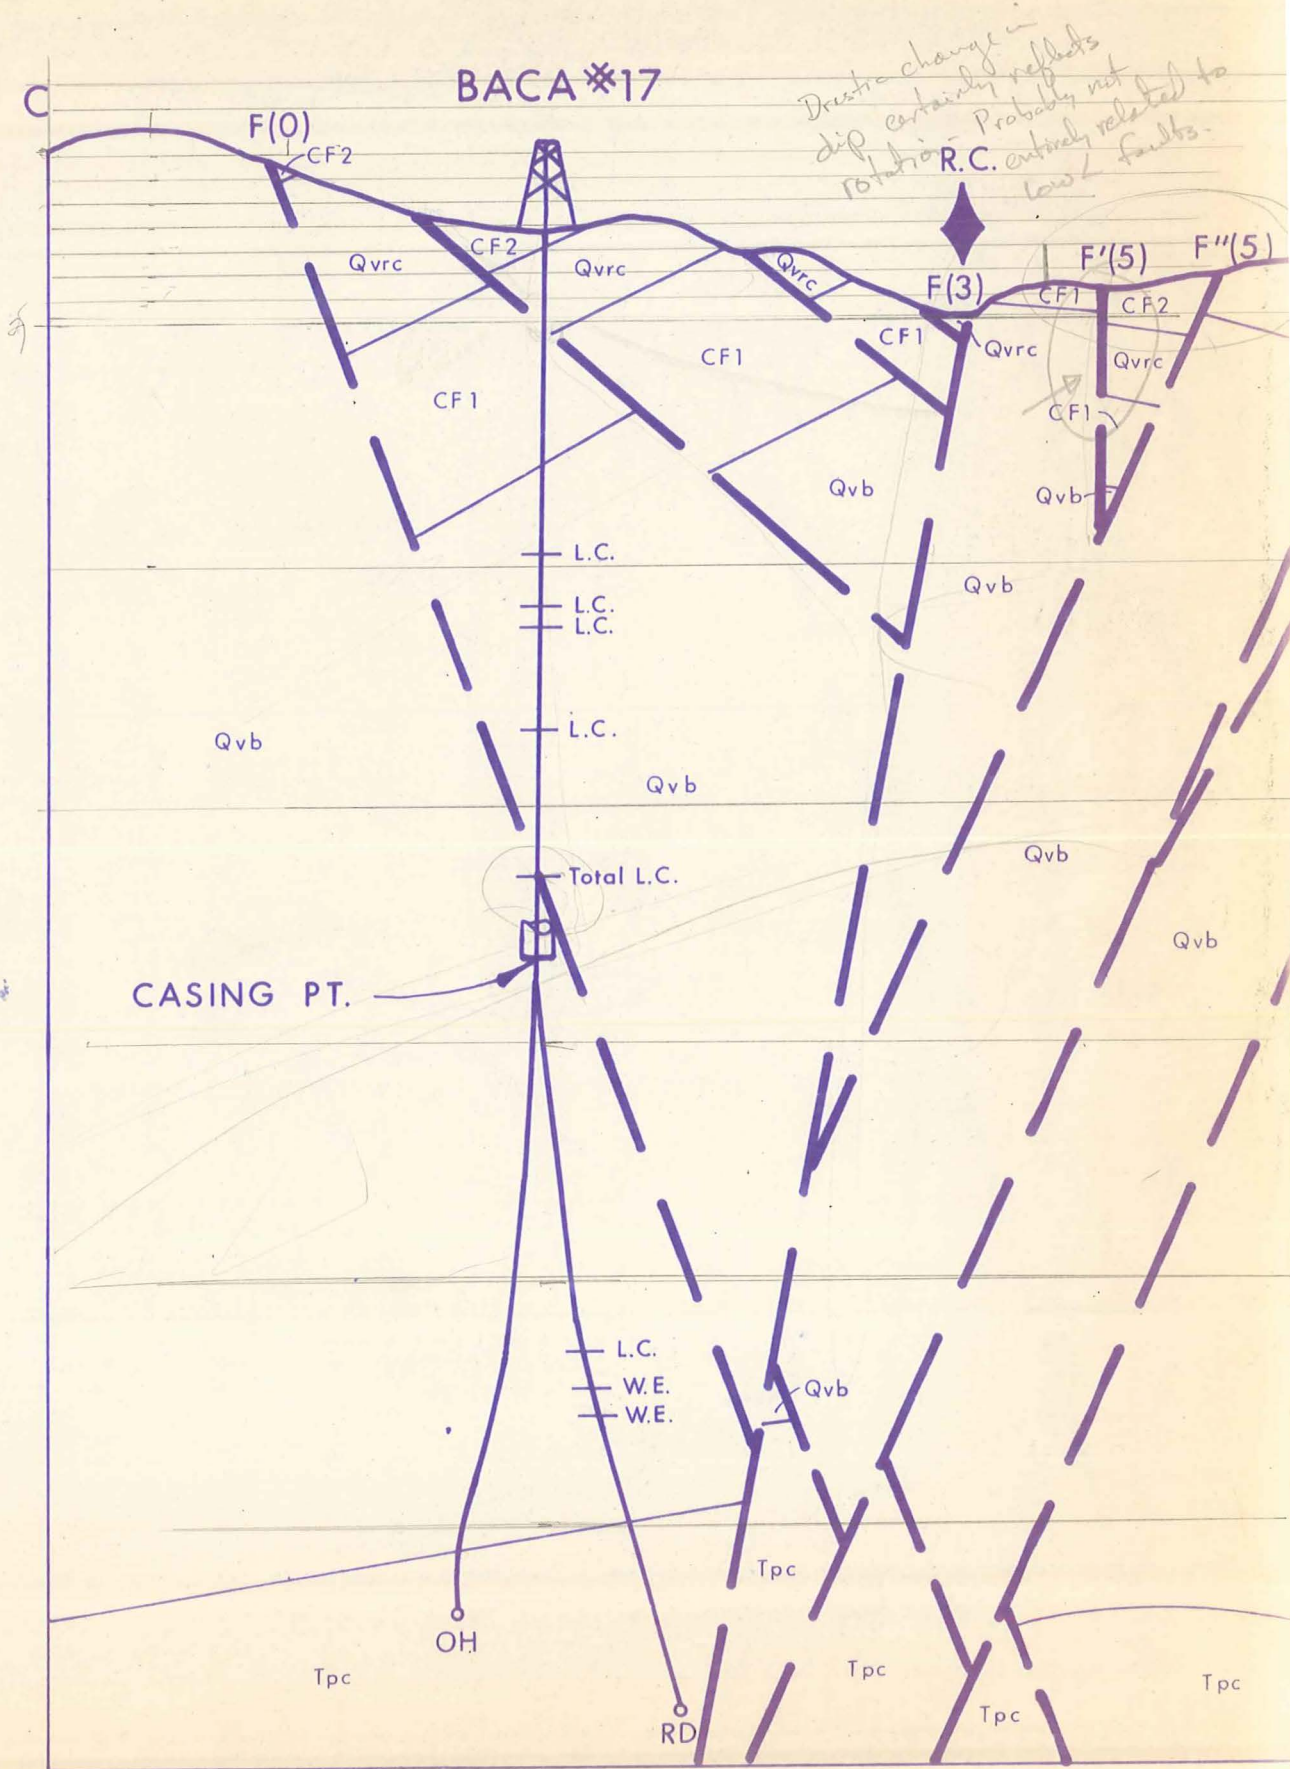
FIGURE 8. Cross Section through Baca 17; C-C' on Figure 1.

Low-angle structures are mechanically significant to the geothermal development of this area because Baca 17 failed during production tests where a shallow-dipping fault intersected the well course (Fig. 8). This does not indicate that casing failure on Baca 17 was the result of fault movement, but sloughing of the fault contact combined with a lack of returns while cementing the casing may have provided an environment that localized buckling when stressed. Careful cement jobs are a requirement in wells which penetrate these structures.

The geology and structure of the area surrounding Baca 17 is shown in Figure 8. This well traversed a section of Caldera Fill (2), Redondo Creek Rhyolite, Caldera Fill (1), Bandelier Tuff, and Paliza Canyon Andesite. Dips of strata in Caldera Fill (2), surface contacts, and constraints on fault dip require that the contact between Redondo Creek Rhyolite and Caldera Fill (1) coincide with the projection of a low-angle fault. Although this fault has no production significance, its projection in the Baca 17 well course coincides with the point of casing failure. A zone of total lost circulation from 2642 to 3003 corresponds to the projected intersection of F(0) with Baca 17 assuming a 70° dip on F(0). These data confirm earlier conclusions (Baca 16, Fig. 7) on the orientation of F(0).

Below the casing point Baca 17 original trended away from F(0) and F(3), did not intersect steeply-dipping structures, and was tight. The redrill on this well trended towards F(3) but apparently did not intersect this fault (it should be noted that the dips on individual fault zones are oriented identically in each cross-section, whereas in reality they may curve). The very close approach (~ 100 m) of Baca 17 redrill to F(3) or the

intersection of F(3) with this well if actual dip is several degrees less than is shown in Figure 9 probably accounts for its good productivity. A lost circulation zone and water entries in the lower part of this well do not correspond to recognized faults and may reflect locally high joint density.

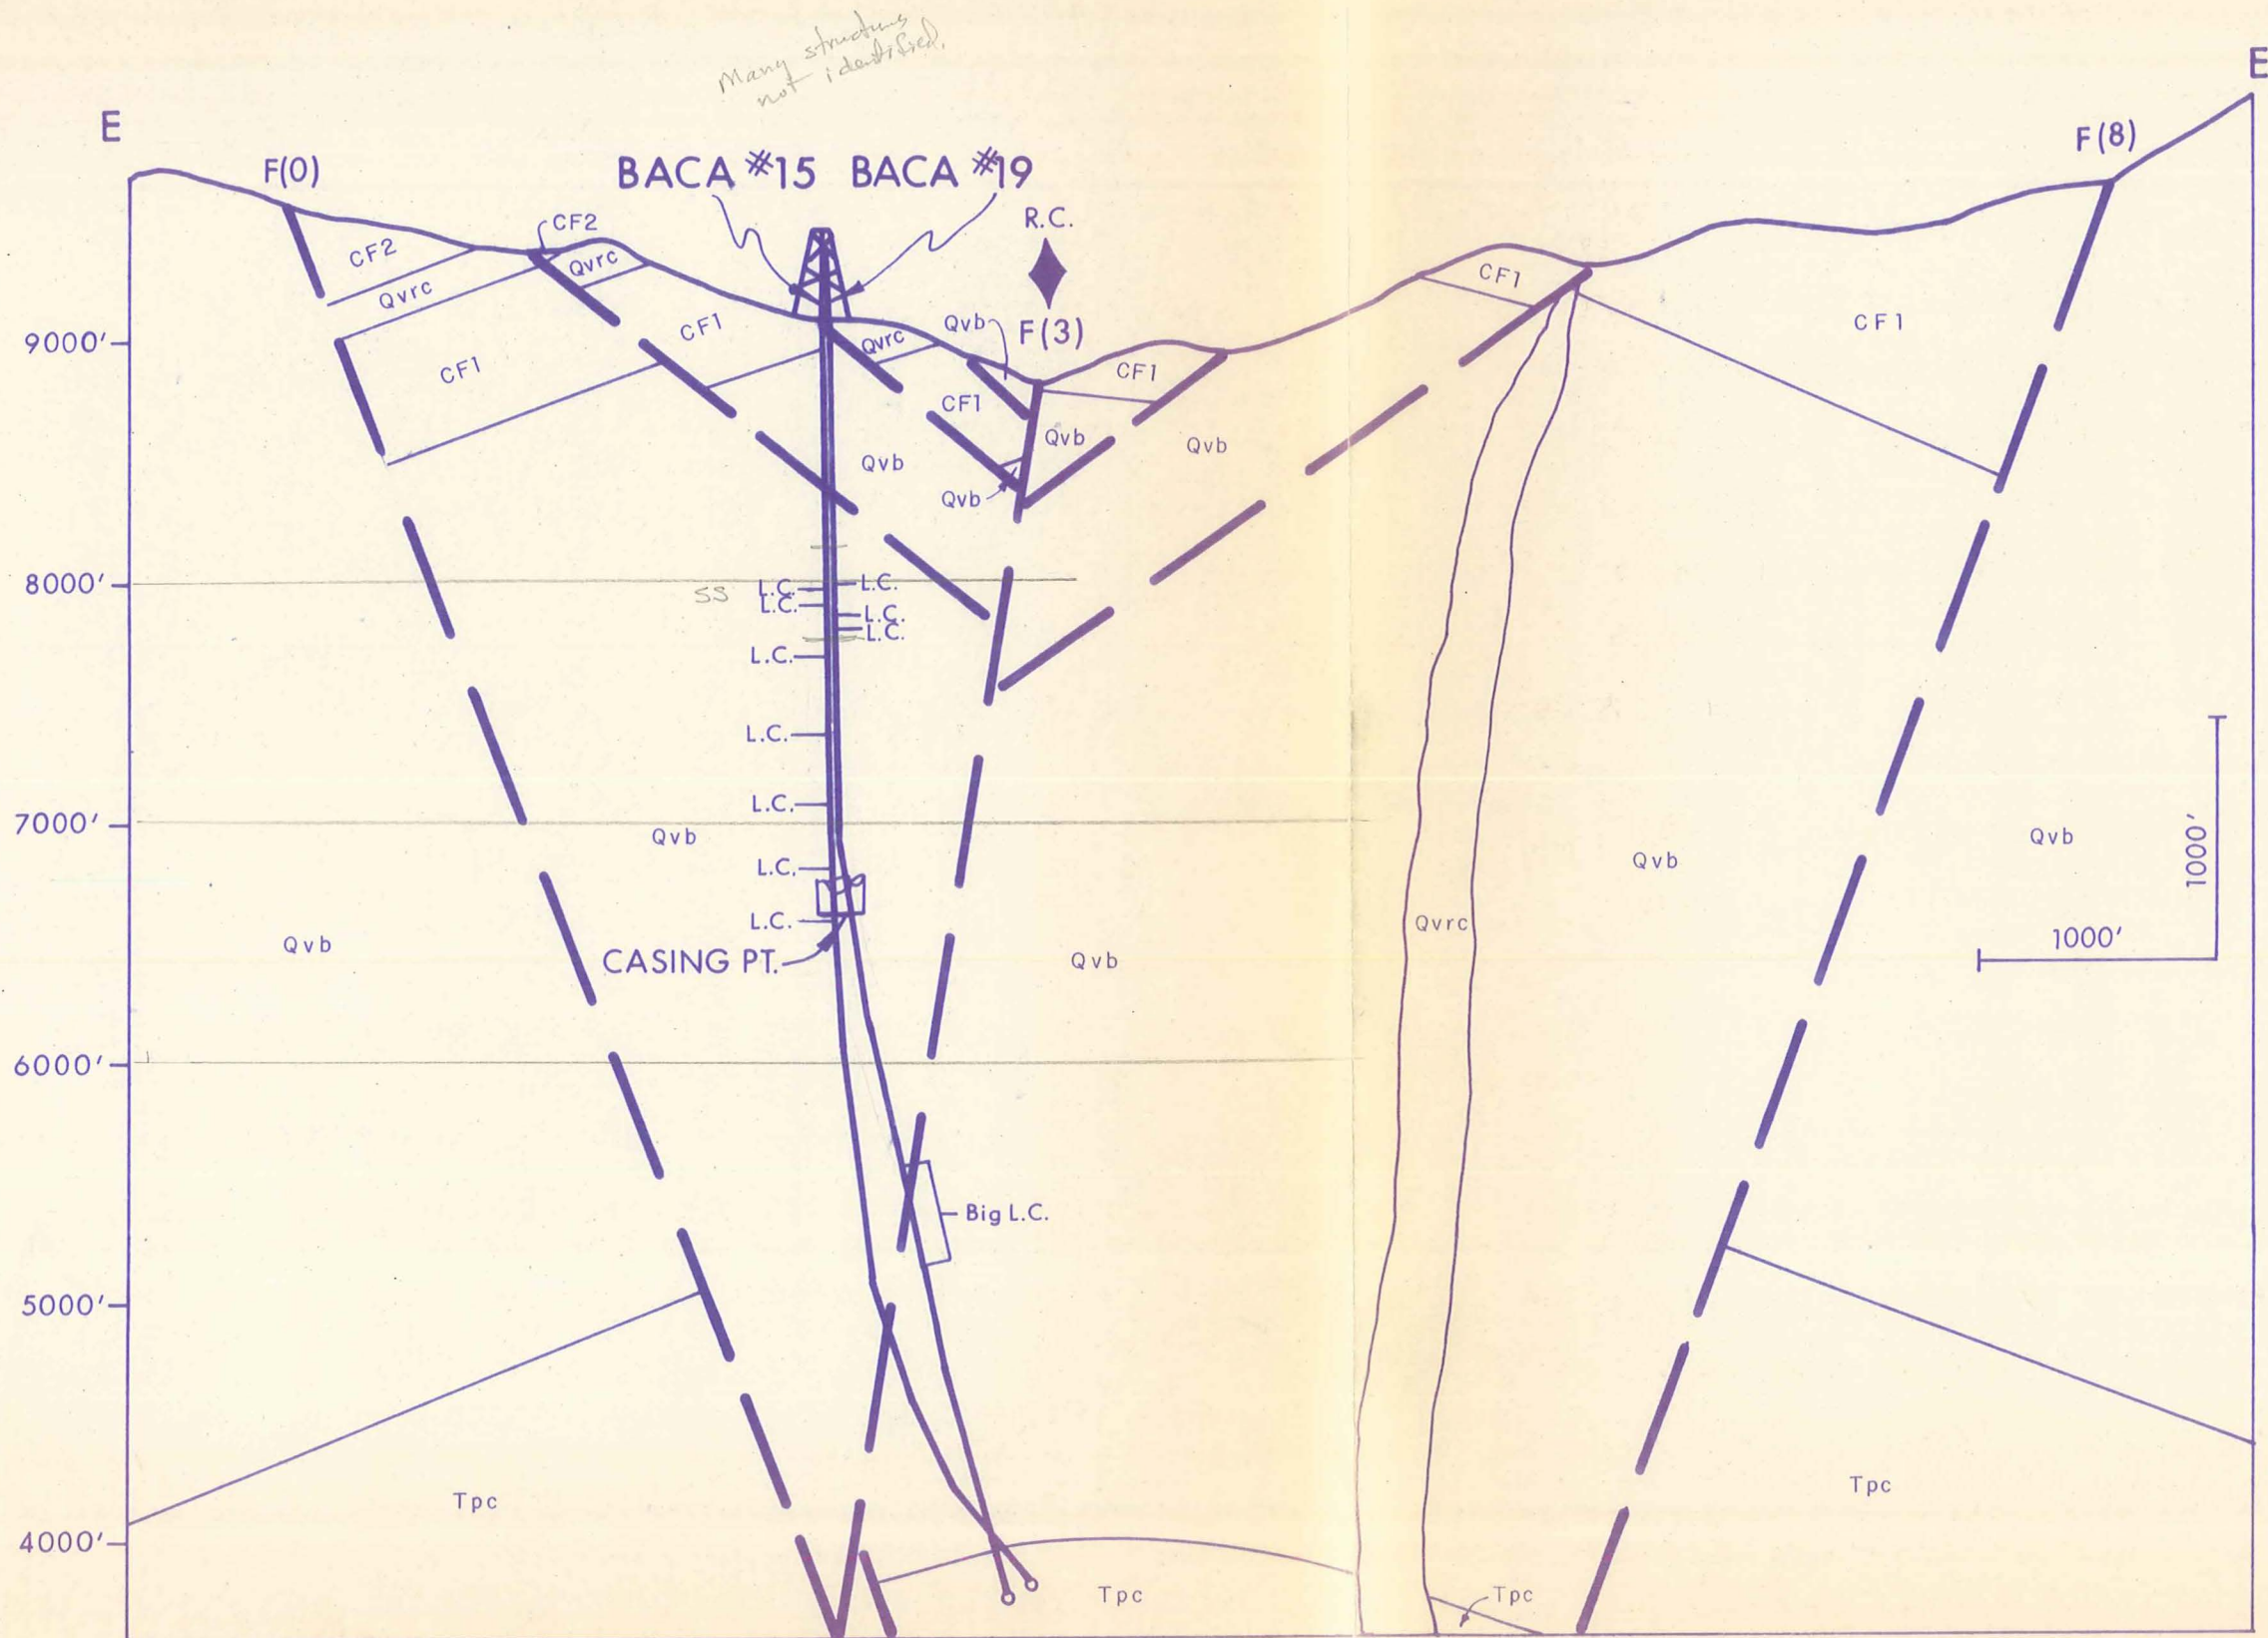
FIGURE 10. Cross Section through Baca 15 and 19; E-E' on Figure 1.

As directional data are not available on either of these wells, all interpretations of Baca 11 and Baca 4 are considered tentative. Preferred well locations (those which "best fit" the geology of adjacent areas) are shown on Figure 9. Above the casing point Baca 11 penetrated two low-angle faults and below crosses F(3), F'''(6), and possibly F(0). Lost circulation zones above and below the casing point appear to be related to the close approach and intersection of F(3) with the well course. The excellent productivity of this well is probably the result of intersecting several steeply-dipping structures below the casing point.

Baca 4 traversed F'''(6) and a westerly trending cross-fault above the casing point. Fractures and water and steam entries above the casing point do not correlate with faulting and probably reflect jointing in the Bandelier Tuff. The intersection of F(8) with the well course occurs below the casing point and corresponds to a steam entry zone. The good productivity

of this well is probably related to the intersection with F(8) below the casing point.

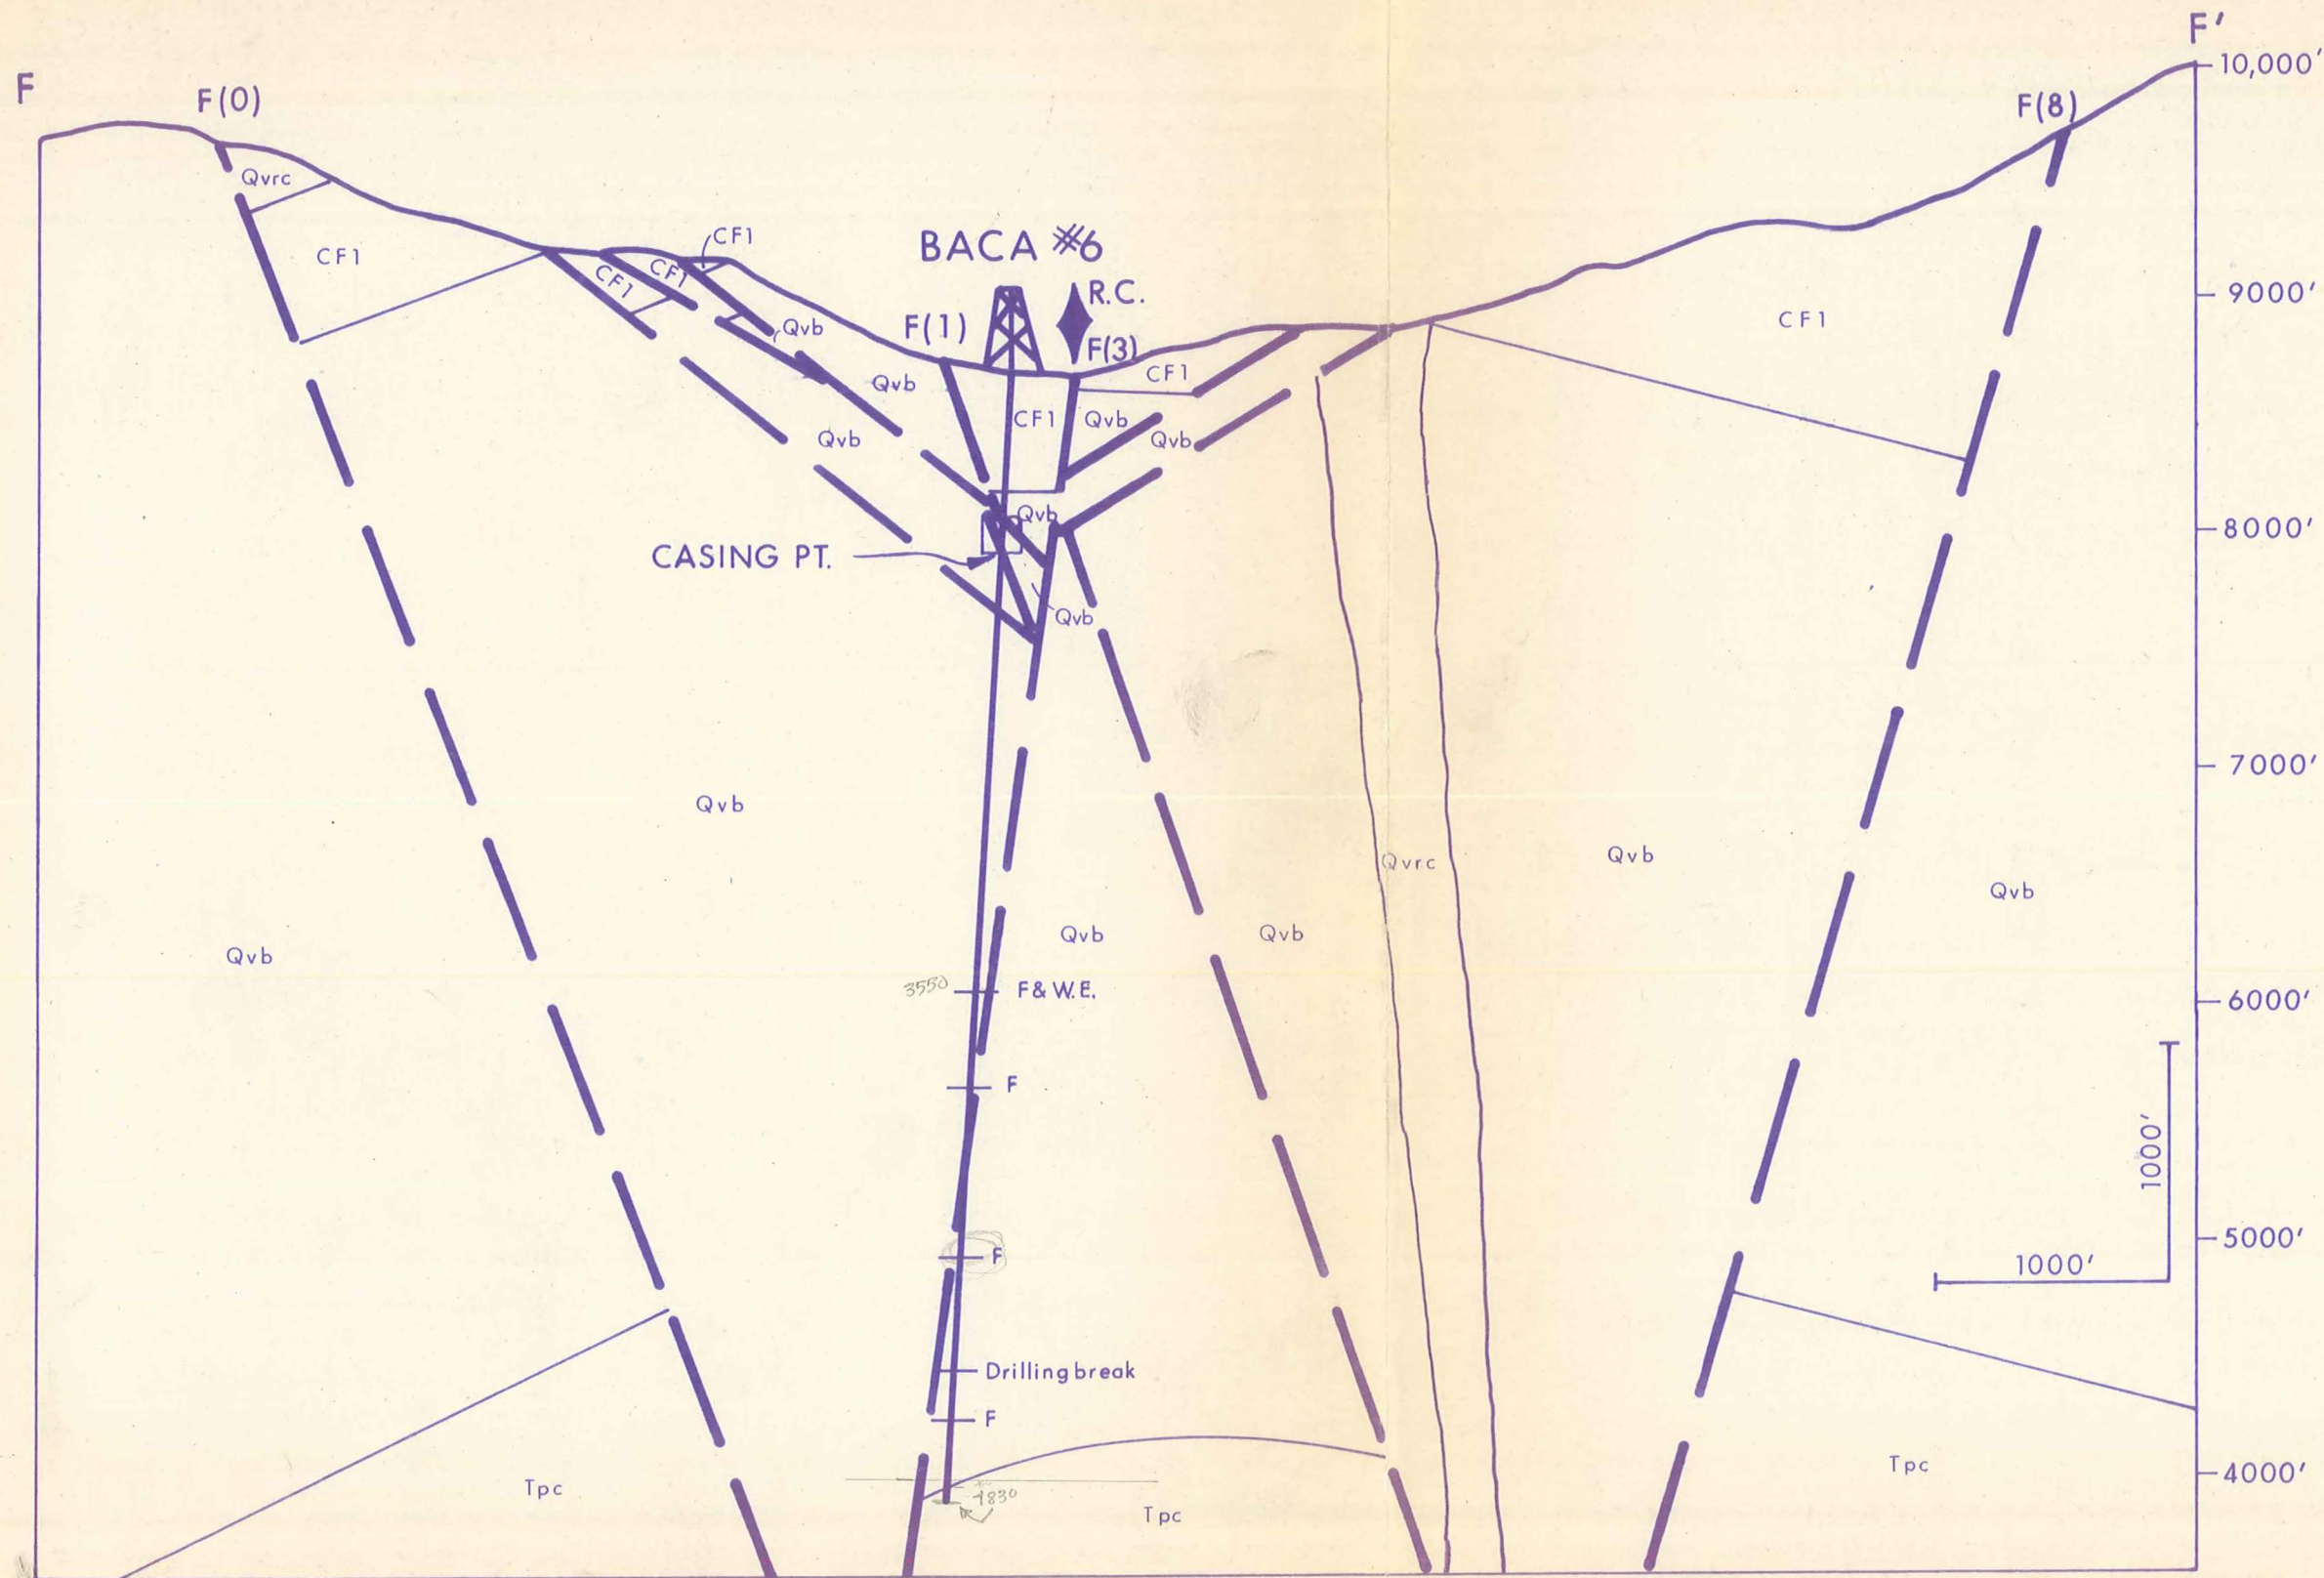
FIGURE 11. Cross Section through Baca 6;
F-F' on Figure 1.

Baca 6 penetrated a steeply-dipping fault, F(1), as well as several shallow-dipping structures in the upper 1500 ft. of the well (Figure 11). Below the casing point this well intersected F(3) and continued down or adjacent to this fault zone for the length of this well (including remedial). Baca 6 is a good producer.

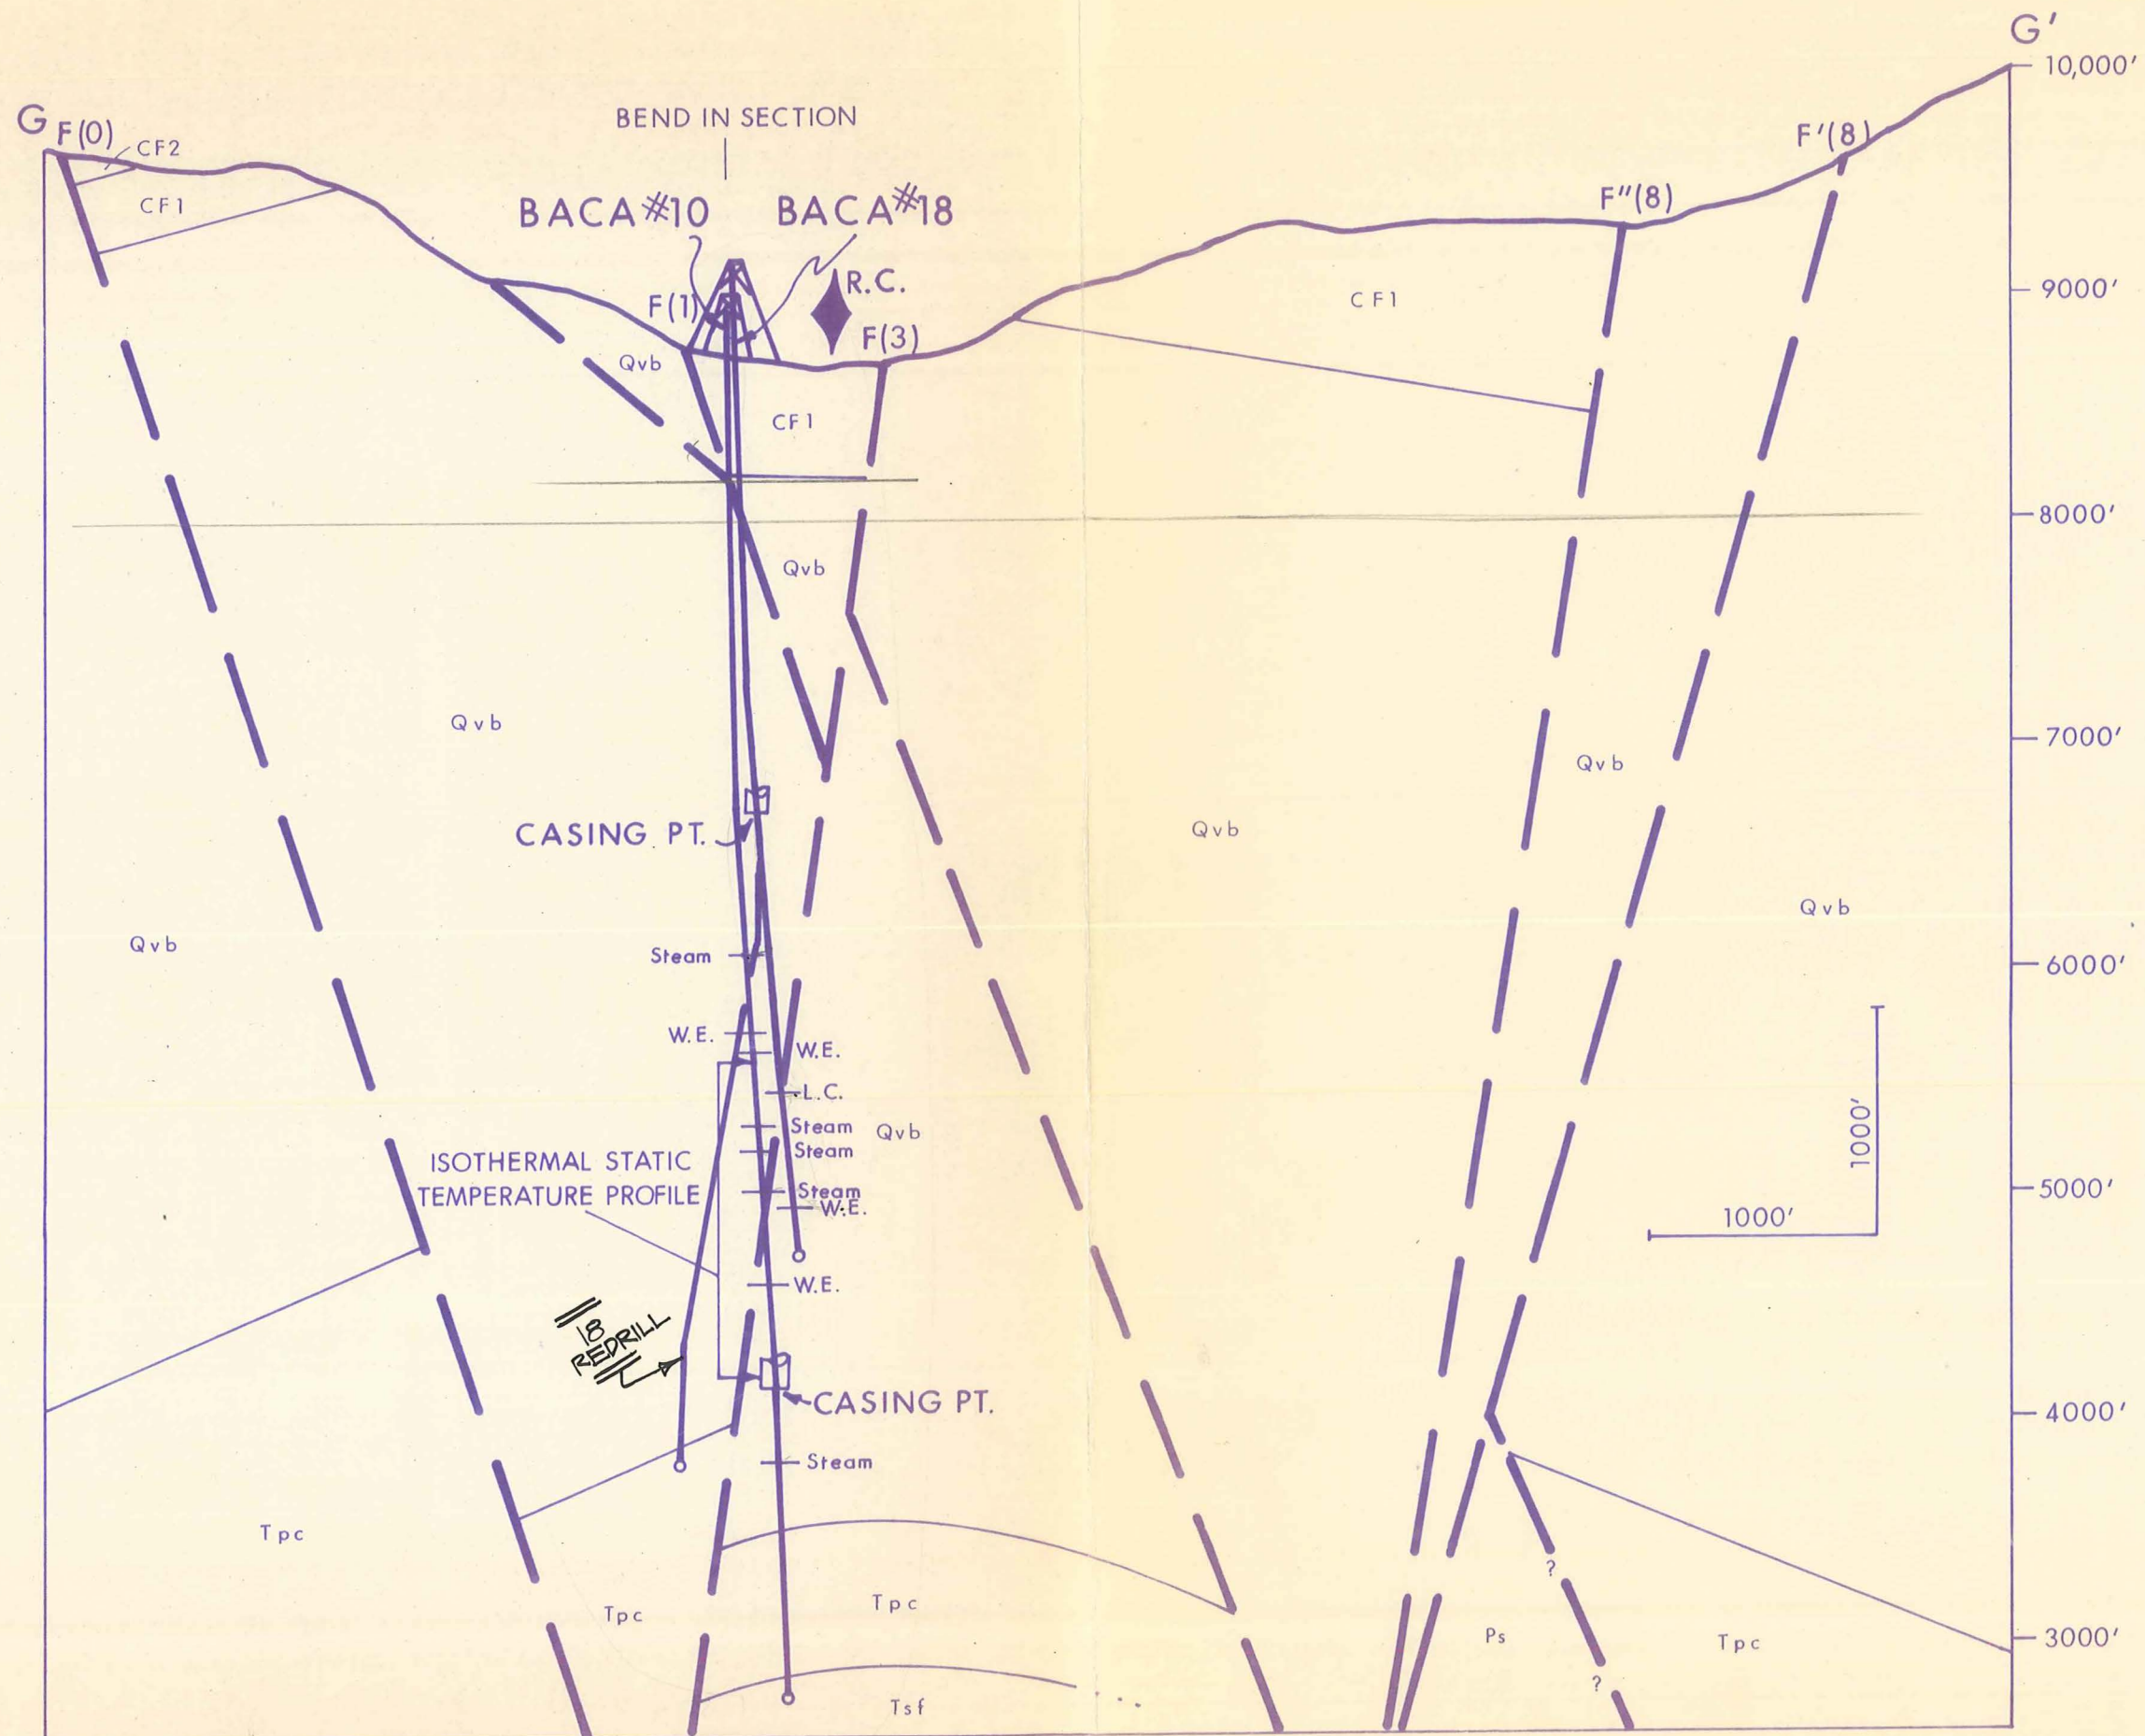
FIGURE 12. Cross Section through Baca 10 and 18; G-G' on Figure 1.

The relationship between fault zones and production is graphically depicted in a cross-section through Baca 10 and Baca 18 (Figure 12). Baca 10 intersected all steeply-dipping fault zones above the casing point. Although this well flowed during initial production tests, attempts to gain production after the 7" liner was set were unsuccessful. The Baca 10 casing was perforated between 5700 to 4600 ft. elevations where there was an isothermal static temperature profile and several steam and water entries. This isothermal zone bounds the projected intersection of Baca 10 with F(3). Fair to poor production was obtained after perforation of the casing.

Baca 18 original also penetrated F(1) above the casing point and crossed F(3) below the casing point but was lost due to mechanical problems. Baca 18 redrill trended away from and did not intersect F(3) which probably accounts for its lack of productivity.

It should be noted that the apparent reverse offset on the base of the Bandelier Tuff is the result of projecting contacts which have a considerable dip across significant lateral distances.

2. Baca 10. The presence of an isothermal static temperature profile horizon which is suggestive of convecting (permeable) zone, and the close spatial association of a producing well (Baca 18), together indicate that Baca 10 should be plugged to ~ 6800 ft. (elevation) and redrilled towards the projection of F(3) in Figure 12.
