STRUCTURE OF THE REDONDO CREEK AREA,
BACA PROJECT, NEW MEXICO: IMPLICATIONS
CONCERNING THE NATURE OF PERMEABILITY/PRODUCTION
AND RECOMMENDATIONS FOR FUTURE DRILLING

Summary and Recommendations

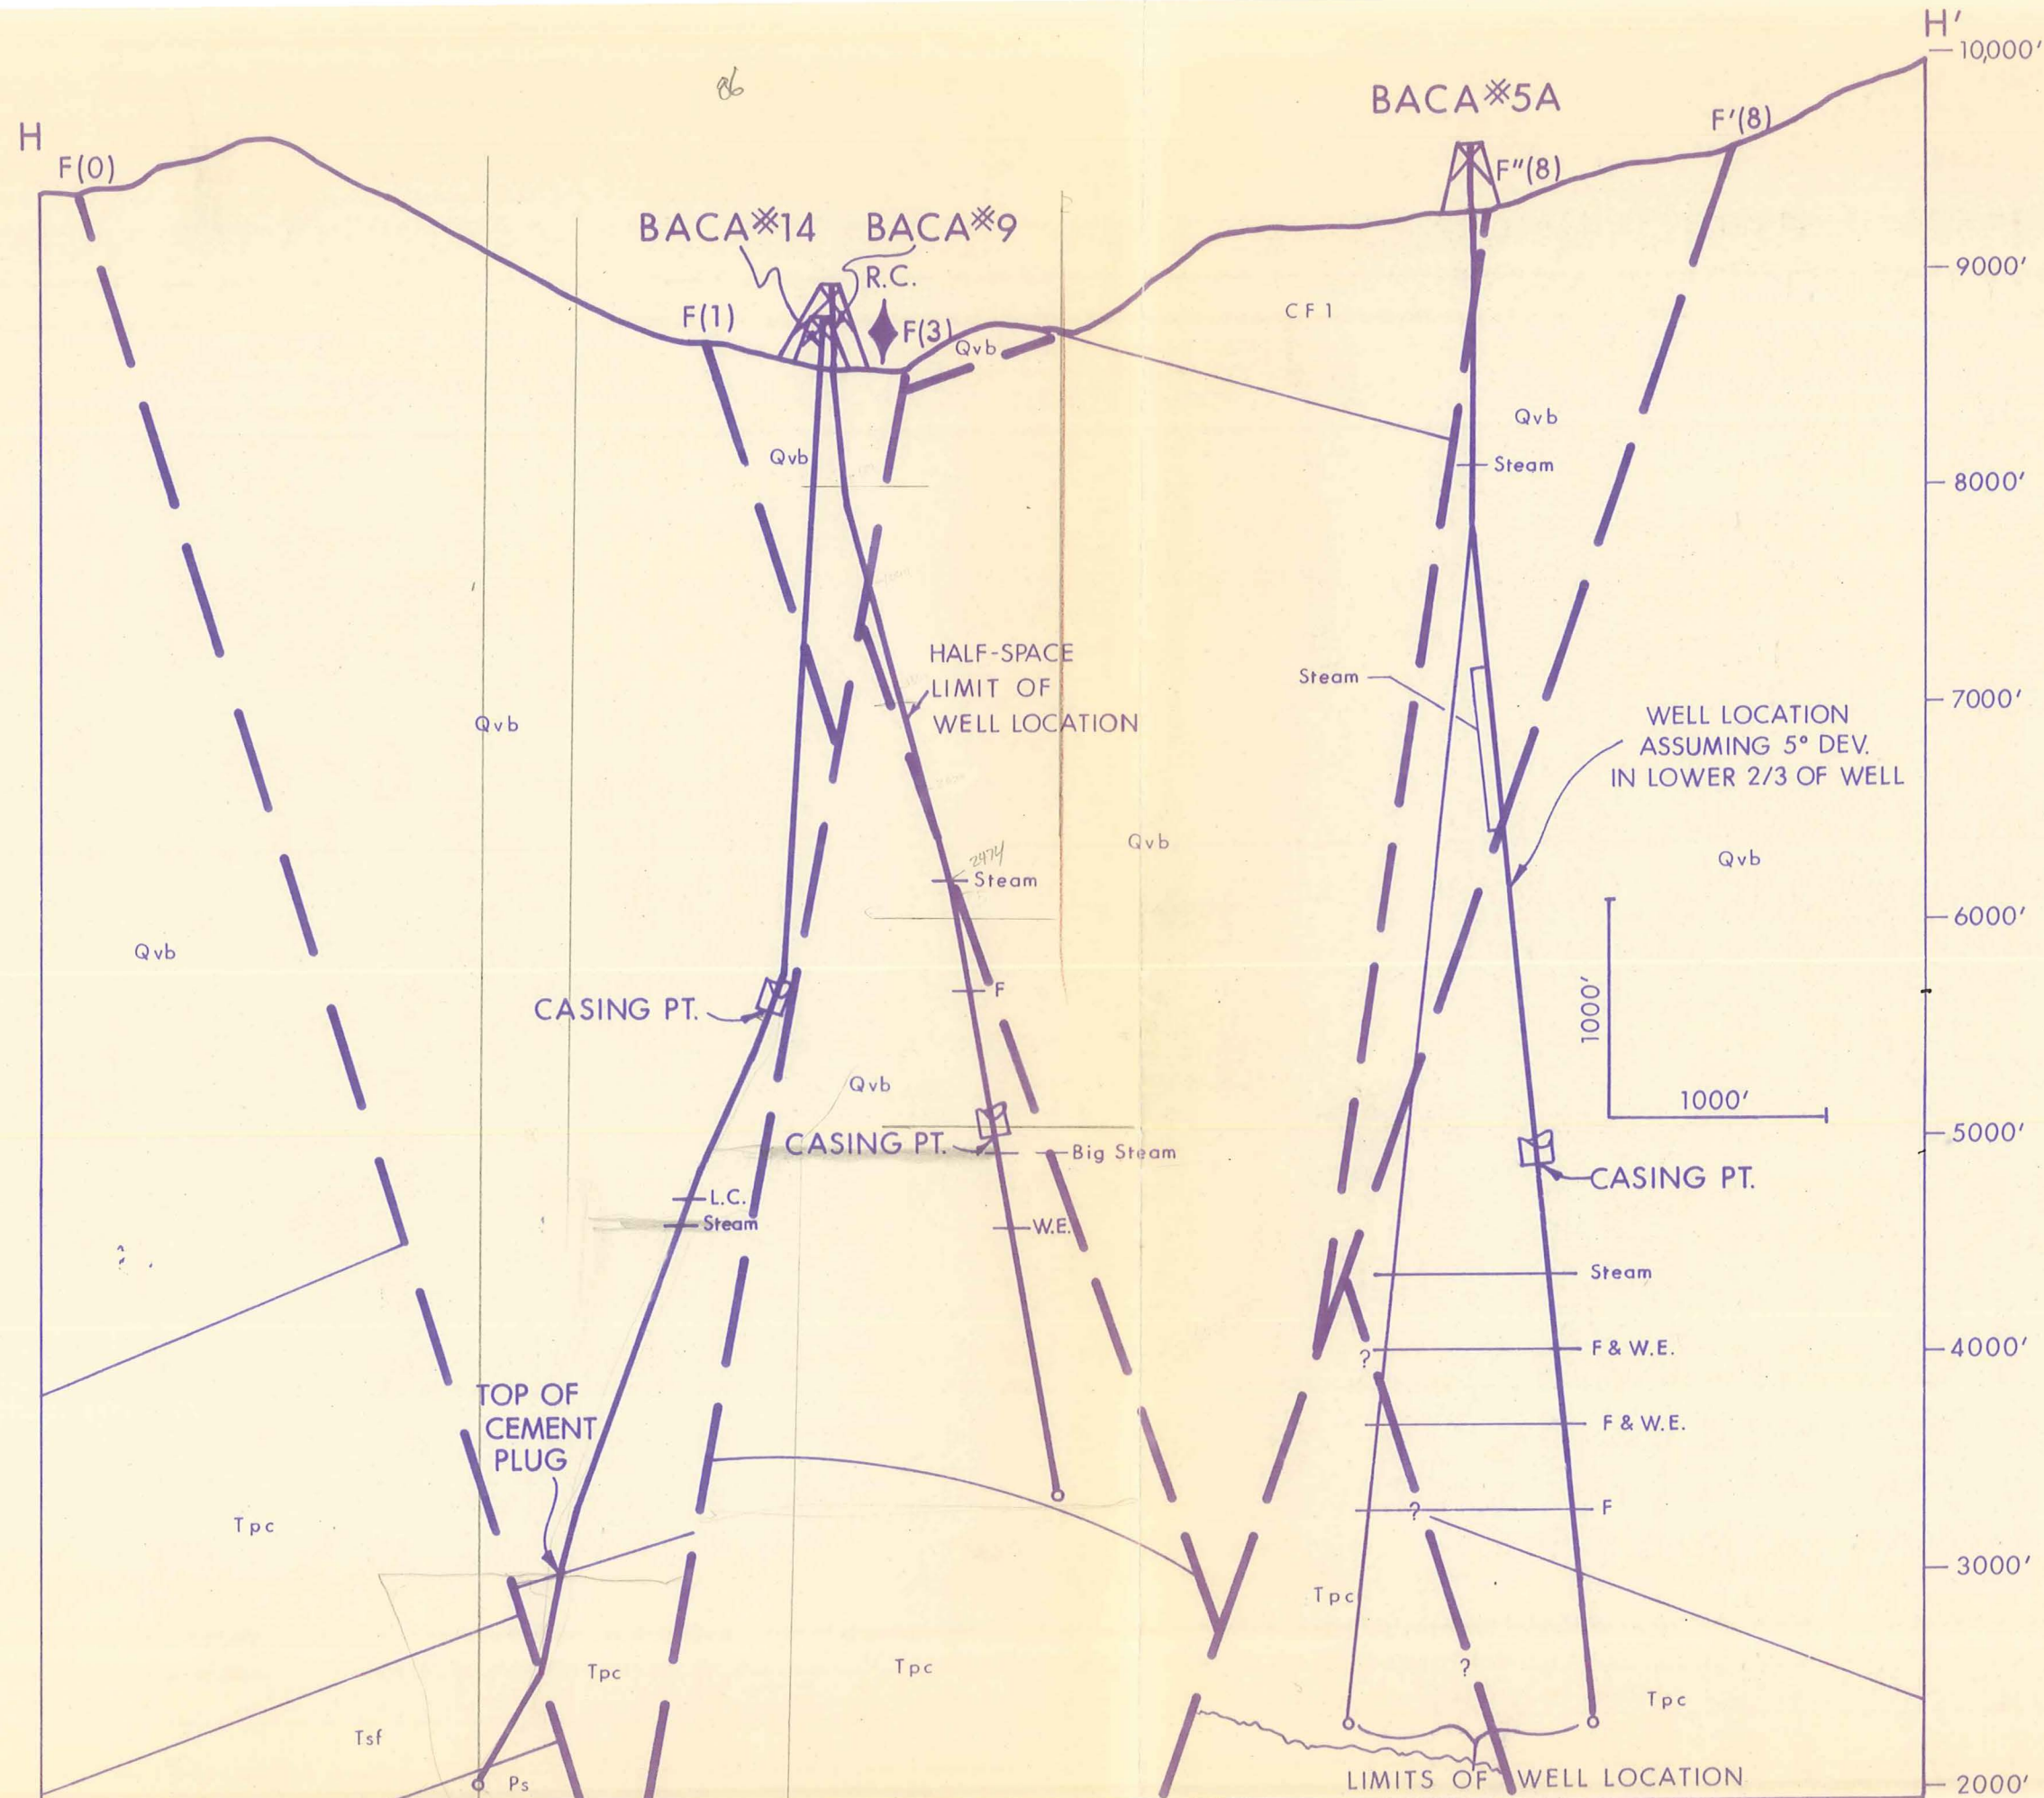
FIGURE 13. Cross Section through Baca 14, 9, and 5A; H-H' on Figure 1.

The geology of this cross-section depicts the "probable" Baca 9 and Baca 5A well locations that fit the structural-stratigraphic constraints in Baca 14 and adjacent areas.

Below the casing point, Baca 14 intersects F(0) at the base of the Paliza Canyon Andesite (this accounts for the very thin section of andesite). During production tests, the Santa Fe Formation flowed into the well requiring that a plug be set to the base of the Bandelier Tuff (thus, F(0) was blocked from the producing interval). Baca 14 did not produce fluids after the plug was set, which suggests that the zone of lost circulation and a steam entry below the casing point probably reflect the local presence of a high density of cooling joints in the Bandelier Tuff.

A large steam zone and sloughing (which resulted in mechanical failure) probably correspond to the intersection of F(1) (as shown in Figure 13) or possibly F(3) with the Baca 9 well course. Baca 9 redrill was cased below the fault intersection and is not a producer. Steam and water entries below the casing point are likely related to jointing in the Bandelier Tuff.

Baca 5A cuts several steeply-dipping faults F''(8) and F'(8), in the upper portion of this well. A large steam entry and a temperature reversal characterize the location of F'(8) in the

well course. Below the casing point Baca 5A did not penetrate any fault zones and would not produce fluids due to the temperature reversal in the upper portion of this well.

temperature associated with F'(8) suggest that a re-drill from ~ 8300 ft. (elevation) which was directed to the northwest (intersection of F'(8) with F''(8) in Figure 13) would yield a producing well.

3. Baca 14. The close approach of Baca 14 to F(3) near the casing point, combined with the apparent productivity of F(3), suggests that this well should be plugged to near the casing point and redrilled (vertically) towards F(3) (Figure 13).

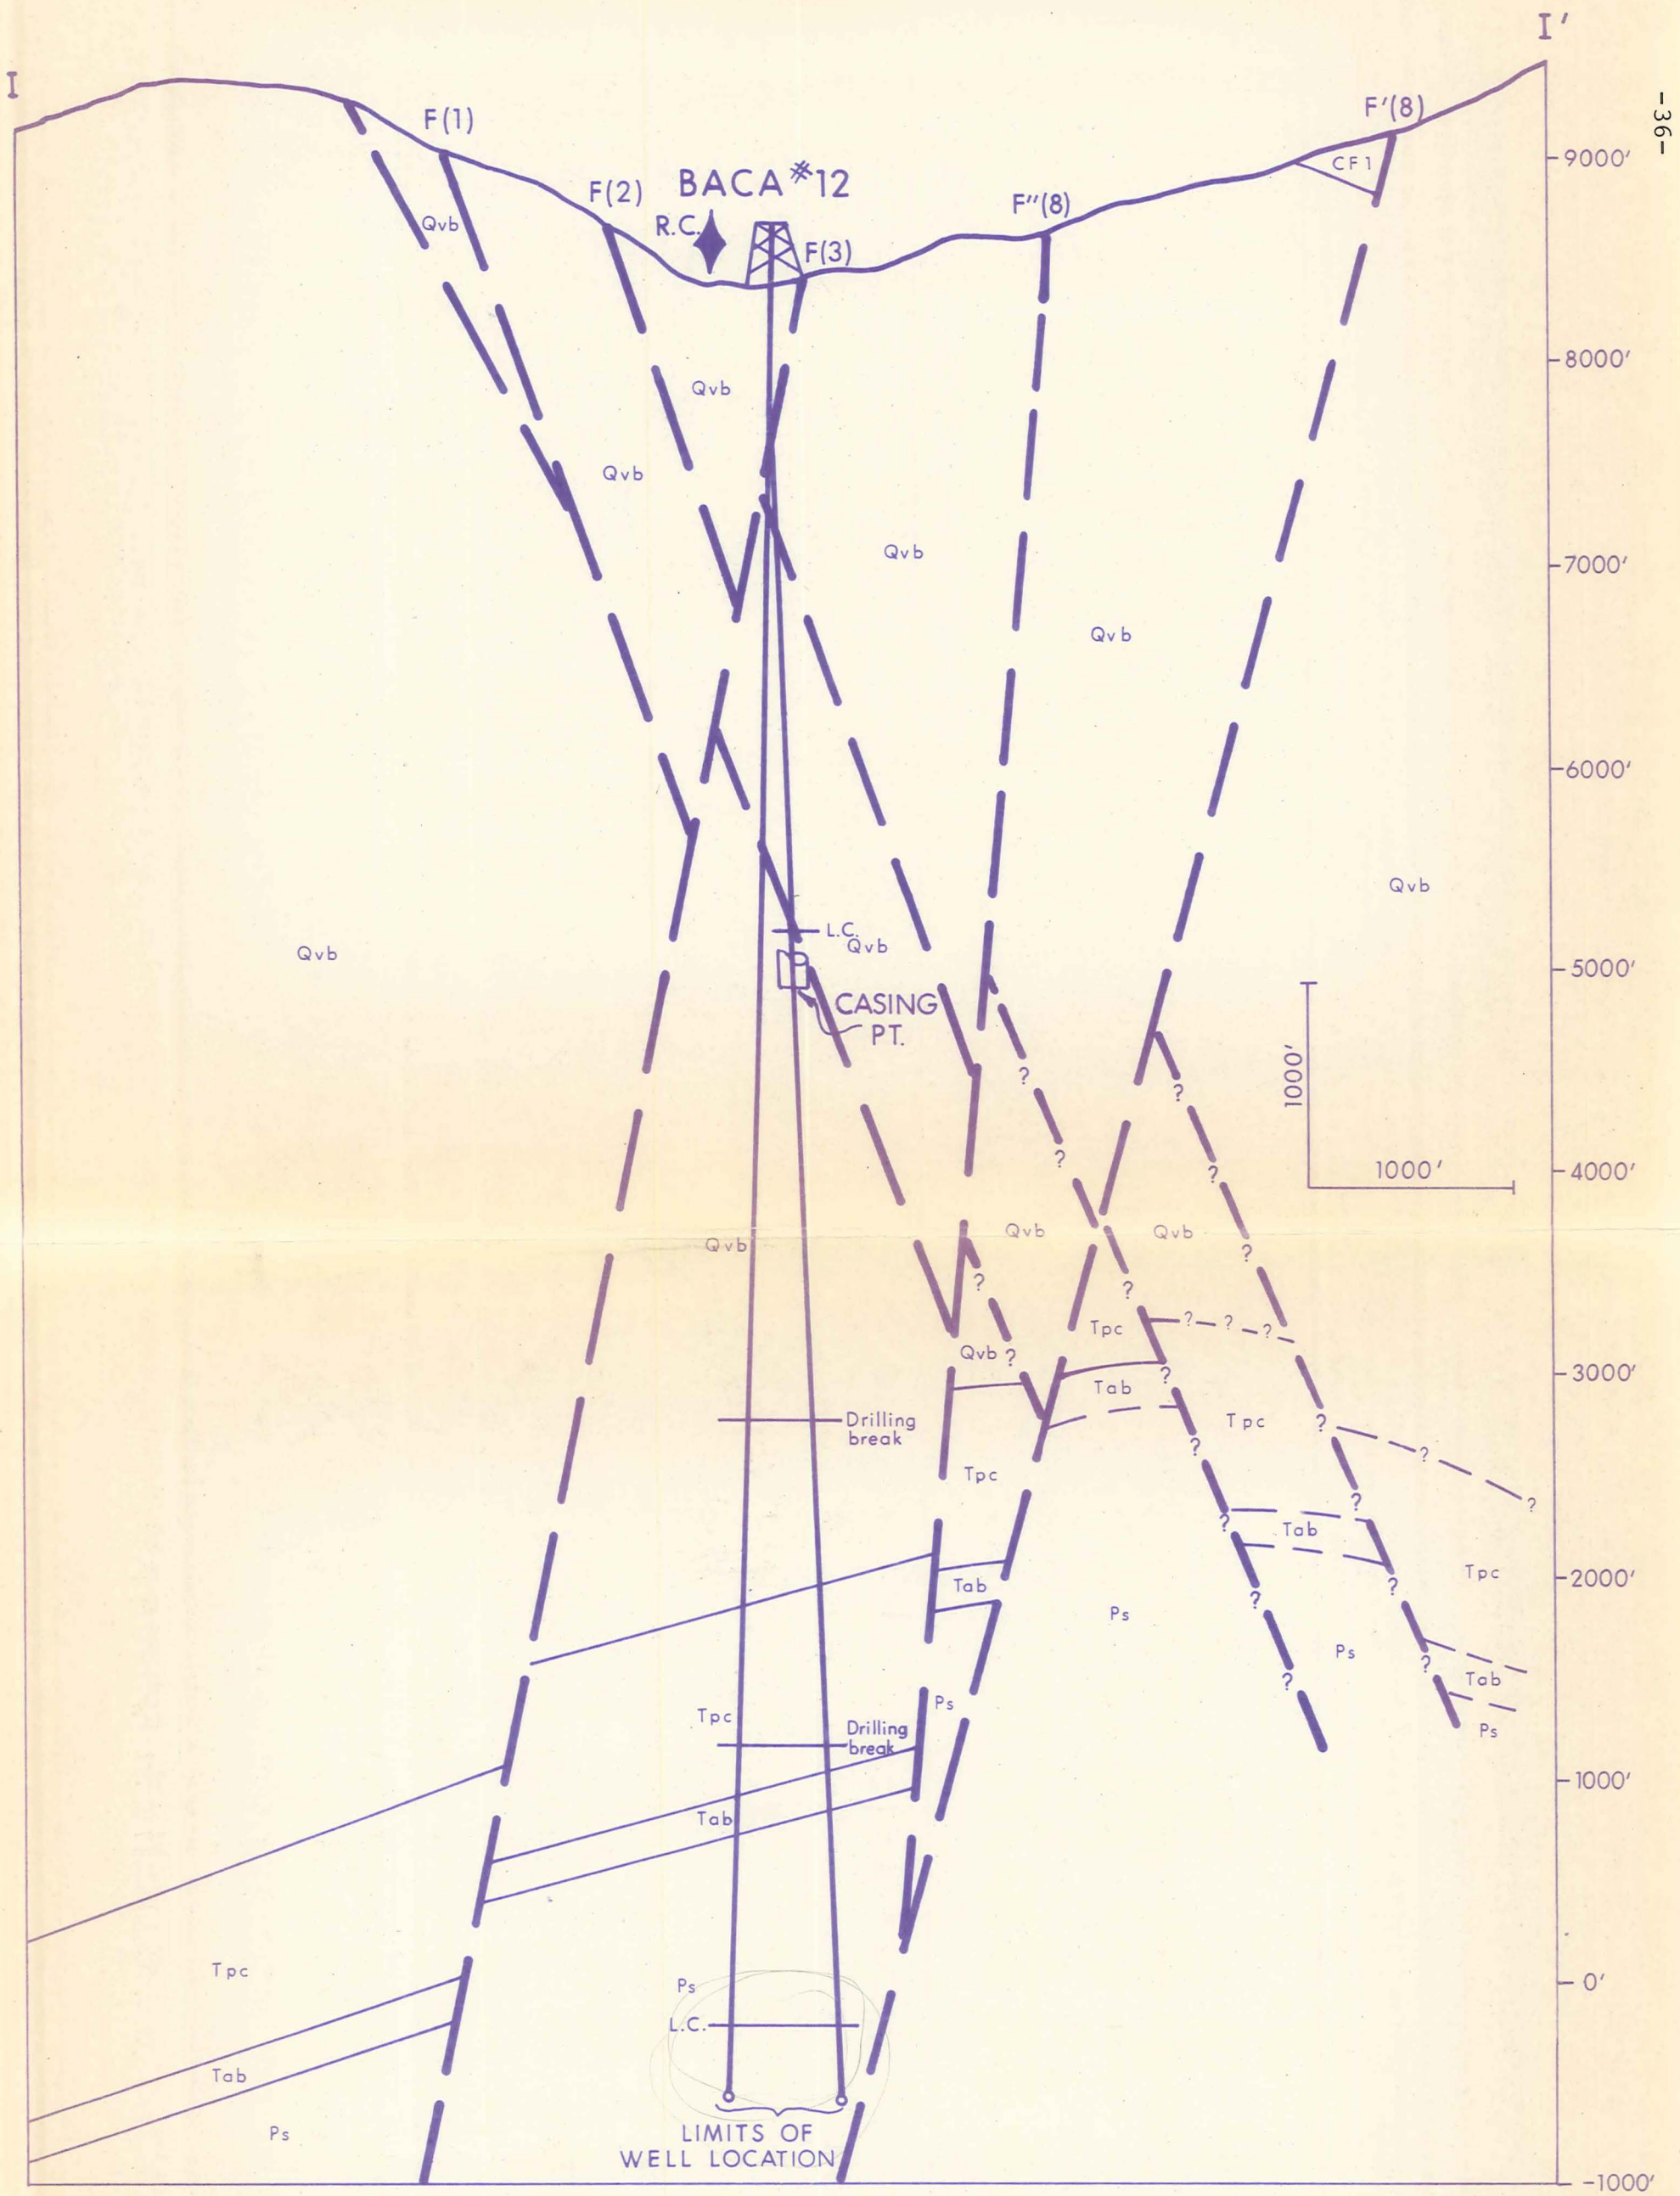
FIGURE 14. Cross Section through Baca 12; I-I' on Figure 1.

All steeply-dipping fault zones crossed the Baca 12 well course above the casing point (Figure 14). A zone of lost circulation and associated temperature reversal probably coincide with the intersection of F(1) with Baca 12. This well did not cross any fault zones below the casing point and is a nonproducer.

It is important to note that approximately 50 to 125 barrels of fluid per hour were lost to the formation while drilling the lower 2600 ft. of this well, which suggests that lost circulation data may not be directly correlative to well producibility.
