GL02867-3 of 10

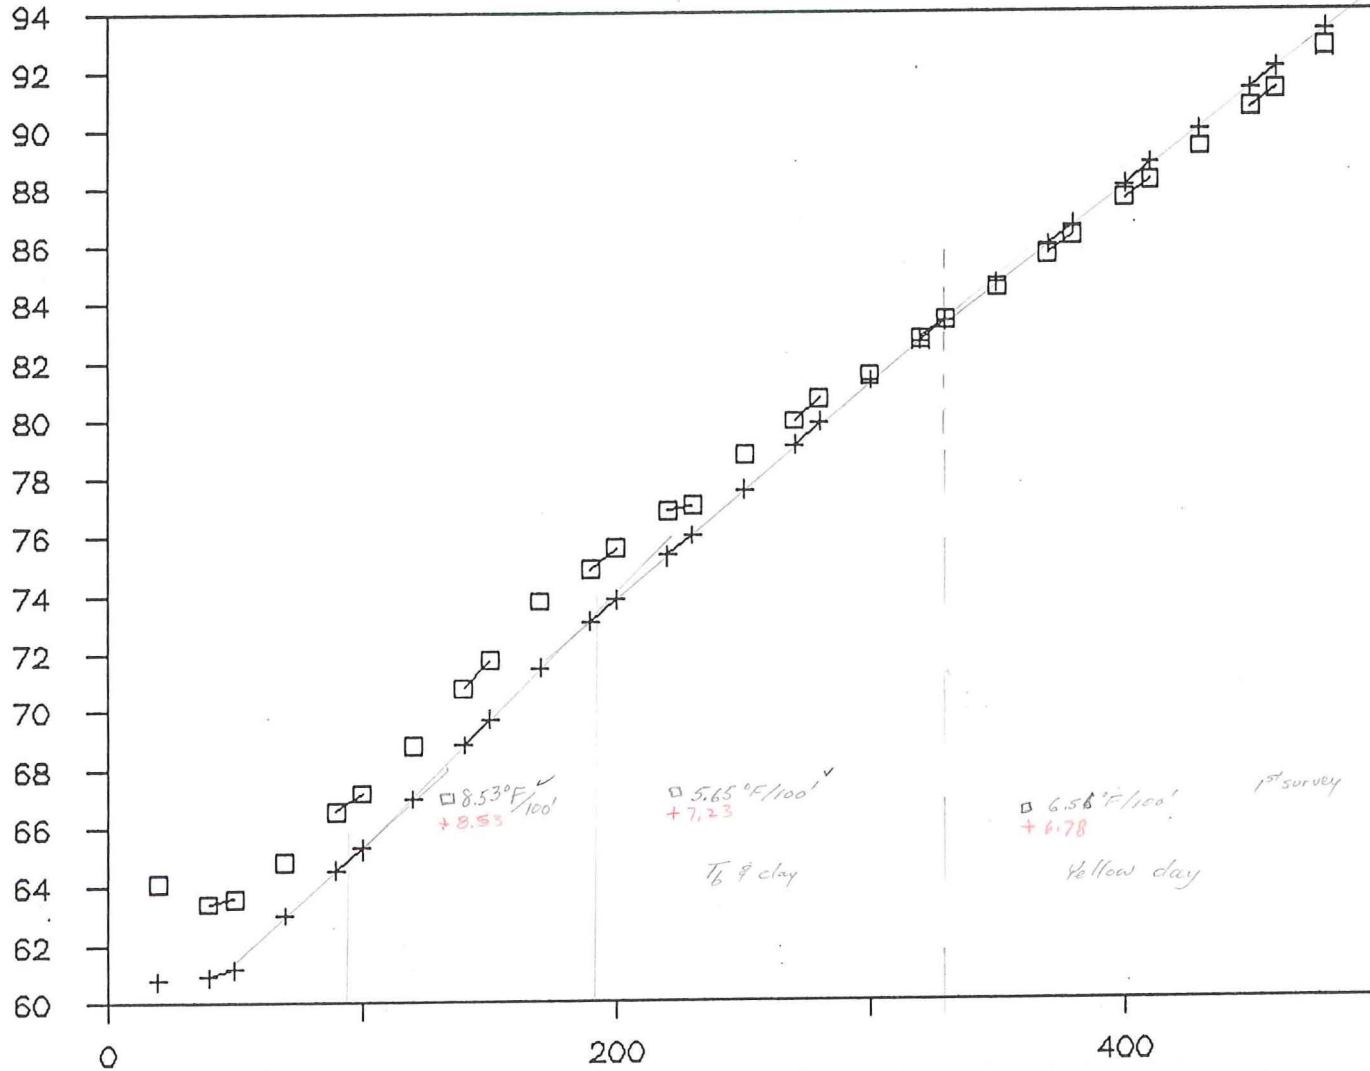
CI-1 ✓

□ 6.6 F/100'(394-492)

Feet (10-24)
+ 6.8 F/100'(394-492)

(10-12)

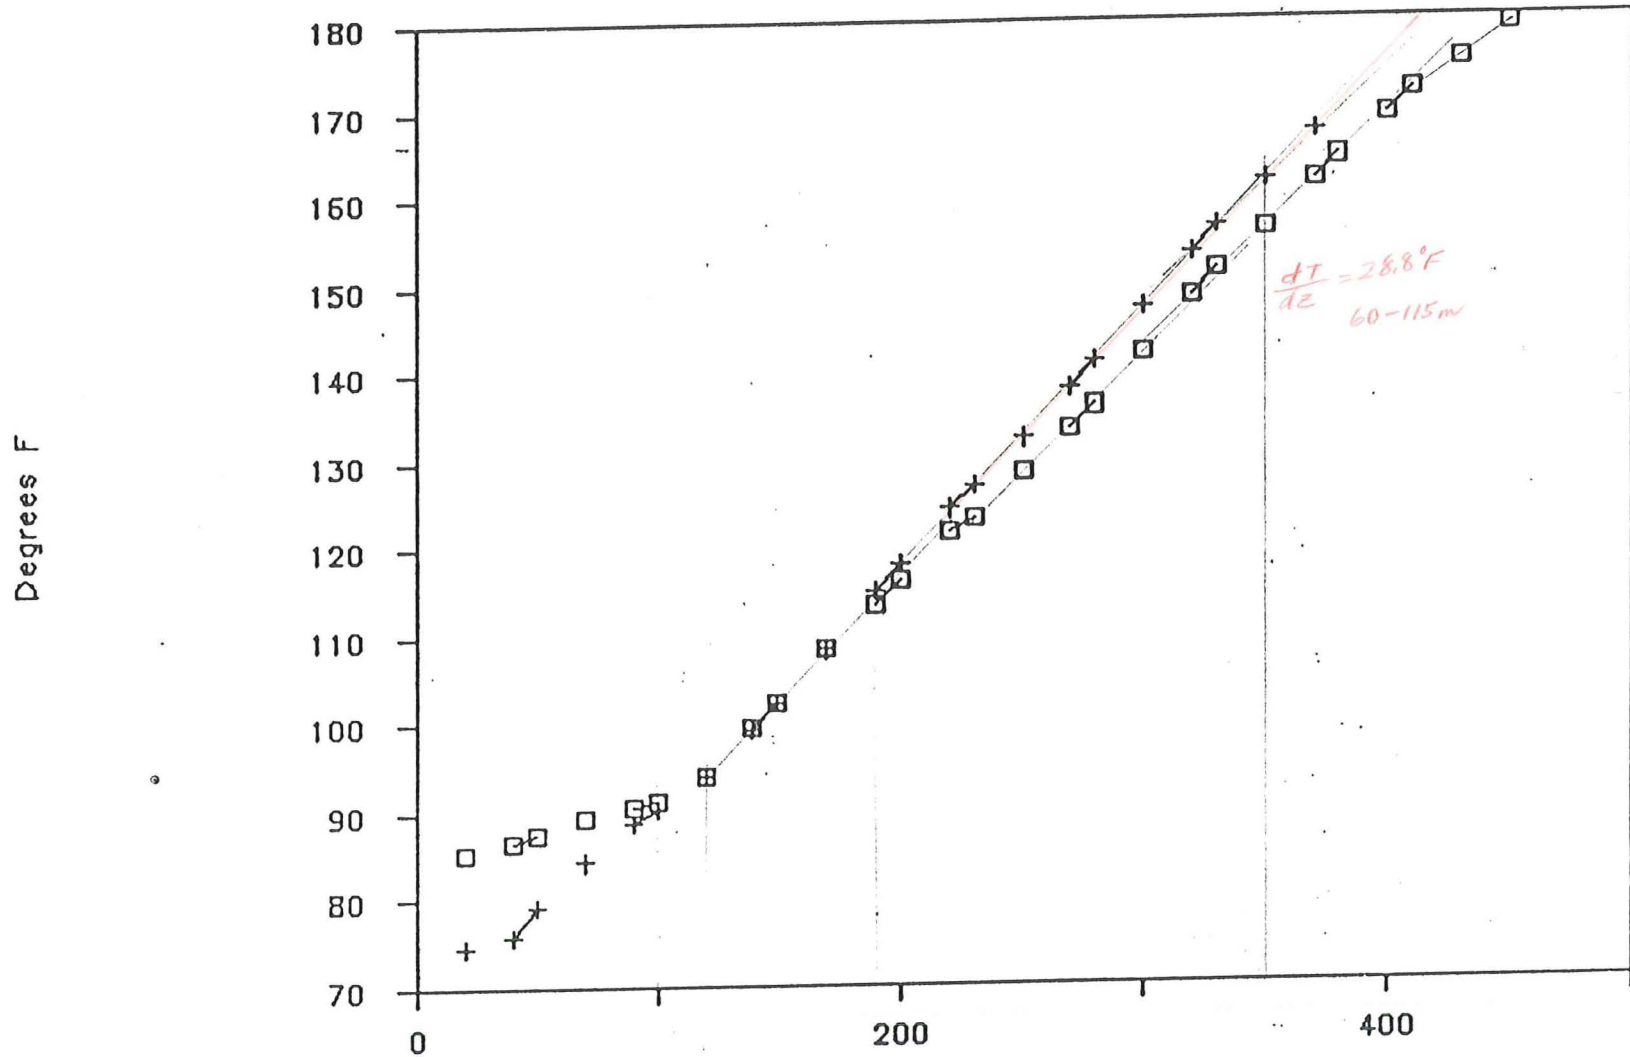
CI-2

□ 19.9 F/100' 443-492
+ See 10-12 Survey

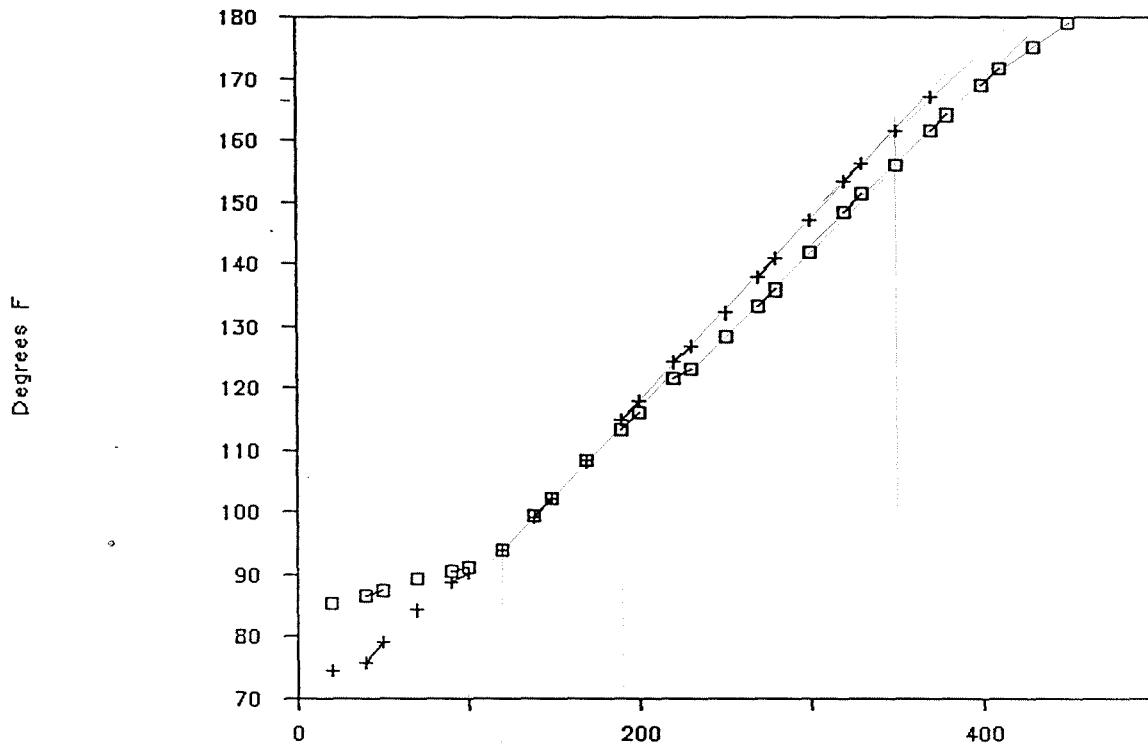
CI-2

□ 19.9 F/100' 443-492

(10-12)

Feet (11-9)
+ See 10-12 Survey

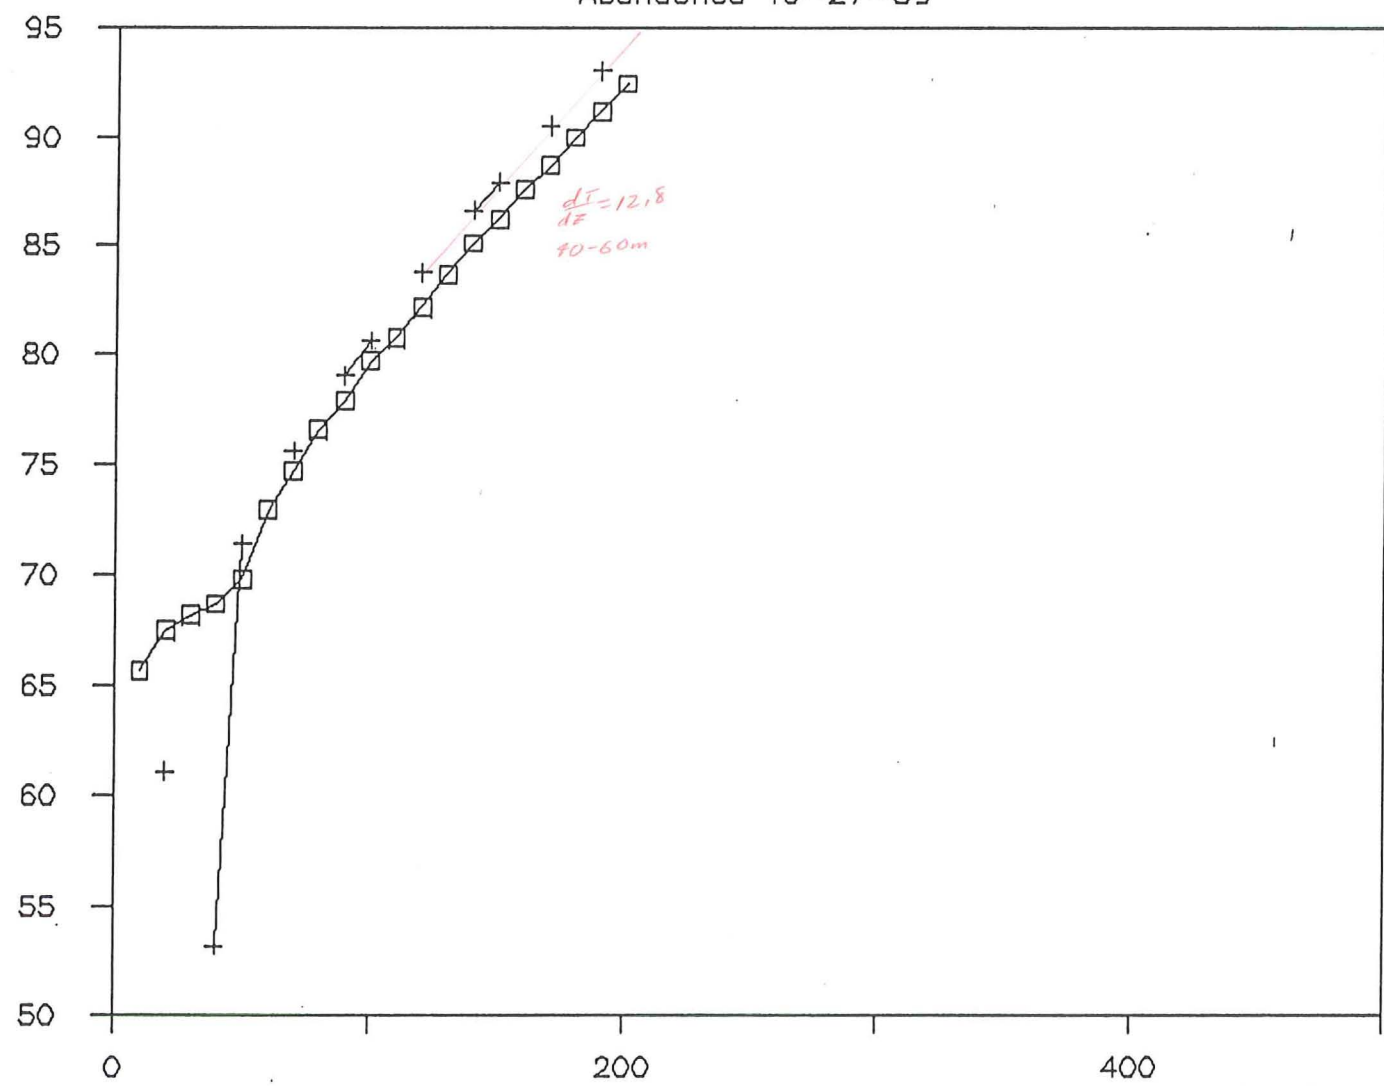
CI-3

$\frac{dT}{dF} = 12.8$
90-60m

□ 12.5 F/100' 130-190

(10-16) Feet ()
+ 12.8 F/100' 140-190

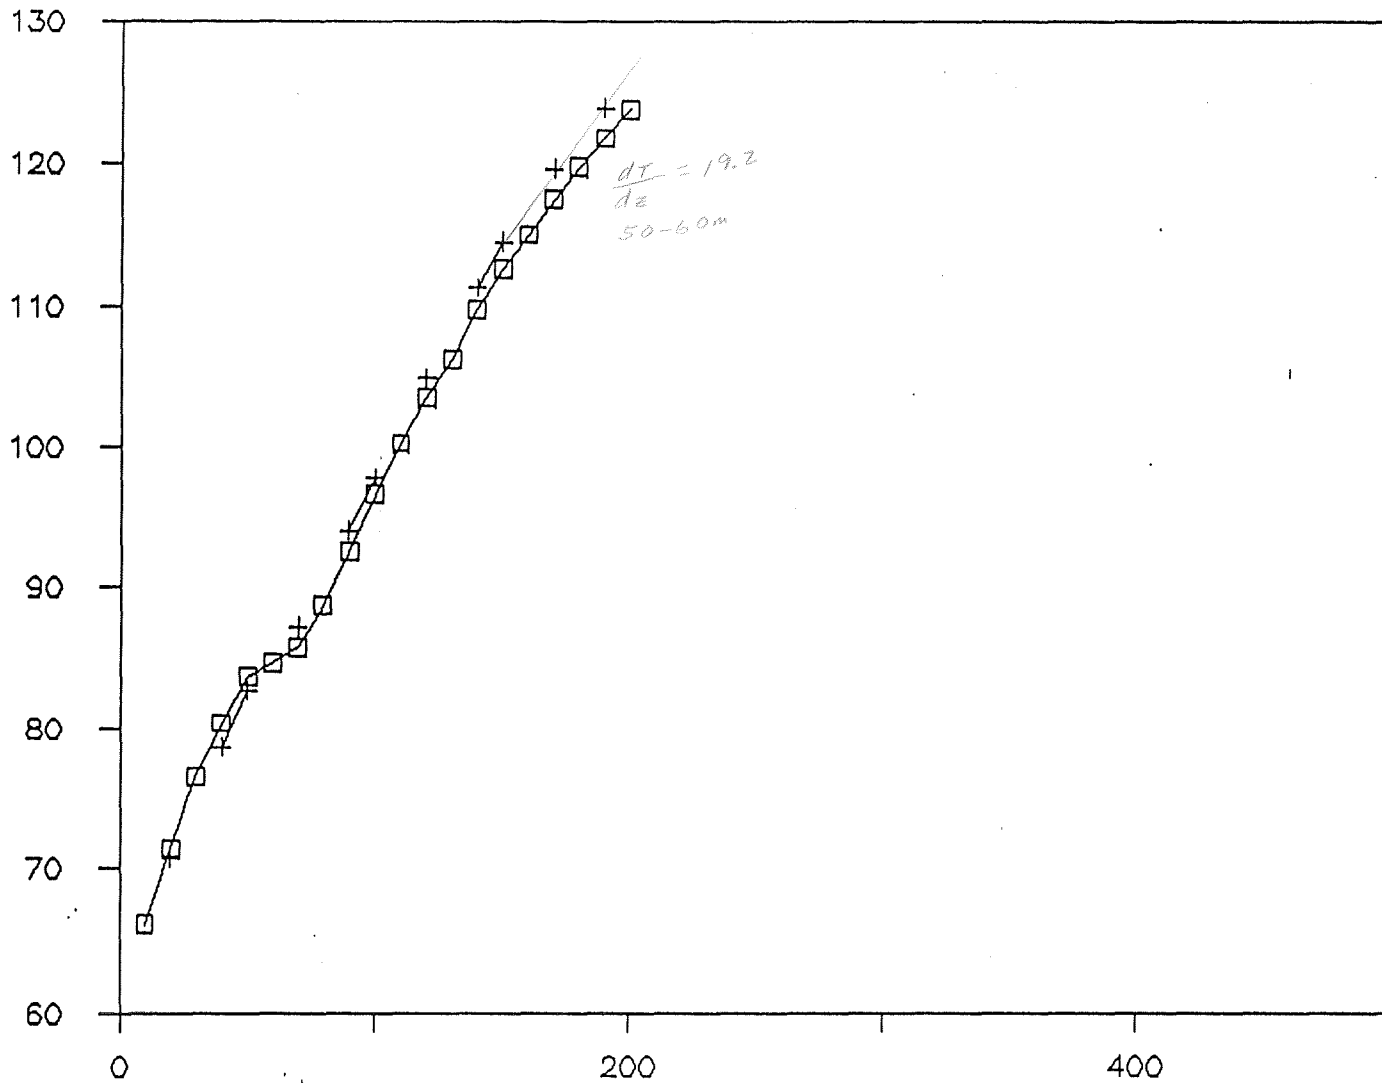
CI-4

□ 20.0 F/100' 180-190

(10-16)

+ 20.9 F/100' 170-190

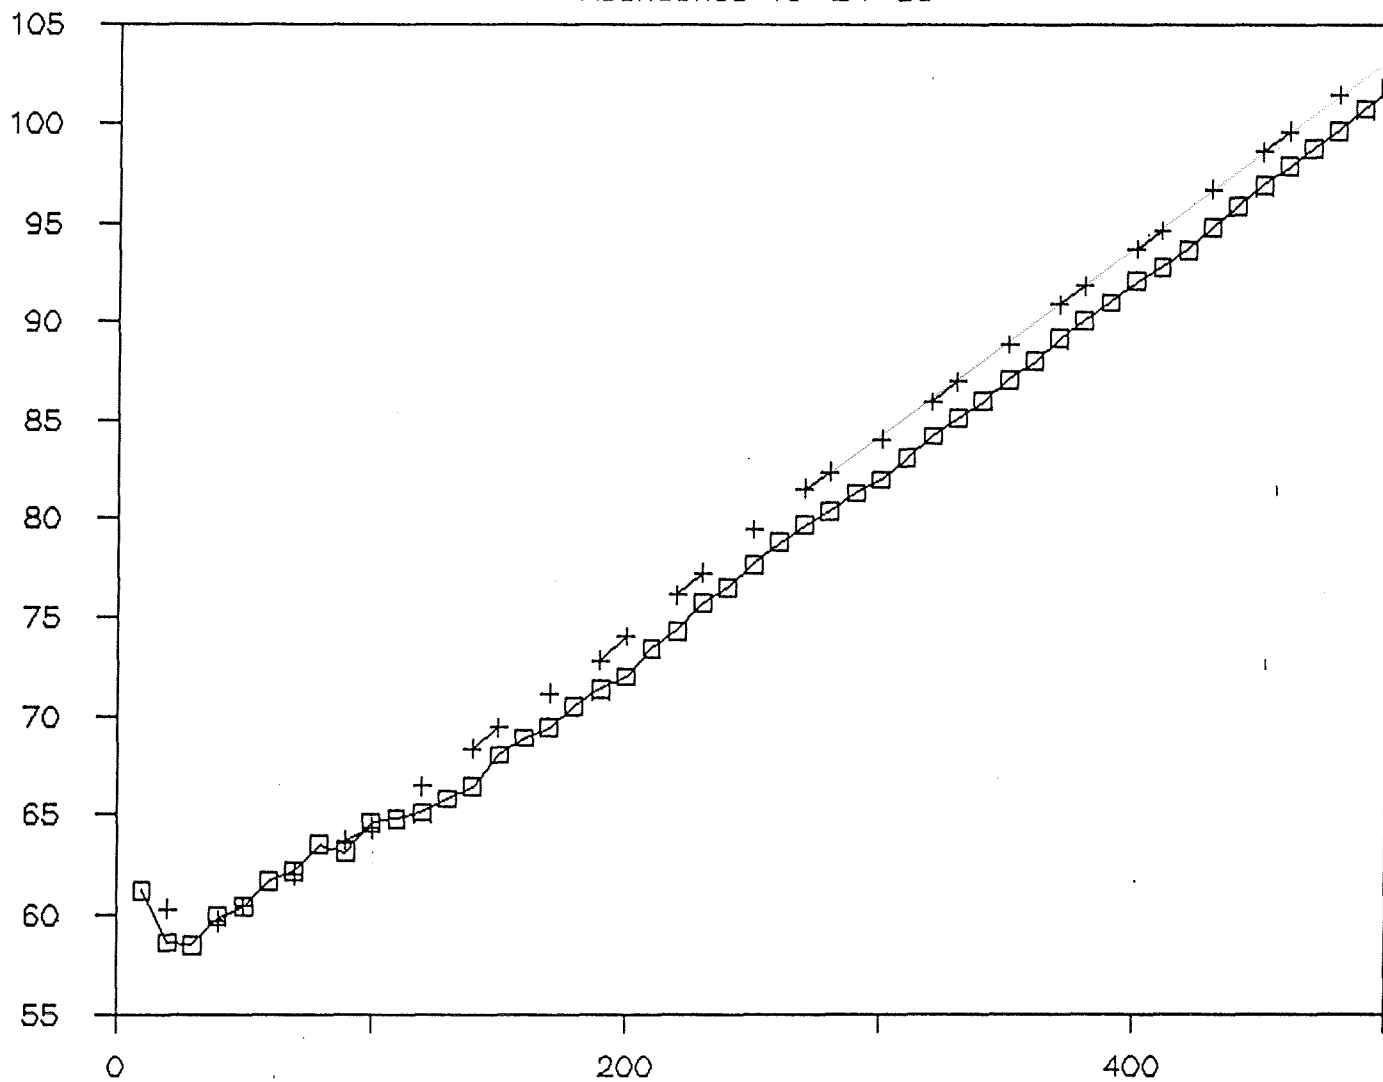
CI-5

□ 9.9 F/100' 300-490

(10-19)

(10-24)

+ 9.7 F/100' 300-480

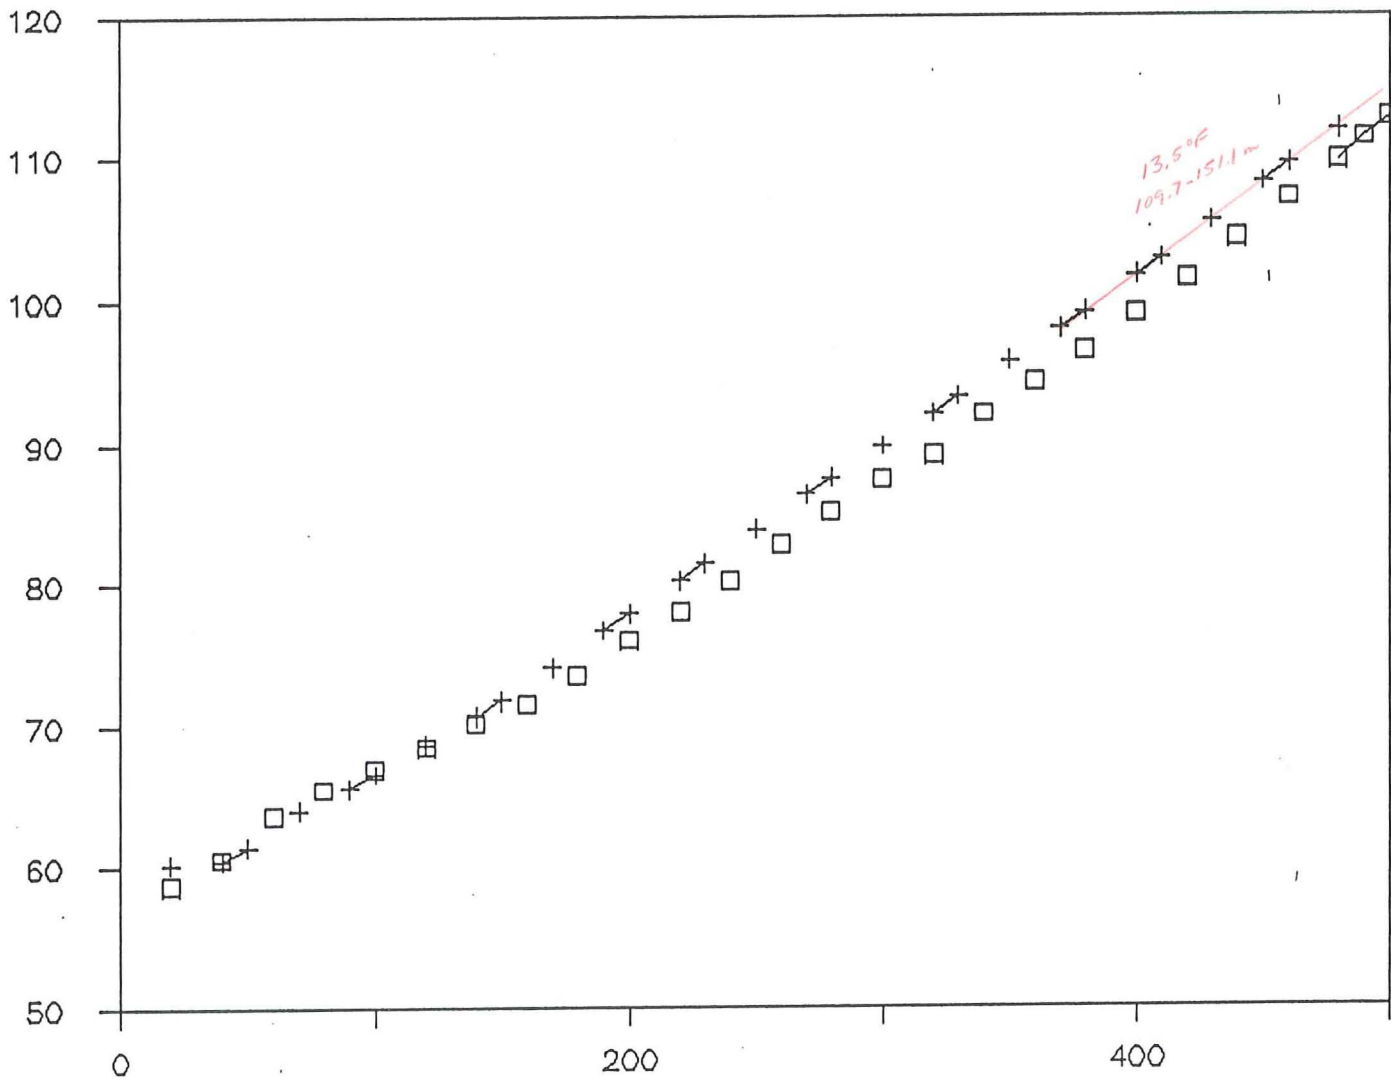
CI-6

□ 14.1 F/100' 420-490

(10-19)

Feet (10-24)
+ 13.0 F/100' 430-480

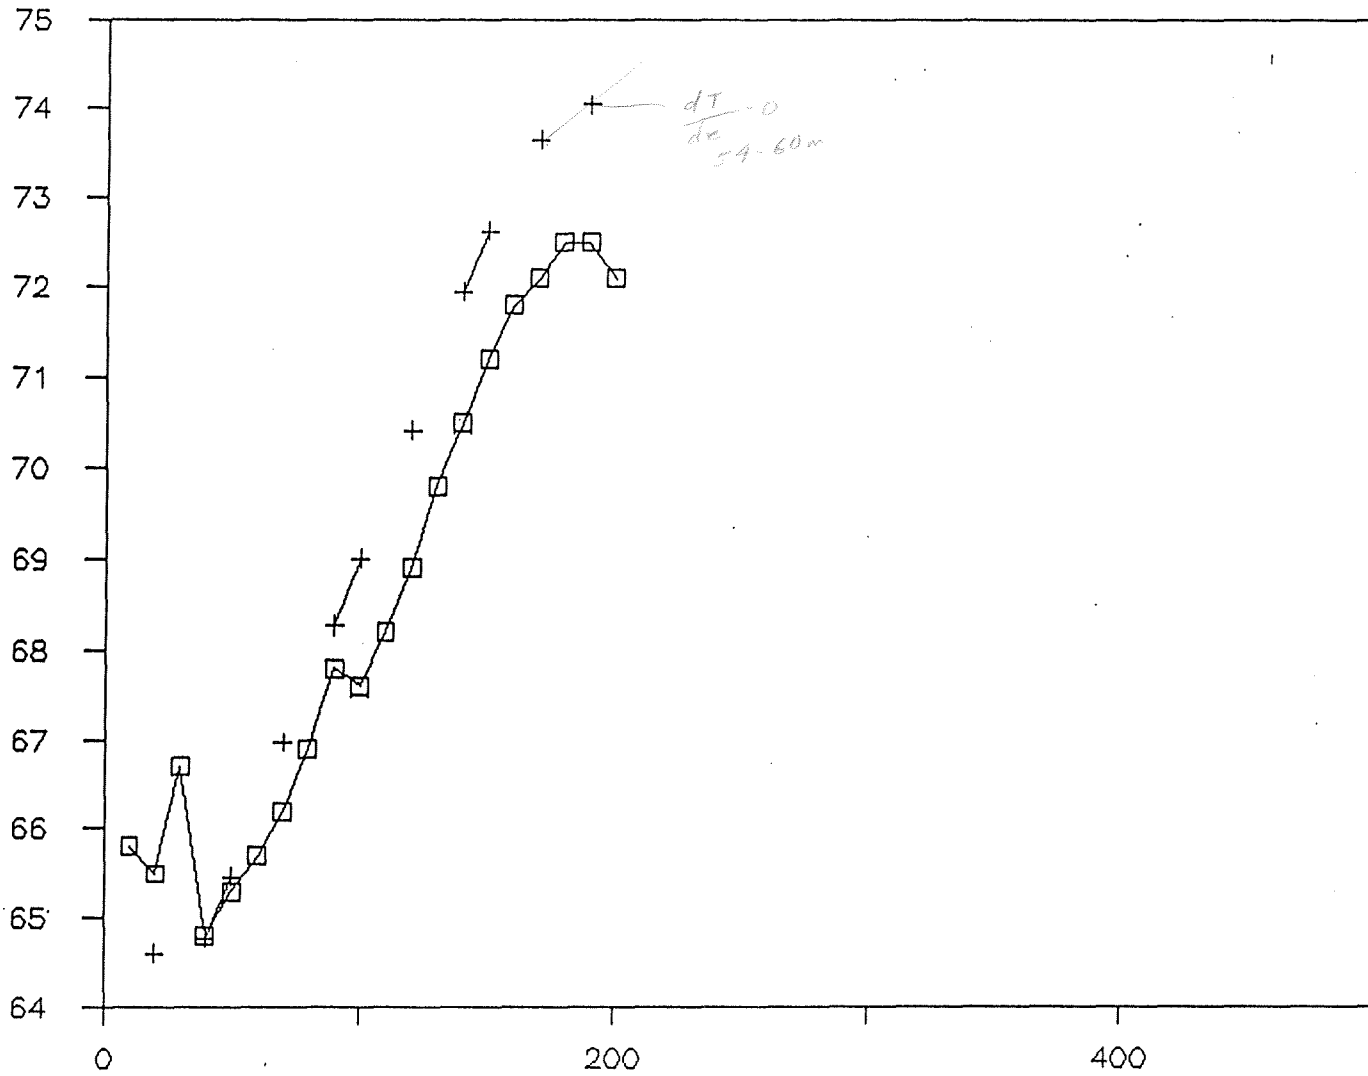
CI-8

□ 4.7? F/100' 40-197.

(10-23)

(11-9)

+ Isothermal

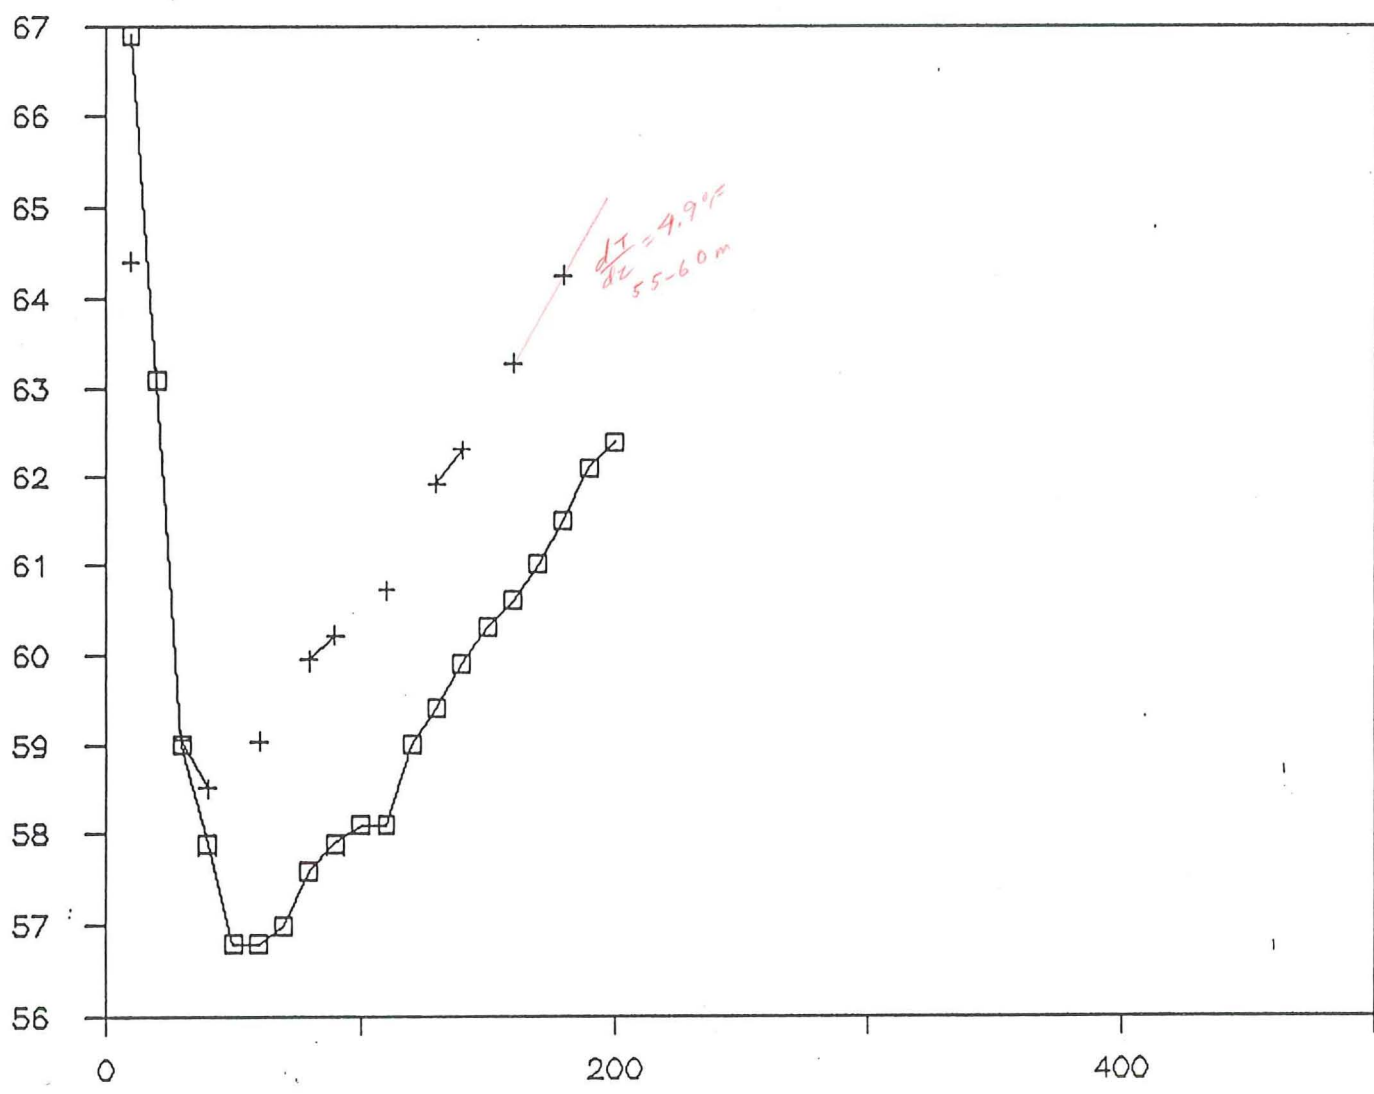
CI-9

□ 4.4 F/100' 120-197

(10-23) Feet ()
+ 4.7 F/100' 120-190

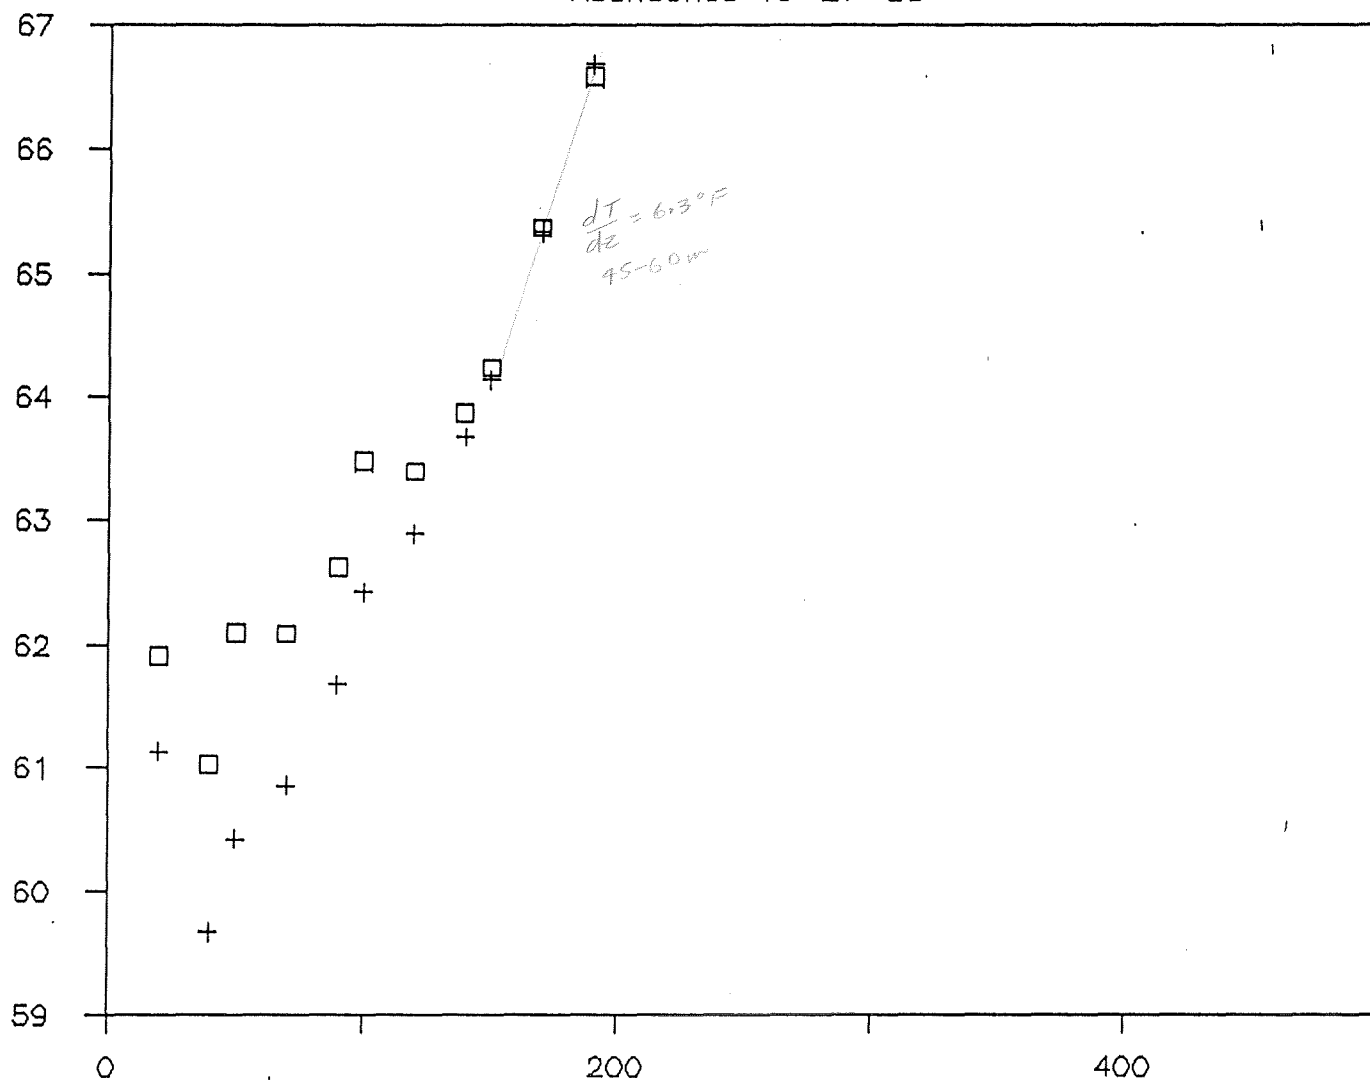
CI-10

$\frac{dT}{dz} = 6.3^\circ F$
45-60m

□ 6.1 F/100 164-197

(10-24) Feet ()
+ 6.4 F/100' 150-190

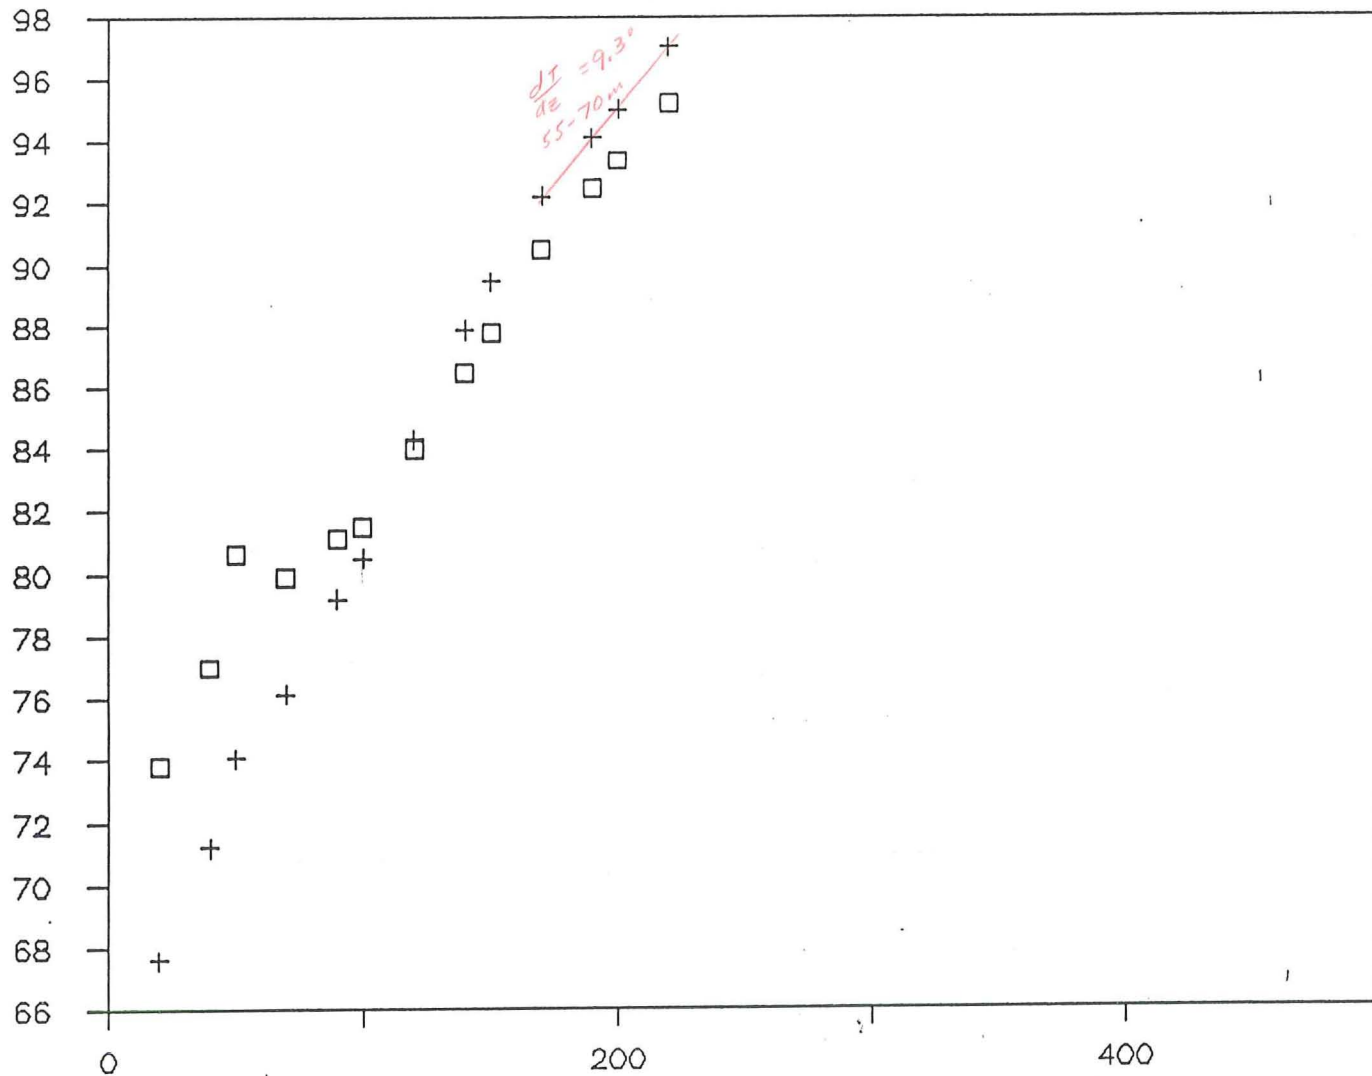
CI-11

(10-24) Feet ()

□ 9.0 F/100' 180-230

+ 9.7 F/100' 190-220
