6107315\_2

OBSERVED DOWNHOLE DRAWDOWN  
AT RRGE #1 WHILE RESERVOIR TESTING  
RRGE #2 AT ~ 400 GPM

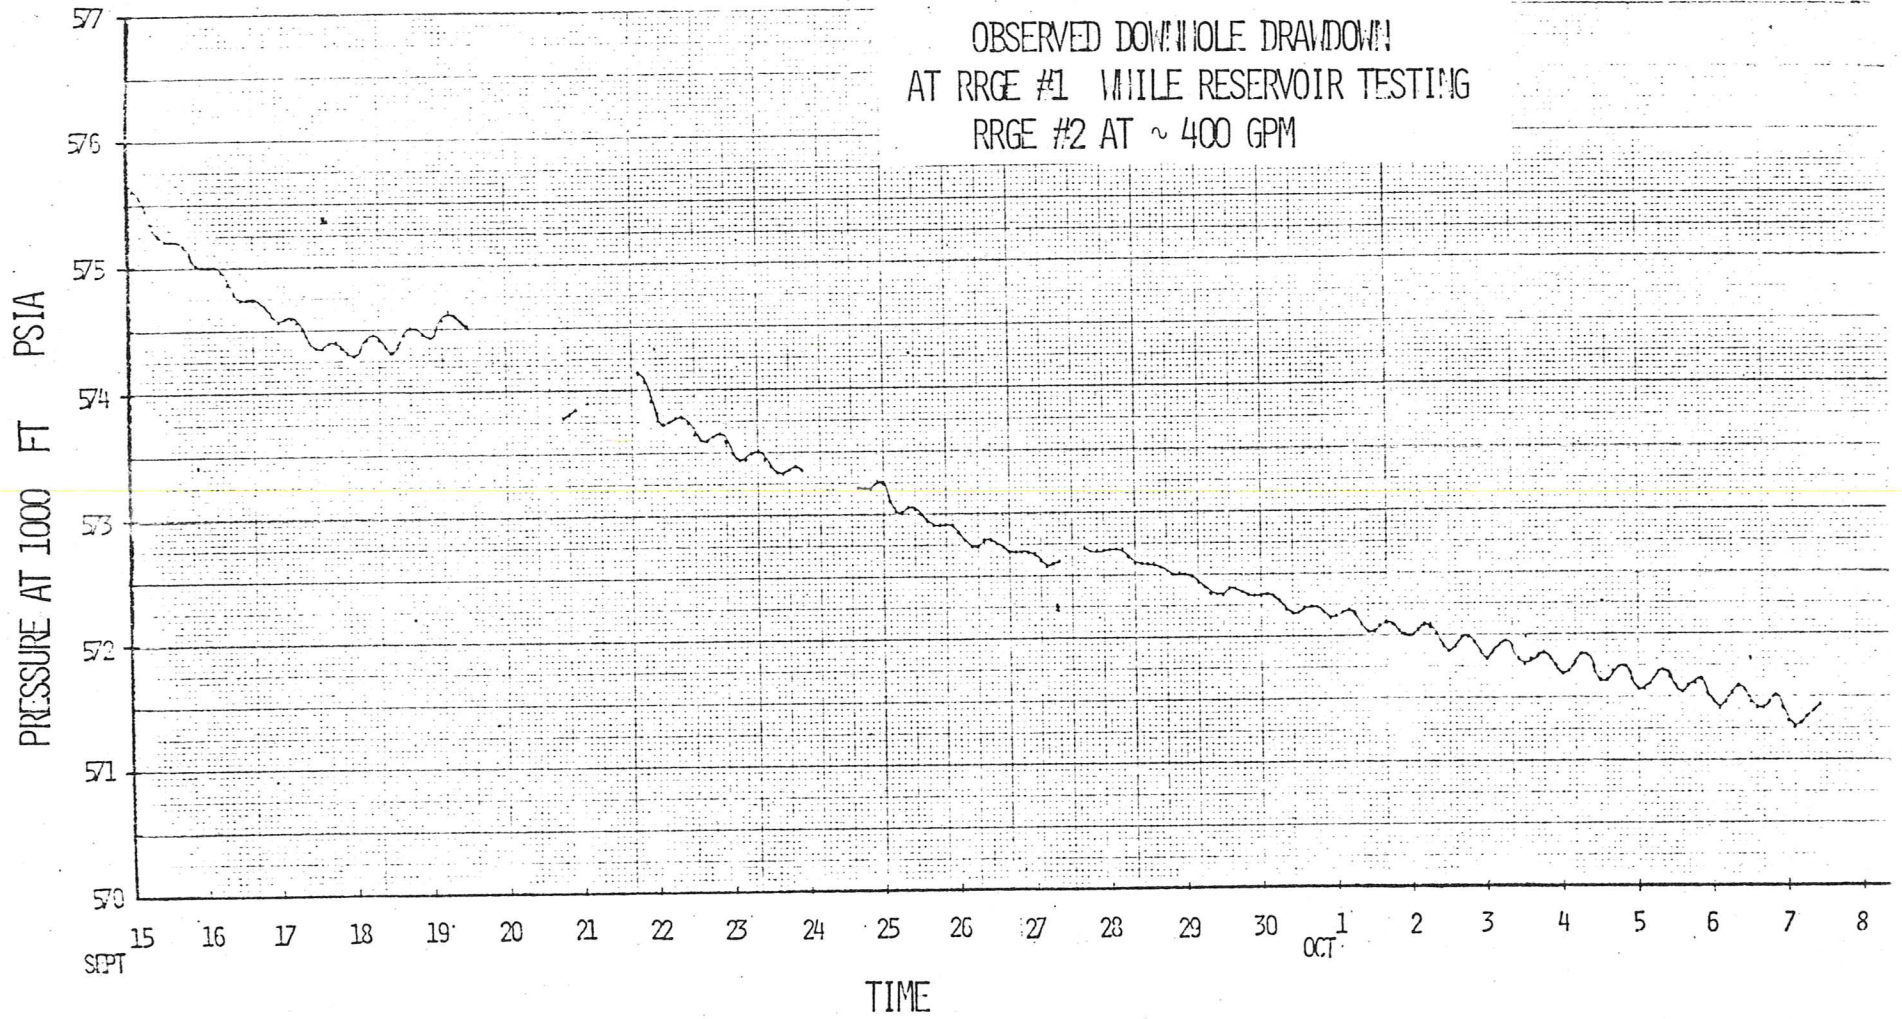
OBSERVED DOWNHOLE DRAWDOWN!  
AT RRGE #1 MILE RESERVOIR TESTING  
RRGE #2 AT ~ 400 GPM

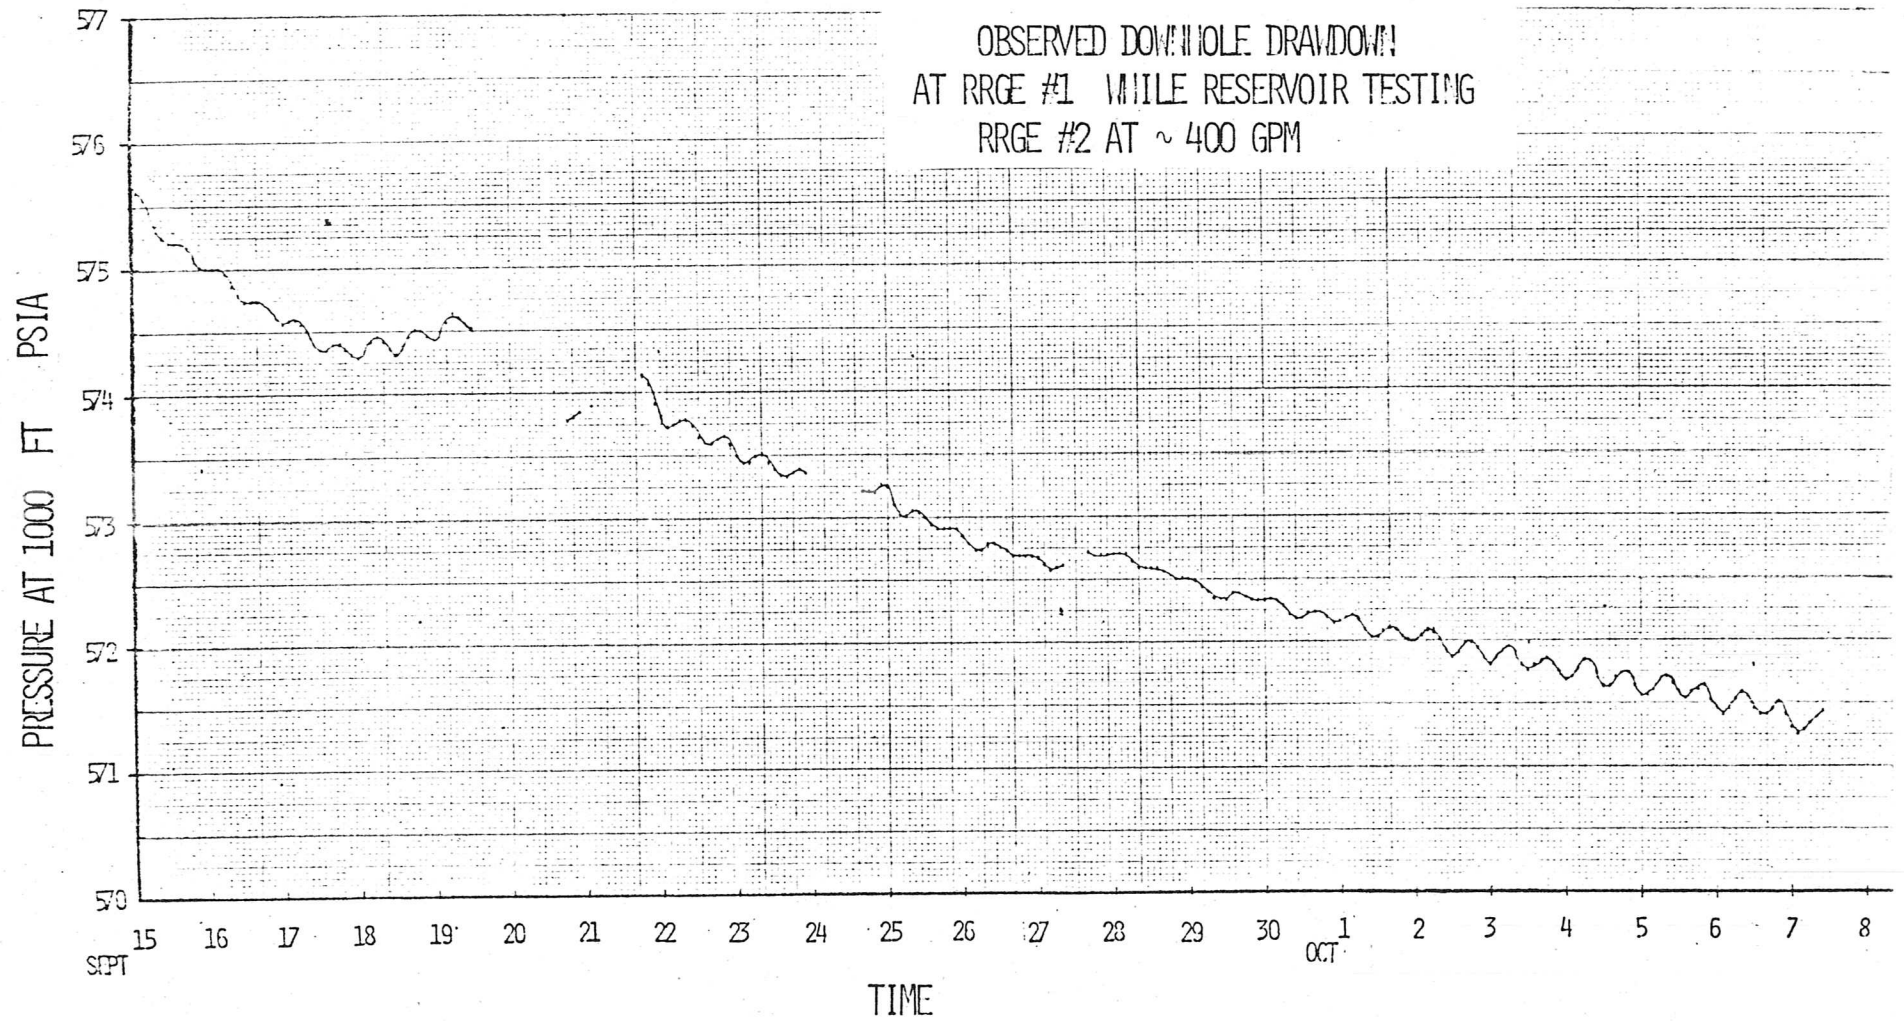
OBSERVED DOWNHOLE DRAWDOWN!  
AT RRGE #1 MILE RESERVOIR TESTING  
RRGE #2 AT ~ 400 GPM

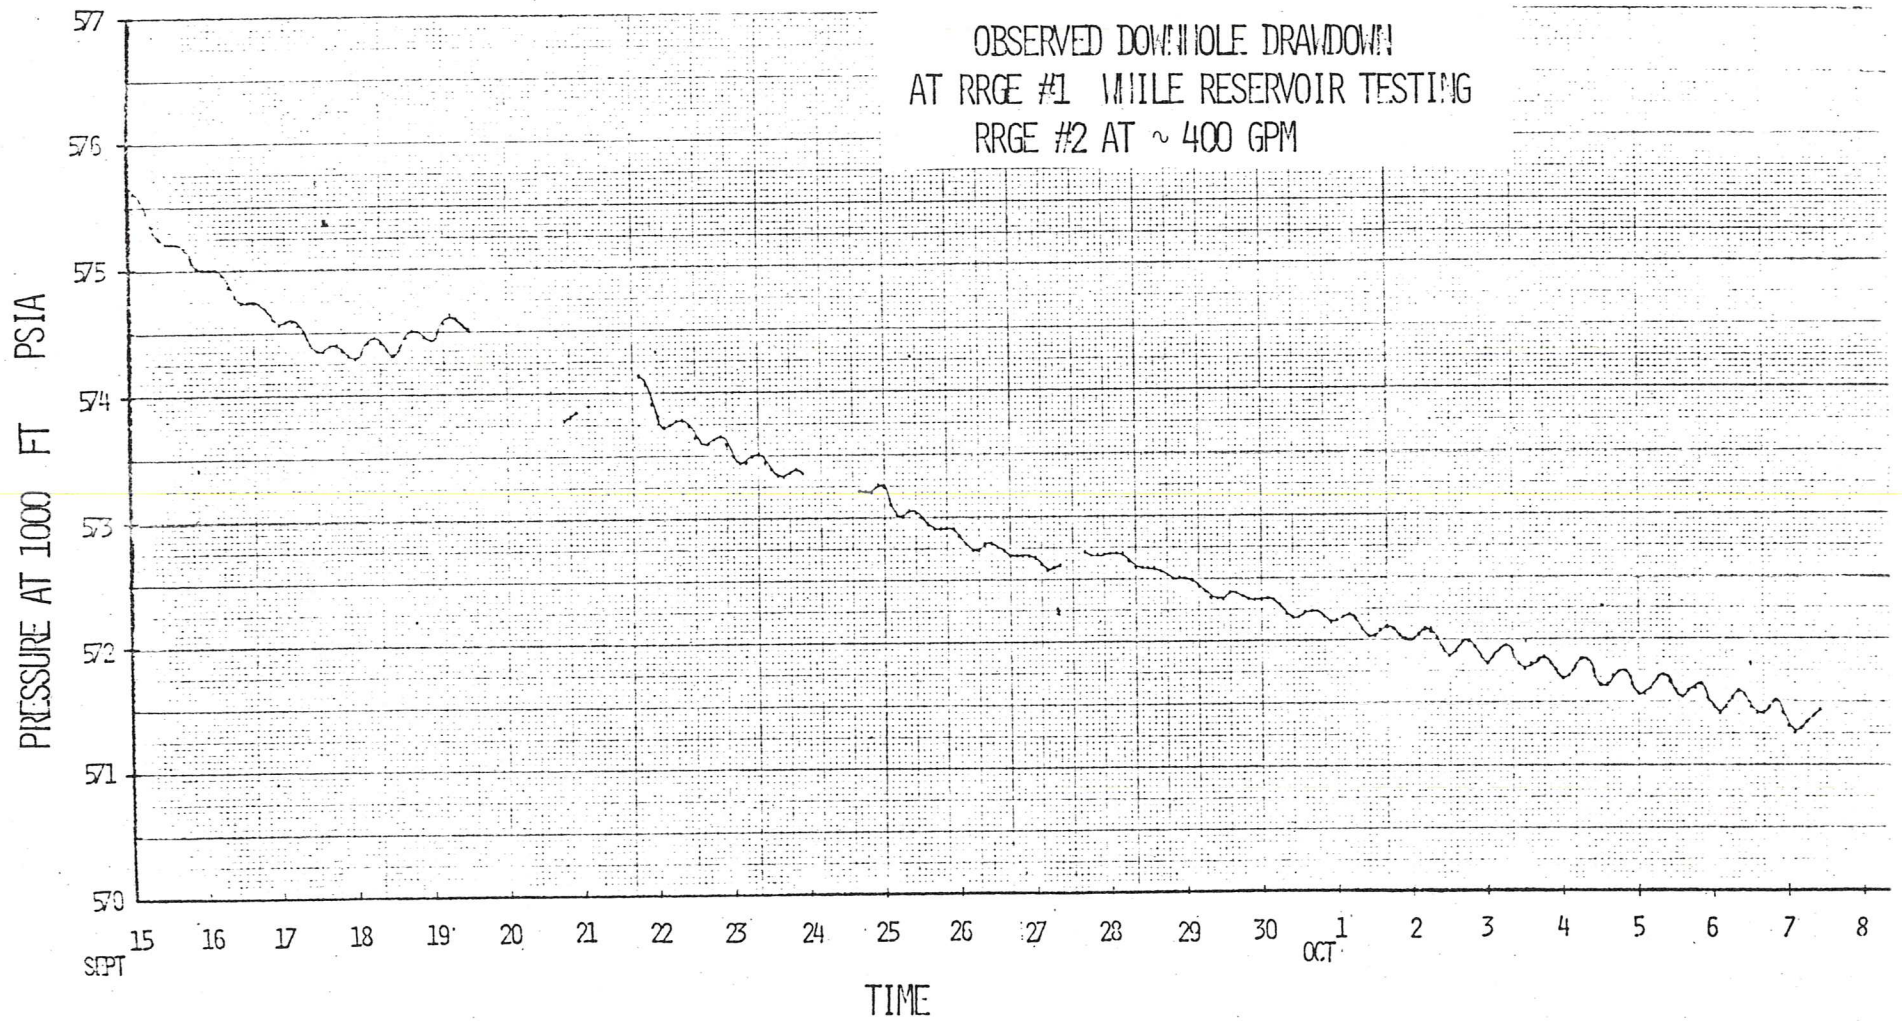
OBSERVED DOWNHOLE DRAWDOWN!  
AT RRGE #1 MILE RESERVOIR TESTING  
RRGE #2 AT ~ 400 GPM

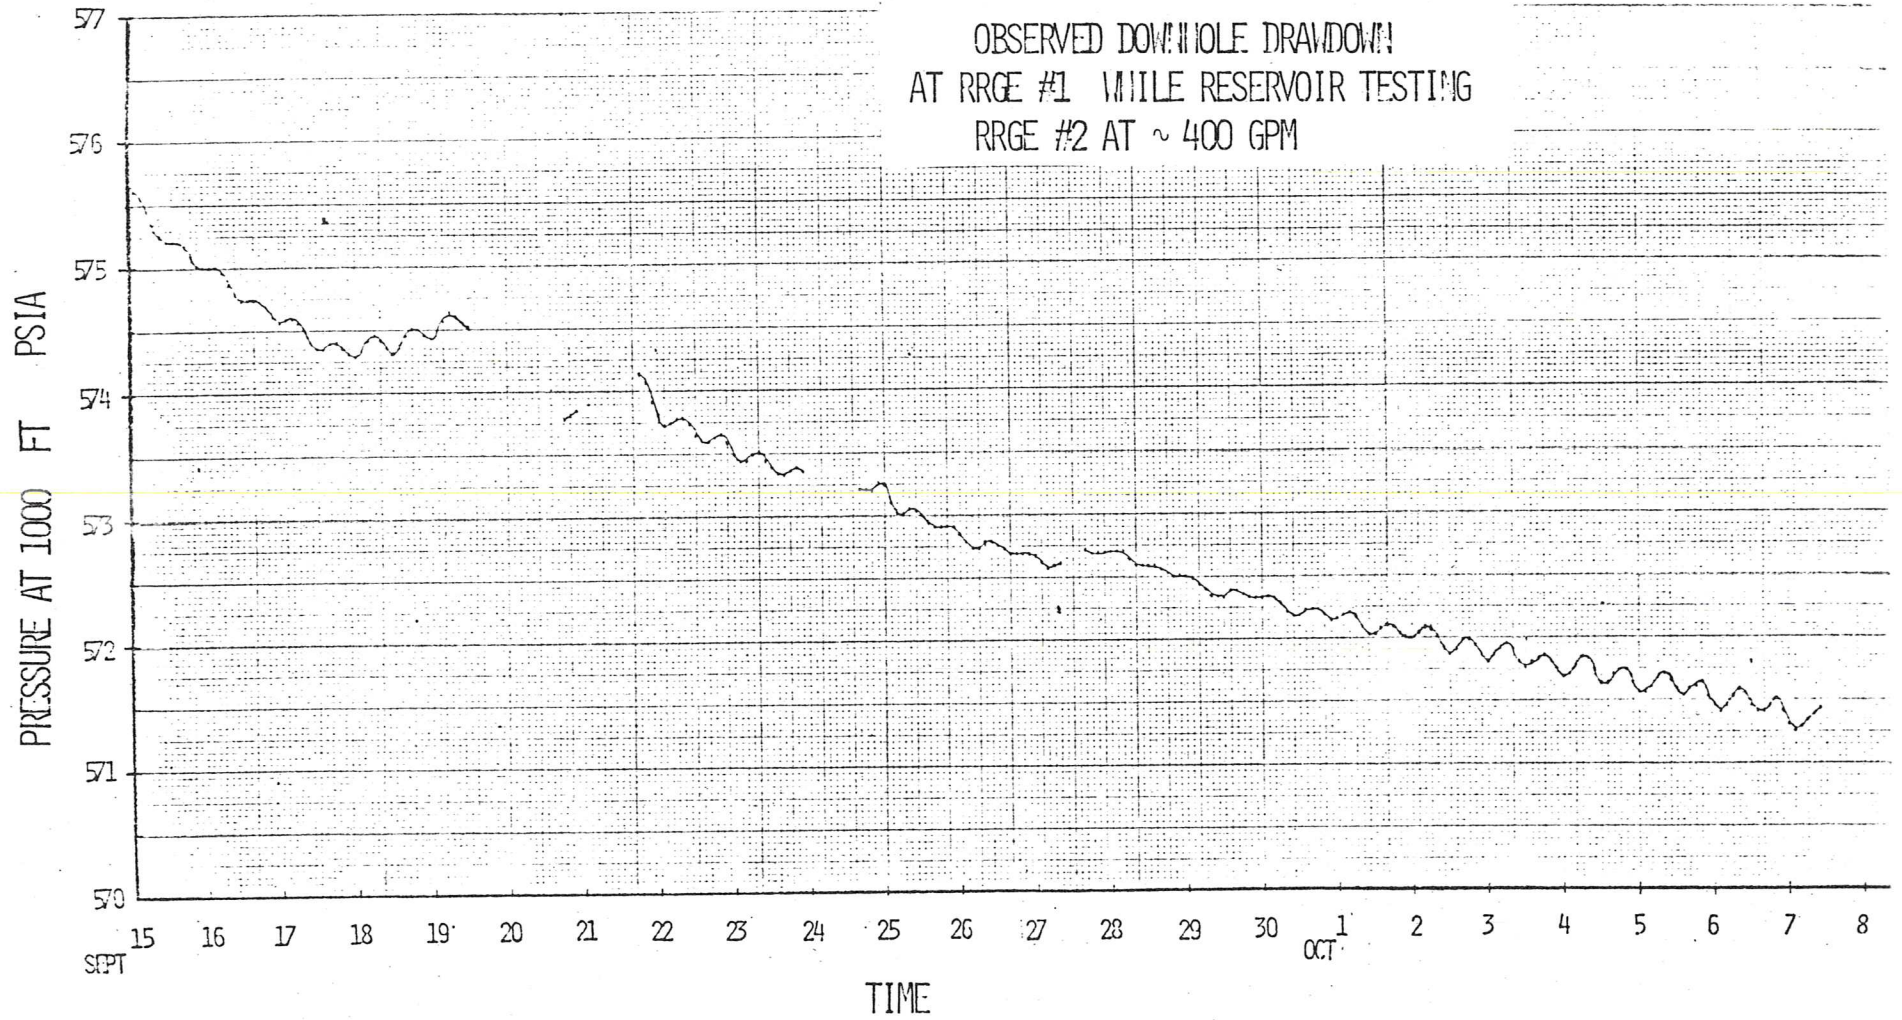
OBSERVED DOWNHOLE DRAWDOWN!  
AT RRGE #1 MILE RESERVOIR TESTING  
RRGE #2 AT ~ 400 GPM

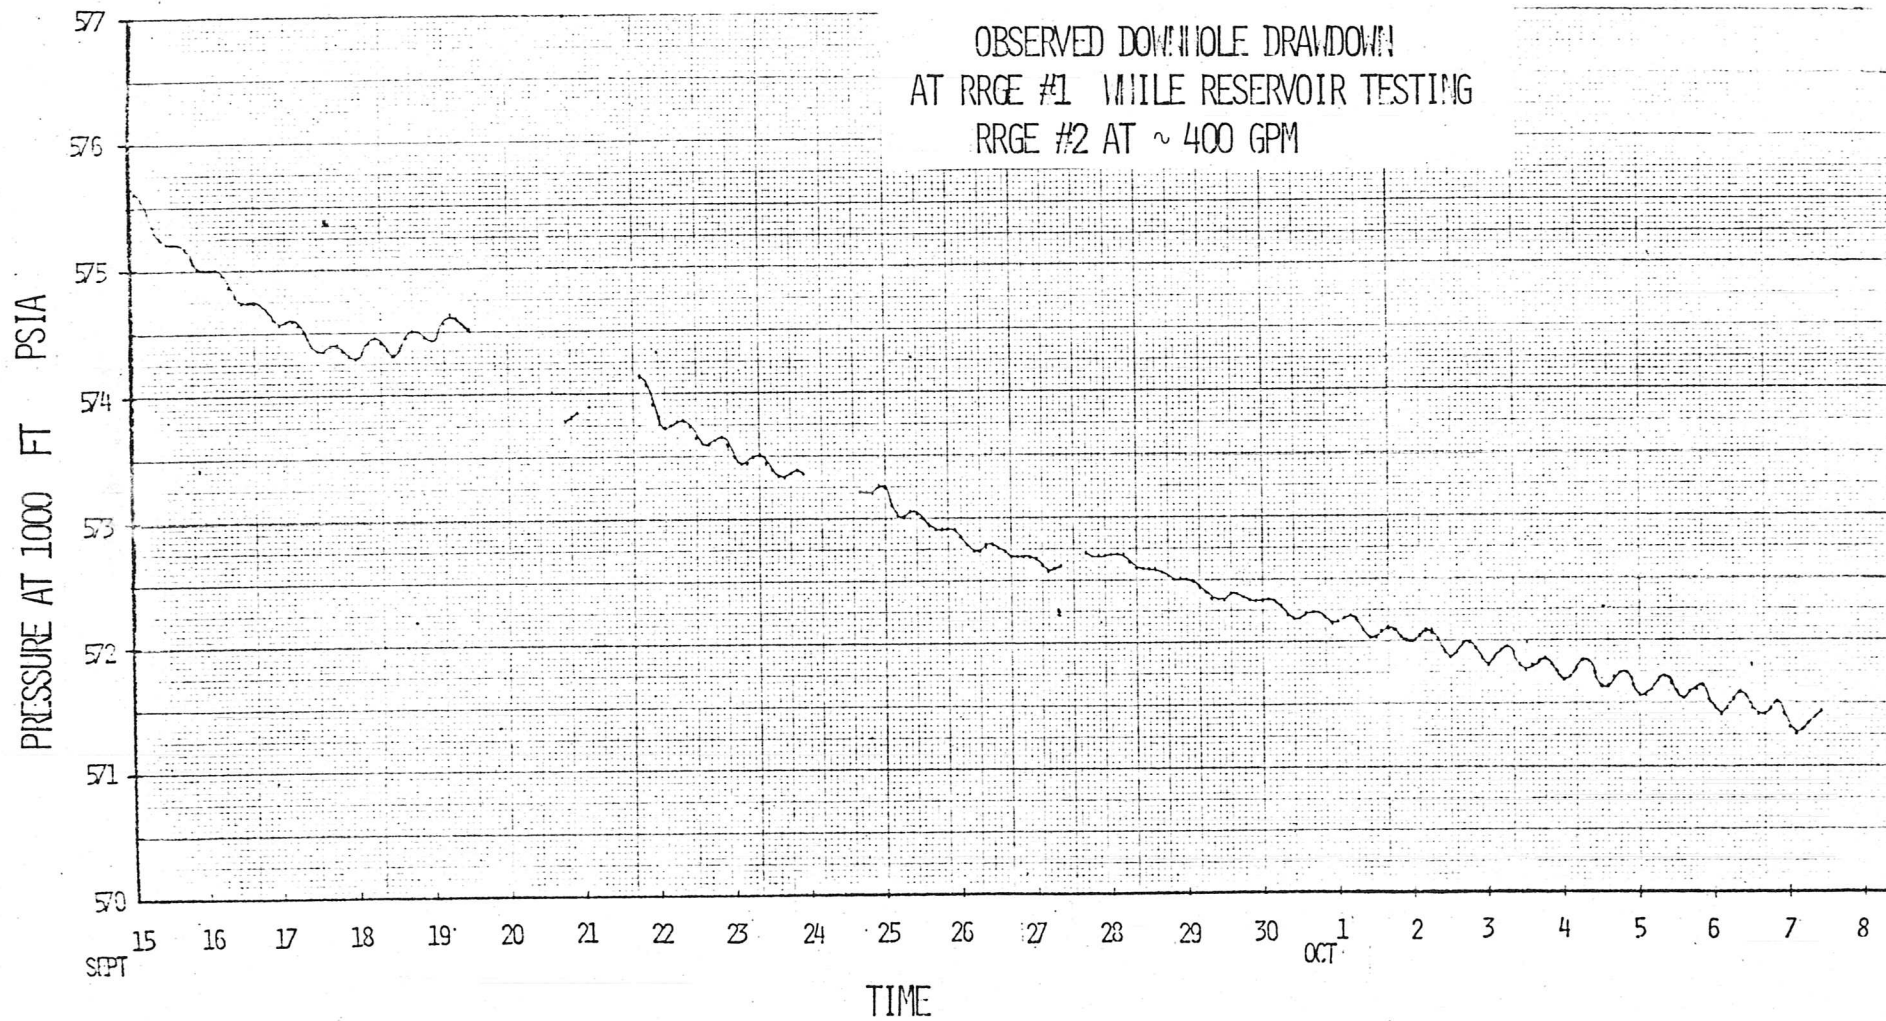
OBSERVED DOWNHOLE DRAWDOWN  
AT RRGE #1 MILE RESERVOIR TESTING  
RRGE #2 AT ~ 400 GPM
