LACKLAND AIR FORCE BASE

SAN ANTONIO, TEXAS

GEOLOGICAL AND FOUNDATION INVESTIGATION

APRIL 1967

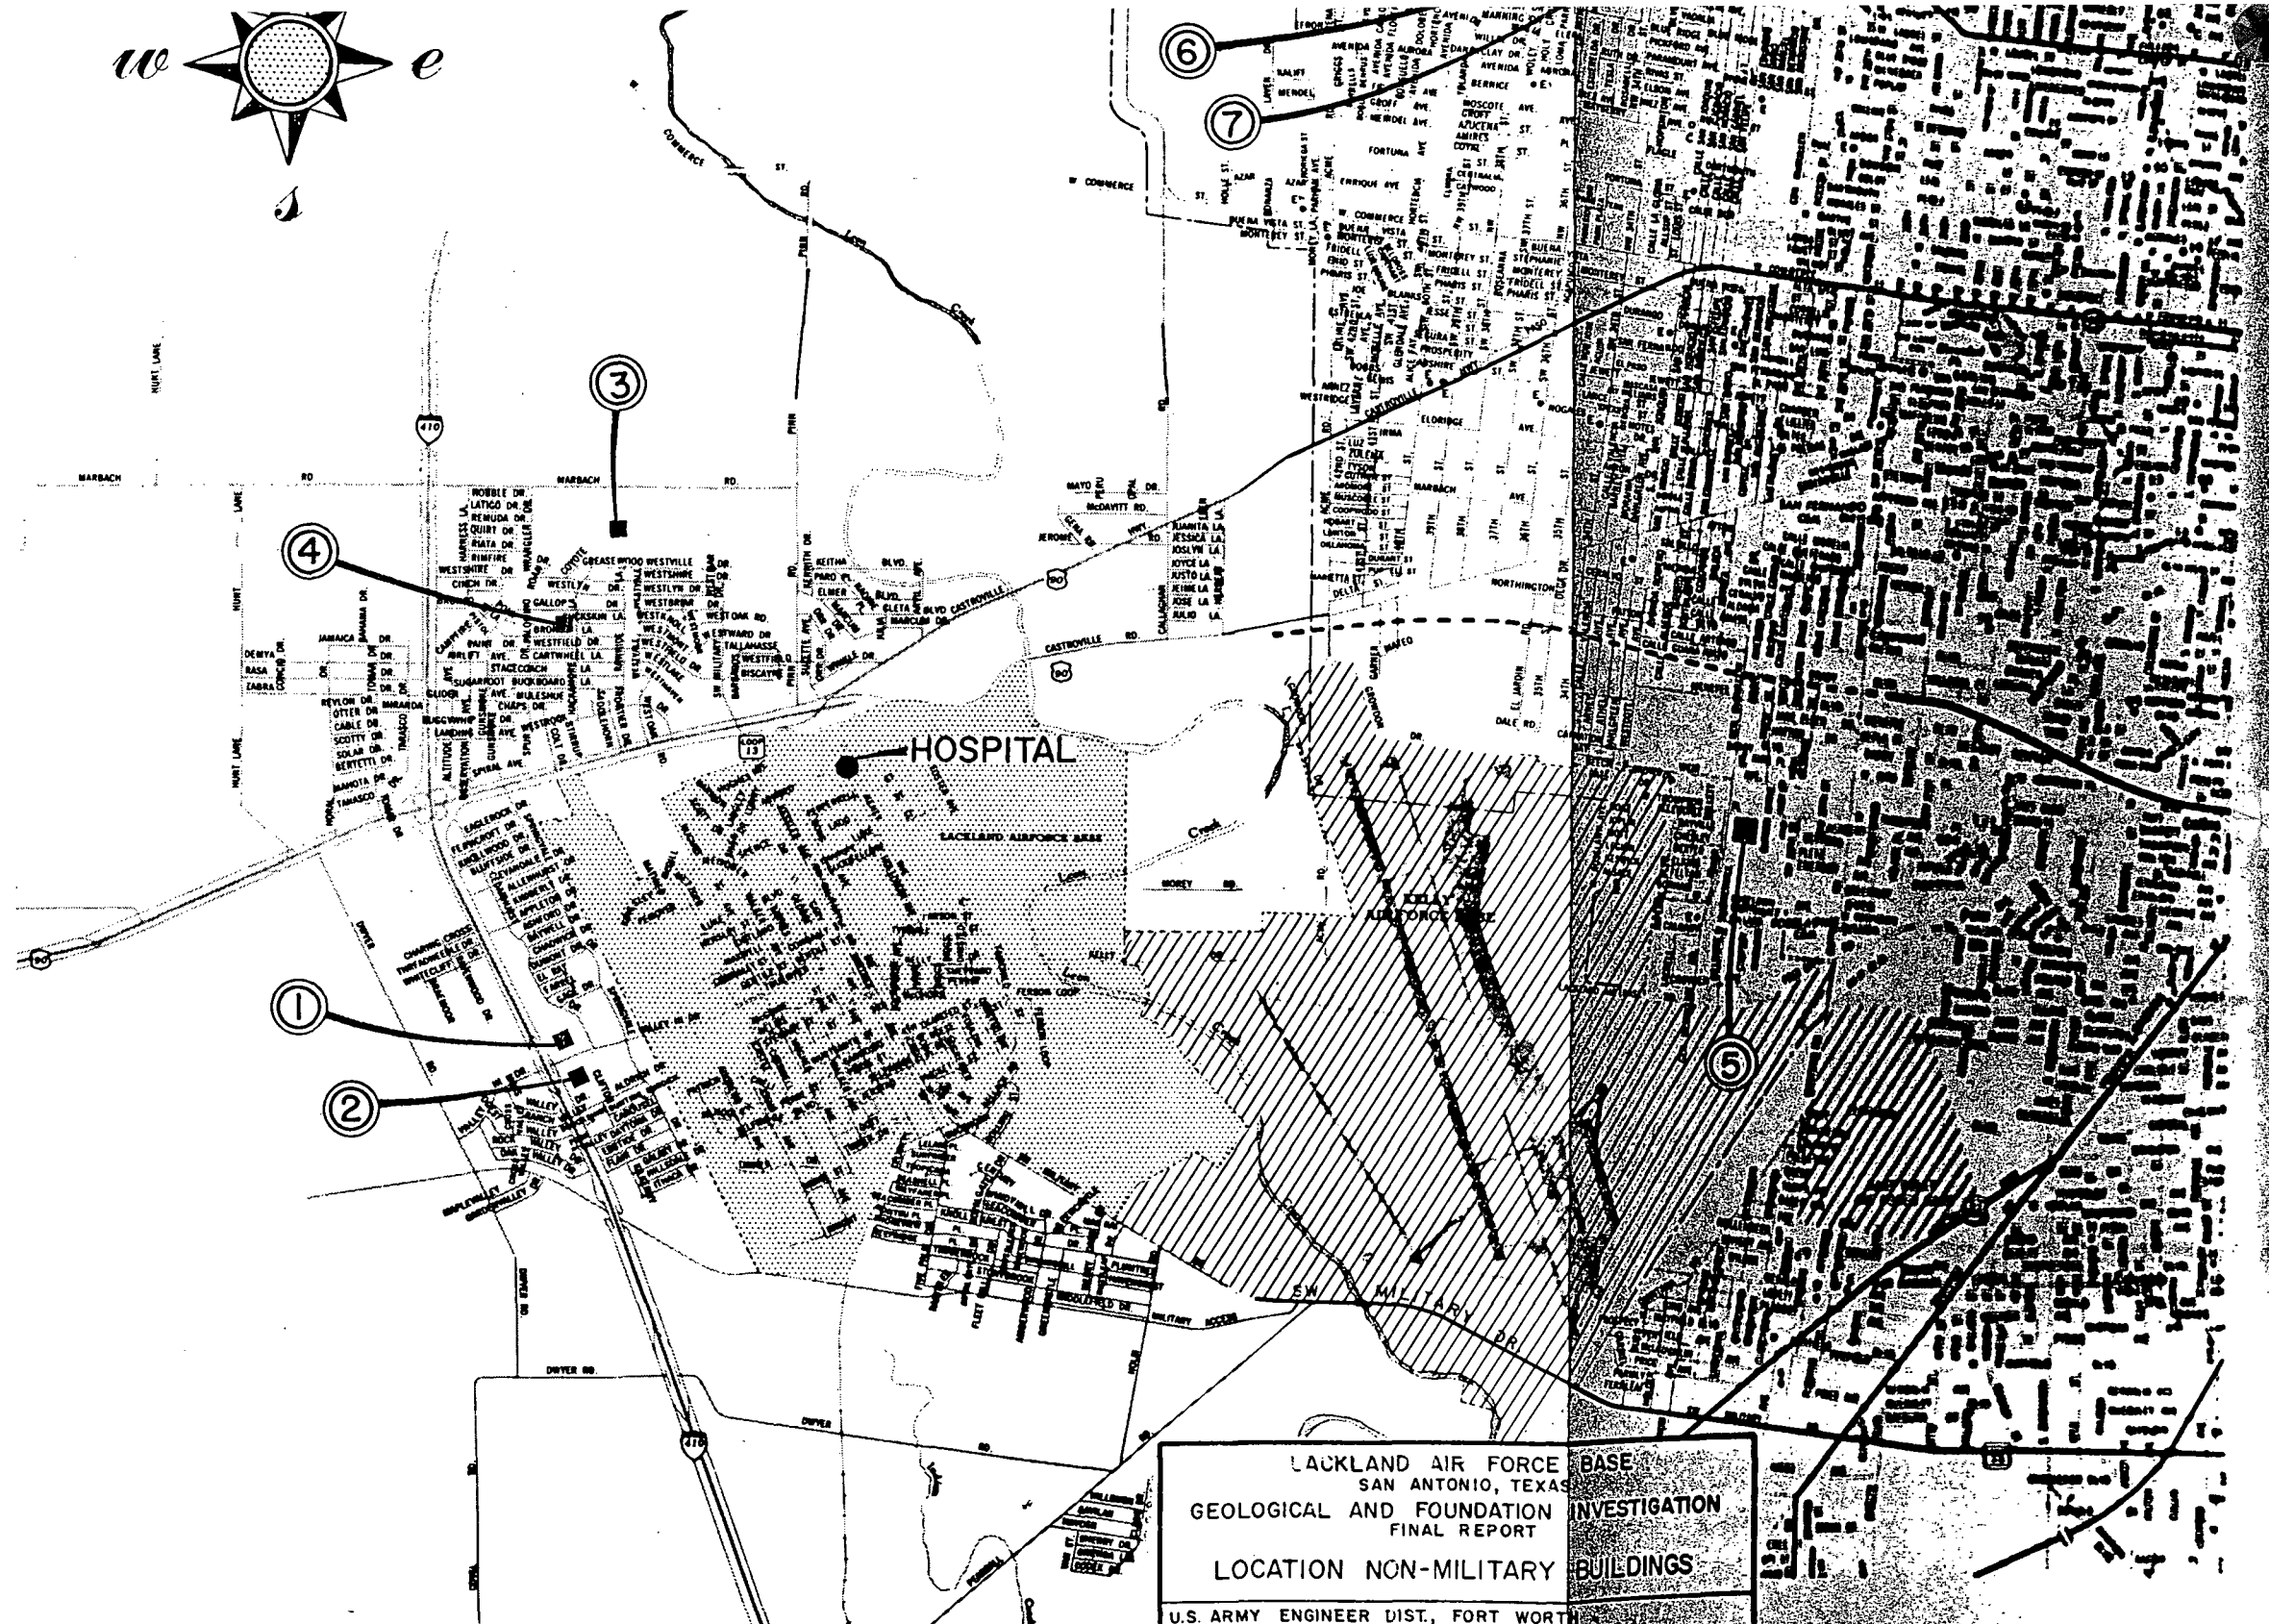
LACKLAND AIR FORCE BASE
SAN ANTONIO, TEXAS
GEOLOGICAL AND FOUNDATION INVESTIGATION
FINAL REPORT
LOCATION NON-MILITARY BUILDINGS
U.S. ARMY ENGINEER DIST, FORT WORT
PLATE NO. 33

Commercial and Public School Buildings - The Valley-Hi Shopping Center, Sam Rayburn Junior High School, Westwood Terrace and Mary Hull Elementary Schools, John F. Kennedy High School, and several buildings on St. Mary's University campus were inspected. Locations of these buildings are shown on plate 33. The buildings are rigid frame (steel) with plaster interior walls and masonry exterior walls. The buildings on St. Mary's campus were constructed in the late 1950's. The other buildings were constructed between 1960 and 1964. The building foundation designs are variable, some being drilled and underreamed piers and some a raft (mat) type foundation.

Two elementary schools located just north of Highway 90 (see plate 33) were inspected and found to be in good condition. These buildings are steel frame with masonry walls and are founded on mat type slabs. The interior walls are masonry but carry no roof load. The slabs were placed on 24 inches of caliche gravel and heavily reinforced. At each steel column, the beams are spread to act as a spot footing. This type foundation design has been very successful for one-story structures with steel columns and girders.
