# ANDERSON RANCH DAM

BOISE PROJECT, IDAHO

By Fred J. Davis

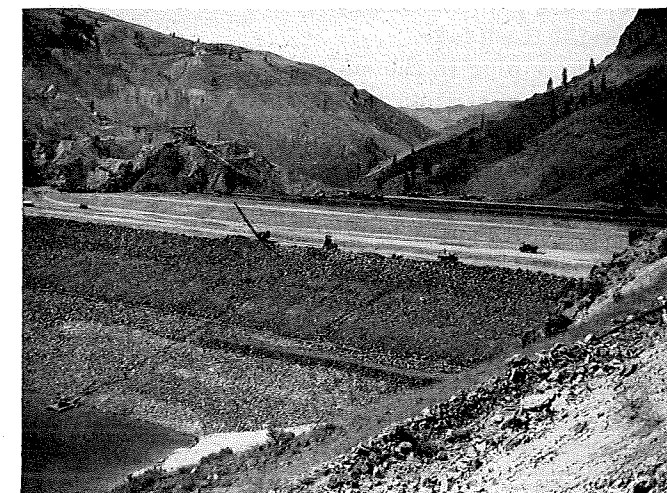
Embankment material from the borrow pits was delivered at the dam by belt conveyor, and spread and compacted by the usual construction equipment. In this photograph, the material being delivered and placed was in the impervious zone of the dam. In the foreground, the upstream slope of the embankment was being surfaced with rock for wave protection.
