HALLIBURTON SERVICES

The following is an analysis of the probable cause of the collapsed 13 3/8" casing in the RRGE #1 in Cassis County, Idaho:

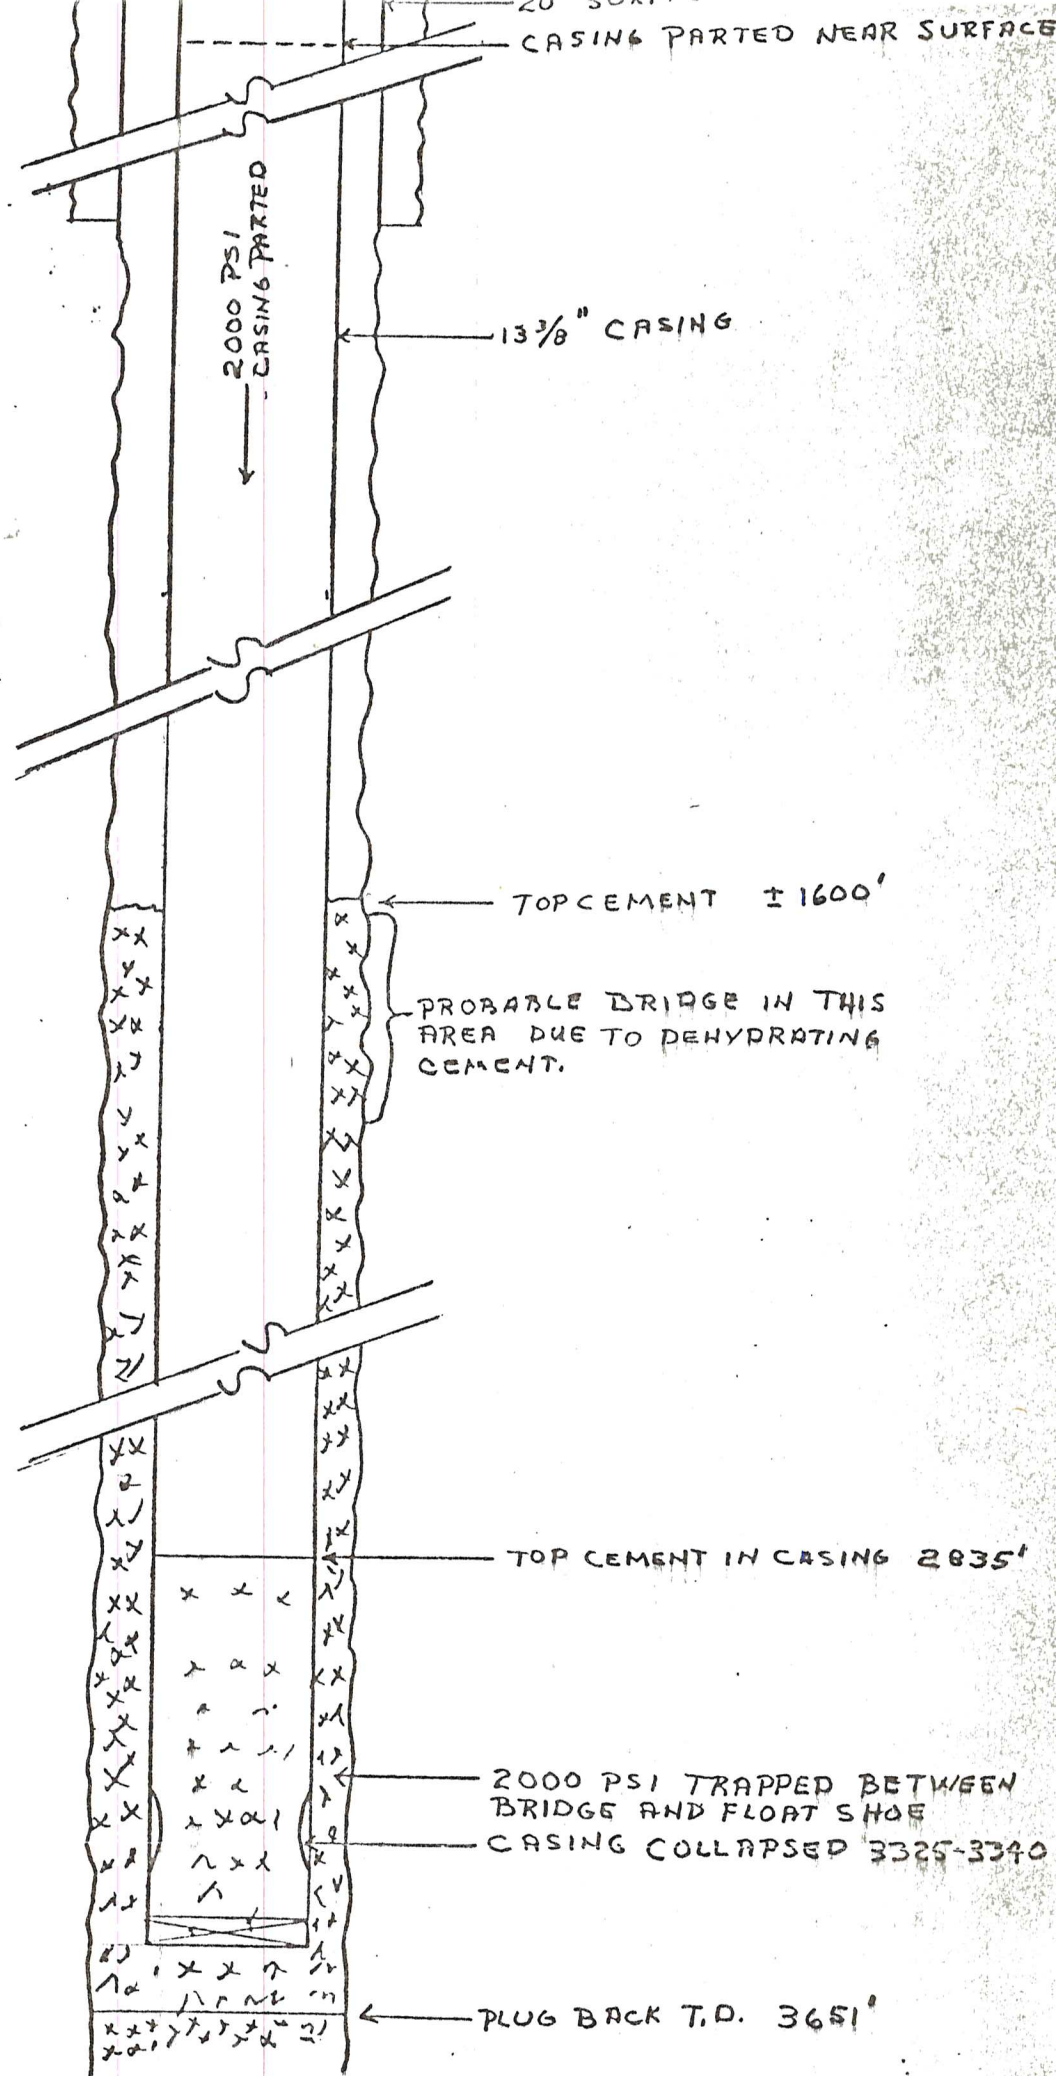
The attached diagram shows graphically the probable cause of the collapsed casing.

probably due in a small part to the changing hydro- agree
 static head and the most part to thickening of the
 cement slurry due to loss of water into the formation. ← disagree
 The first portion of the slurry would thicken to the
 point of non-pumpability because it had the longer con-
 tact time with the formation. When the lead slurry
 was no longer pumpable at 2000 psi, movement ceased.
 The 2000 psi was trapped inside the casing and also
 in the annulus between the thickened slurry at the top
 and the float shoe at the bottom. When the casing
 parted, the pressure inside the pipe was relieved to
 hydrostatic instantly while the pressure in the annulus,
 trapped between the thickened cement and the float shoe,
 could not be relieved. At this point the 2000 psi
 trapped exceeded the 1,540 psi collapse of 13 3/8",
 61# casing. This excess pressure collapsed the casing
 from 3,325' to 3,340'.
