RESULTS AND INTERPRETATION OF GEOPHYSICAL STUDIES
NEAR THE PICACHO FAULT, SOUTH-CENTRAL ARIZONA

LEROY W. PANKRATZ, HANS D. ACKERMANN, AND ROBERT C. JACHENS

OPEN-FILE REPORT 78-1106

1978

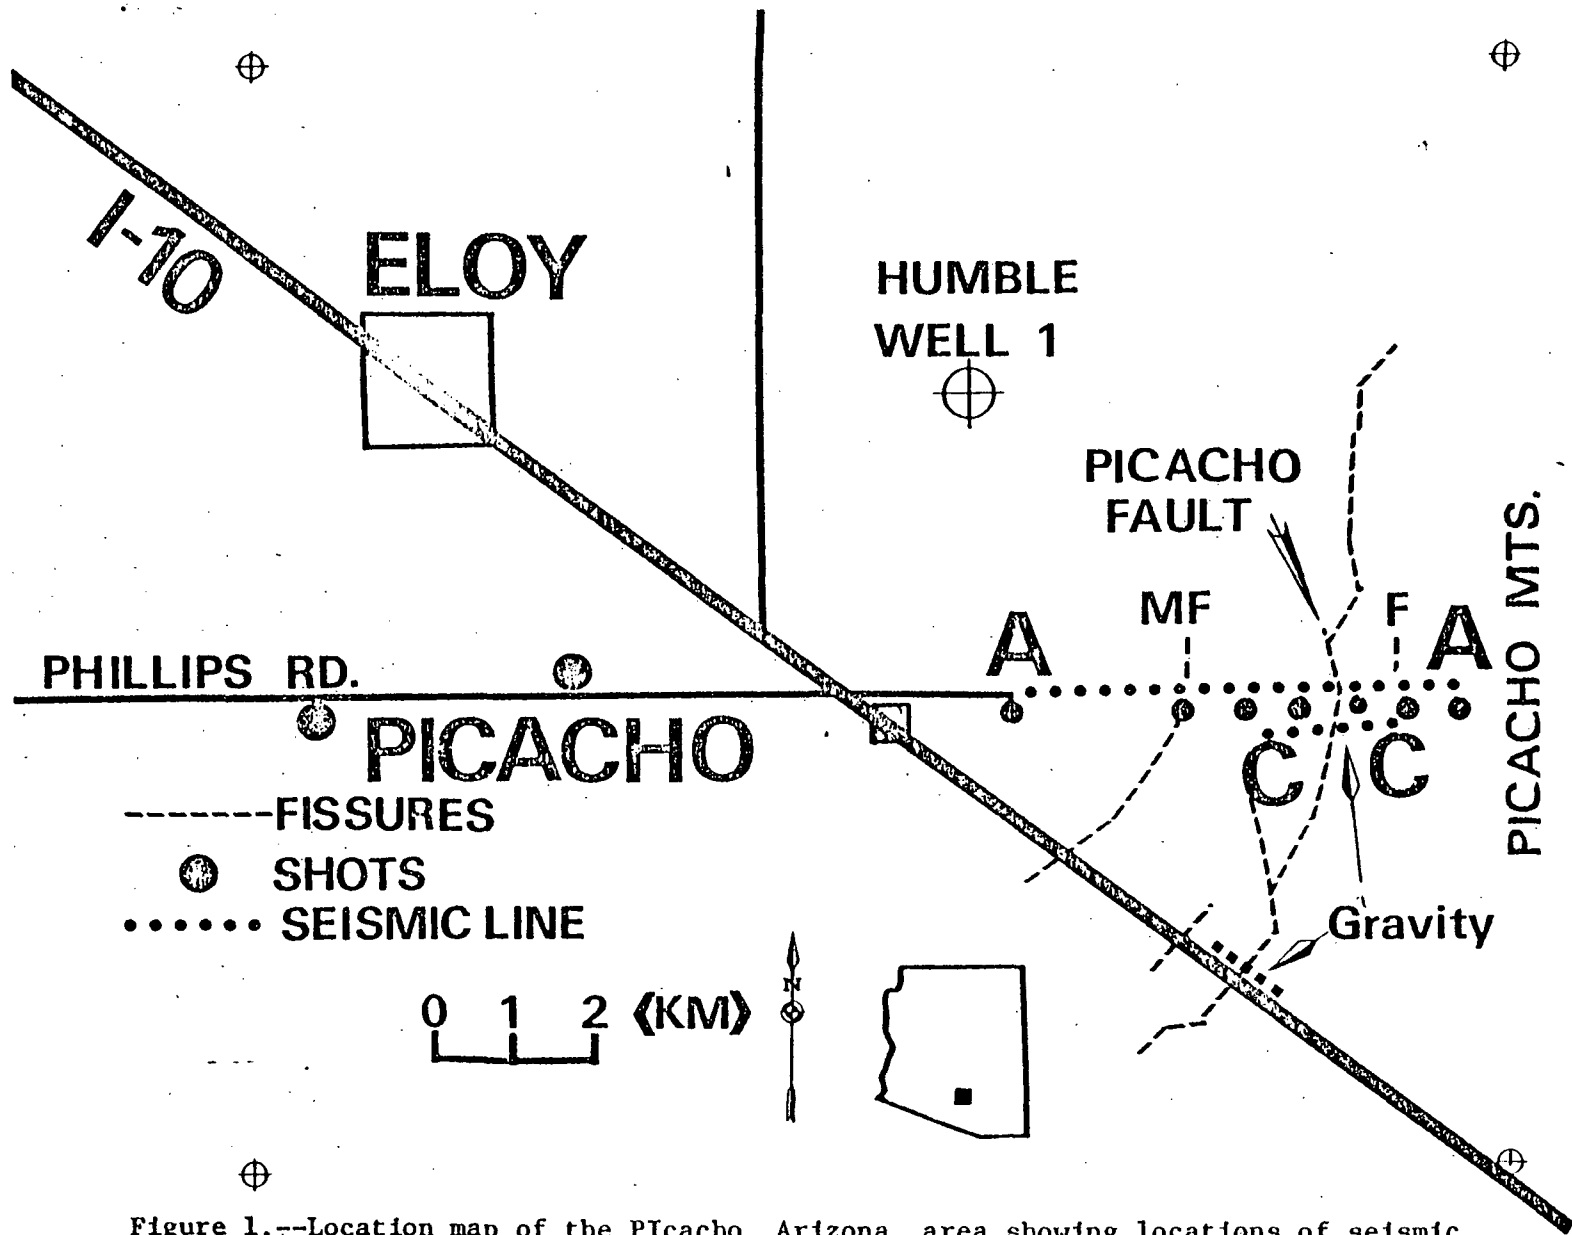
Figure 1.--Location map of the Picacho, Arizona, area showing locations of seismic lines AA and CC, the more distinctive fissures, and shot locations for line AA.

Two end-to-end 2.76-km-long spreads (AA in figure 1), consisting of 24 geophones each at 120 m separation, were shot to map the basement structure. These spreads will be referred to as the Phillips Road spreads, because they lie along the extension of Phillips Road eastward from Picacho.

A high-resolution seismic-refraction line consisting of three spreads was recorded along a U.S. Bureau of Reclamation geodetic survey line. Each spread was 345 m long and consisted of 24 geophones at 15-m spacing. These spreads (CC in figure 1), referred to as the Crack spreads, focused on the alluvial layers. Numerous shot points, shown in figure 2, were used to provide reverse coverage from many layers. High-velocity explosives were used for all shots; accurate timing was accomplished using a radio shot system. Gravity was measured at 60-m spacing along the seismic lines, with the spacing shortened to 30 m near the fissures. Well-log information from the Humble O&R Well #1, 3.8 km north of the spreads, indicates Precambrian gneiss at a depth of 3011 m (Scurlock, 1973). This information, coupled with outcropping basement on the slopes of the Picacho Mountain 6200 m to the east, indicates a possible basement slope of nearly 30° . On the basis of this information, several distant offset shots west of Picacho were recorded by the Phillips Road spreads in order to map a possible steeply dipping basement horizon (fig. 2).

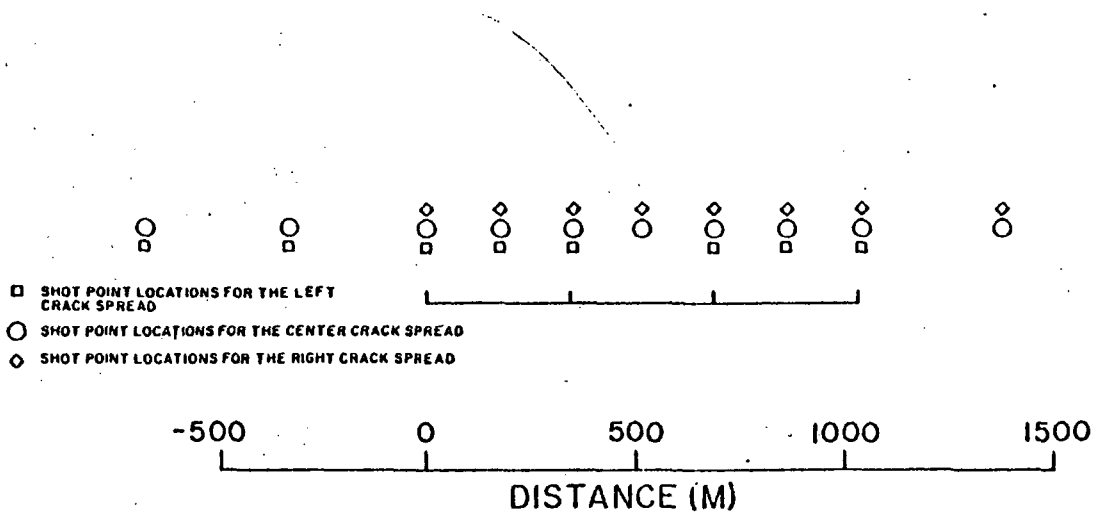
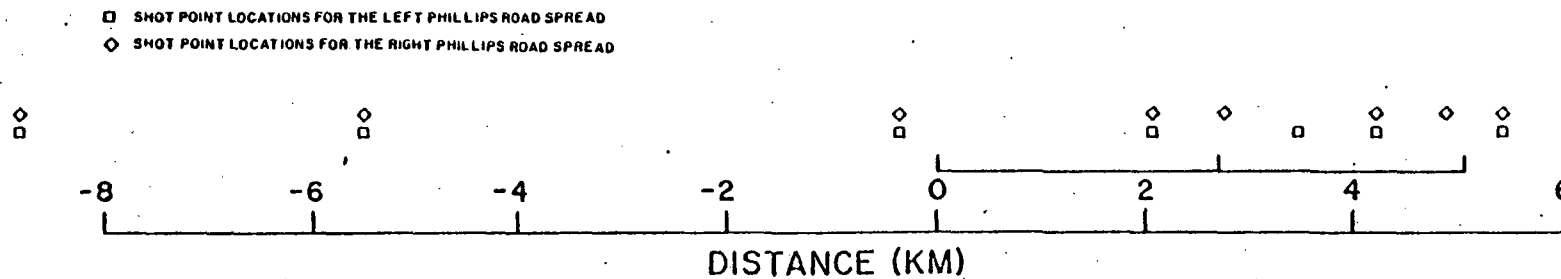
CRACK SPREAD SHOT LOCATIONS

PHILLIPS ROAD SHOT LOCATIONS

Figure 2.--Shot-point locations for the Phillips Road and Crack spreads, illustrating the large number of shots for each spread.

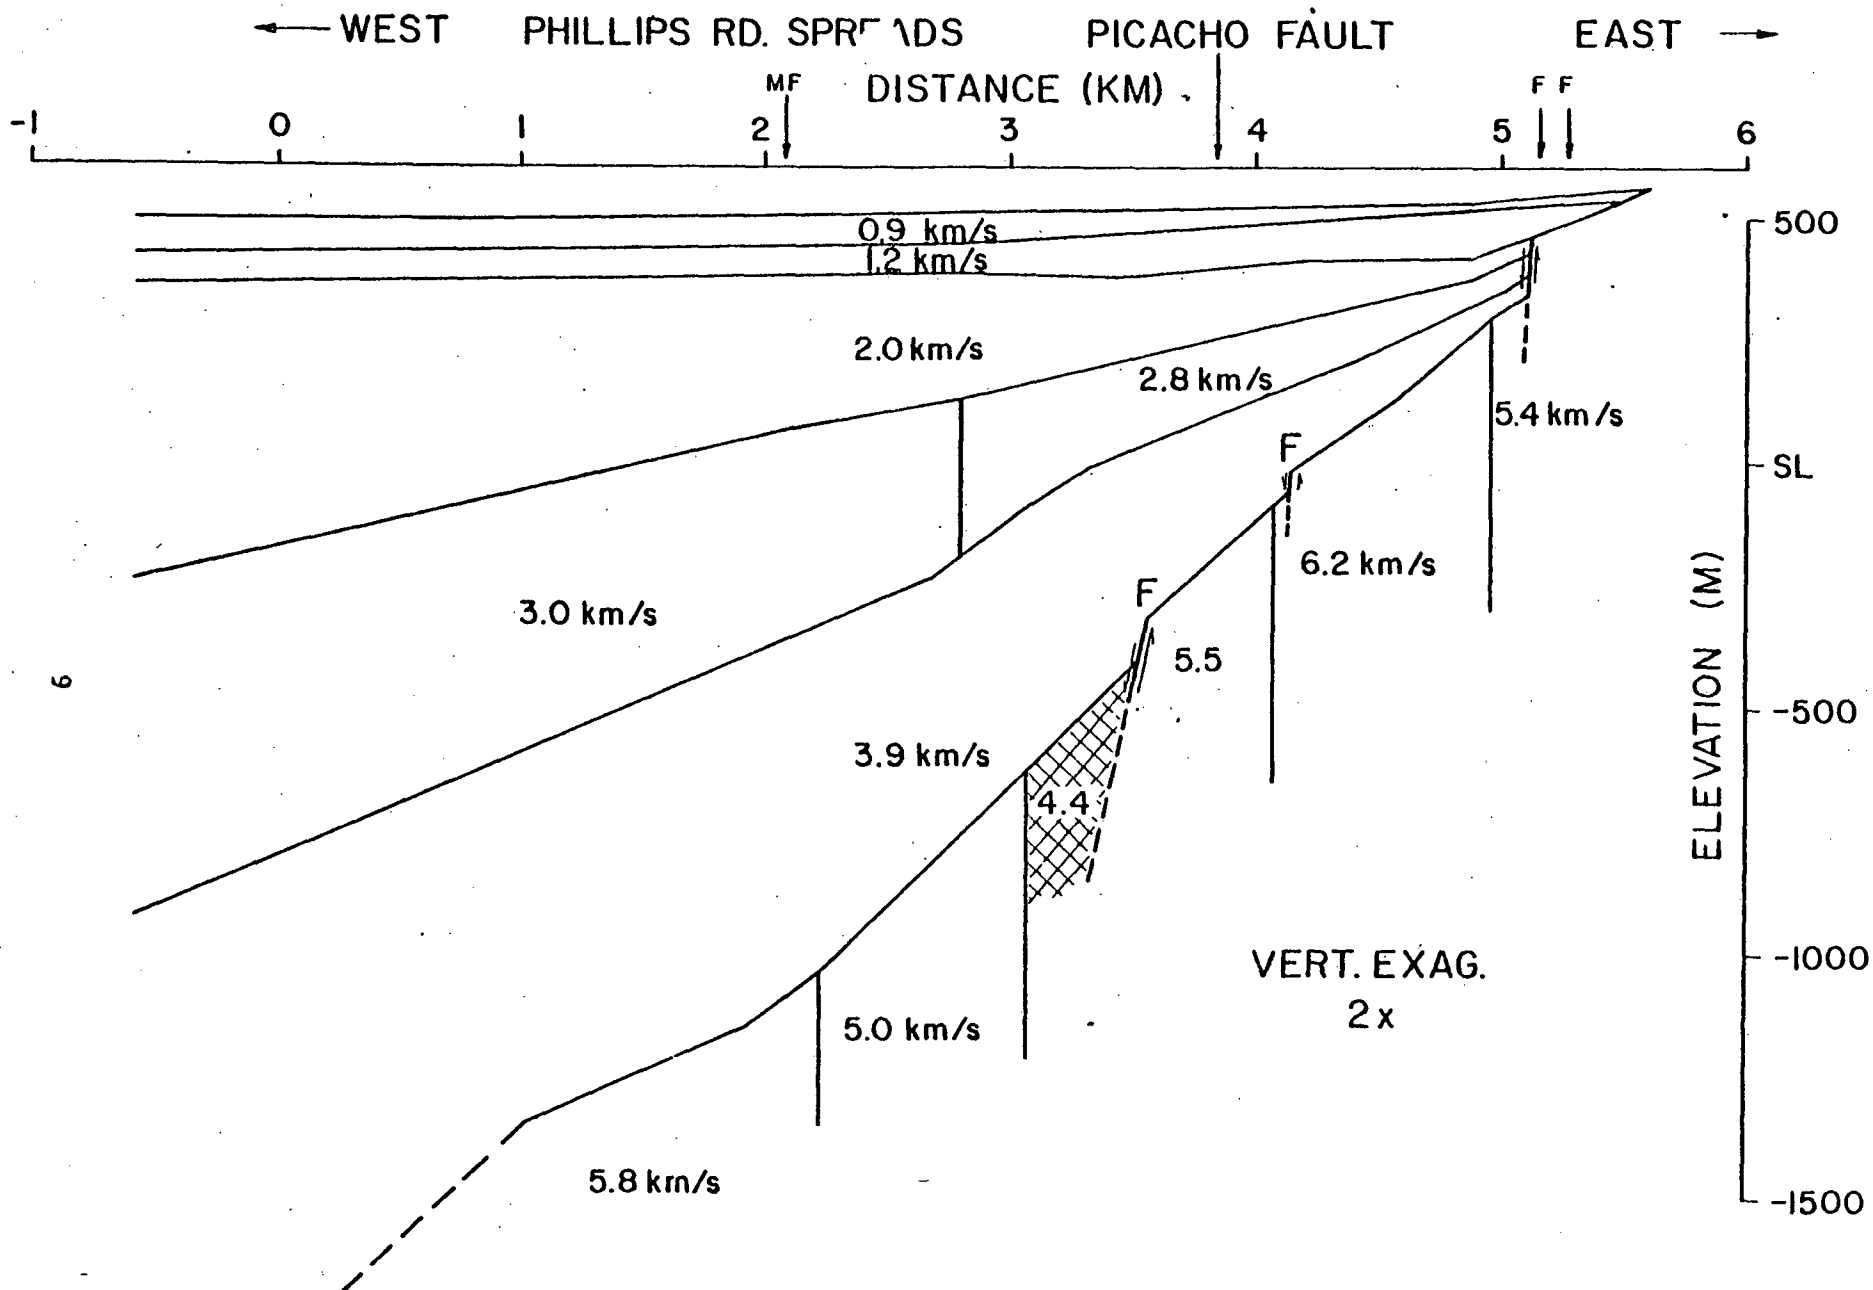
Figure 3.—Seismic velocity model derived from the Phillips Road spreads. Surface traces of the mapped fissures are labeled MF, F, and Picacho fault. Three high angle normal faults are indicated in the basement layer. The cross-hatched zone may represent fractured rock.

Interpretation of the Phillips Road spreads (fig. 3) shows the expected westward-dipping trend in all of the layers. Because of the relatively large shot and geophone spacings for these spreads, only gross features are detectable except in the bottom layer, the crystalline basement. Using an interactive computer program recently developed by Ackermann, horizontal velocity variations along the basement layer were computed. Basement velocities generally range between 4.4- and 6.2-km/sec. Interpretation of the refraction data suggests three high-angle normal faults with offsets ranging from 50 m to 125 m. The shallow easternmost basement fault approximately underlies some newly mapped fissures at the mountain front, suggesting a genetic relationship between the fissures and this fault. The central fault lies several hundred meters upslope from the Picacho fault surface trace. The westernmost interpreted fault lies downslope several hundred meters from the Picacho fault surface trace. It seems to have a lower velocity zone, 4.4-km/sec associated with it, on the downthrown side, suggesting a related zone of fracturing (fig. 3). This basement fault is approximately 500 m below the top of the zone of saturation (top of 2.0-km/sec layer), probably too deep to be directly responsible for the Picacho fault, which is a surface feature. However, interpretation of the higher resolution refraction data from the Crack spreads suggests that this fault may project upwards into the 3.0 km/sec layer.

Even though the Picacho fault as seen on the surface does not exactly coincide with all of the seismic features interpreted here, we believe that their near coincidence infers a genetic relationship. When one scans horizontally across the cross sections (figs. 3 and 4) beneath the Picacho fault, an unusually large number of eastward velocity increases are apparent.

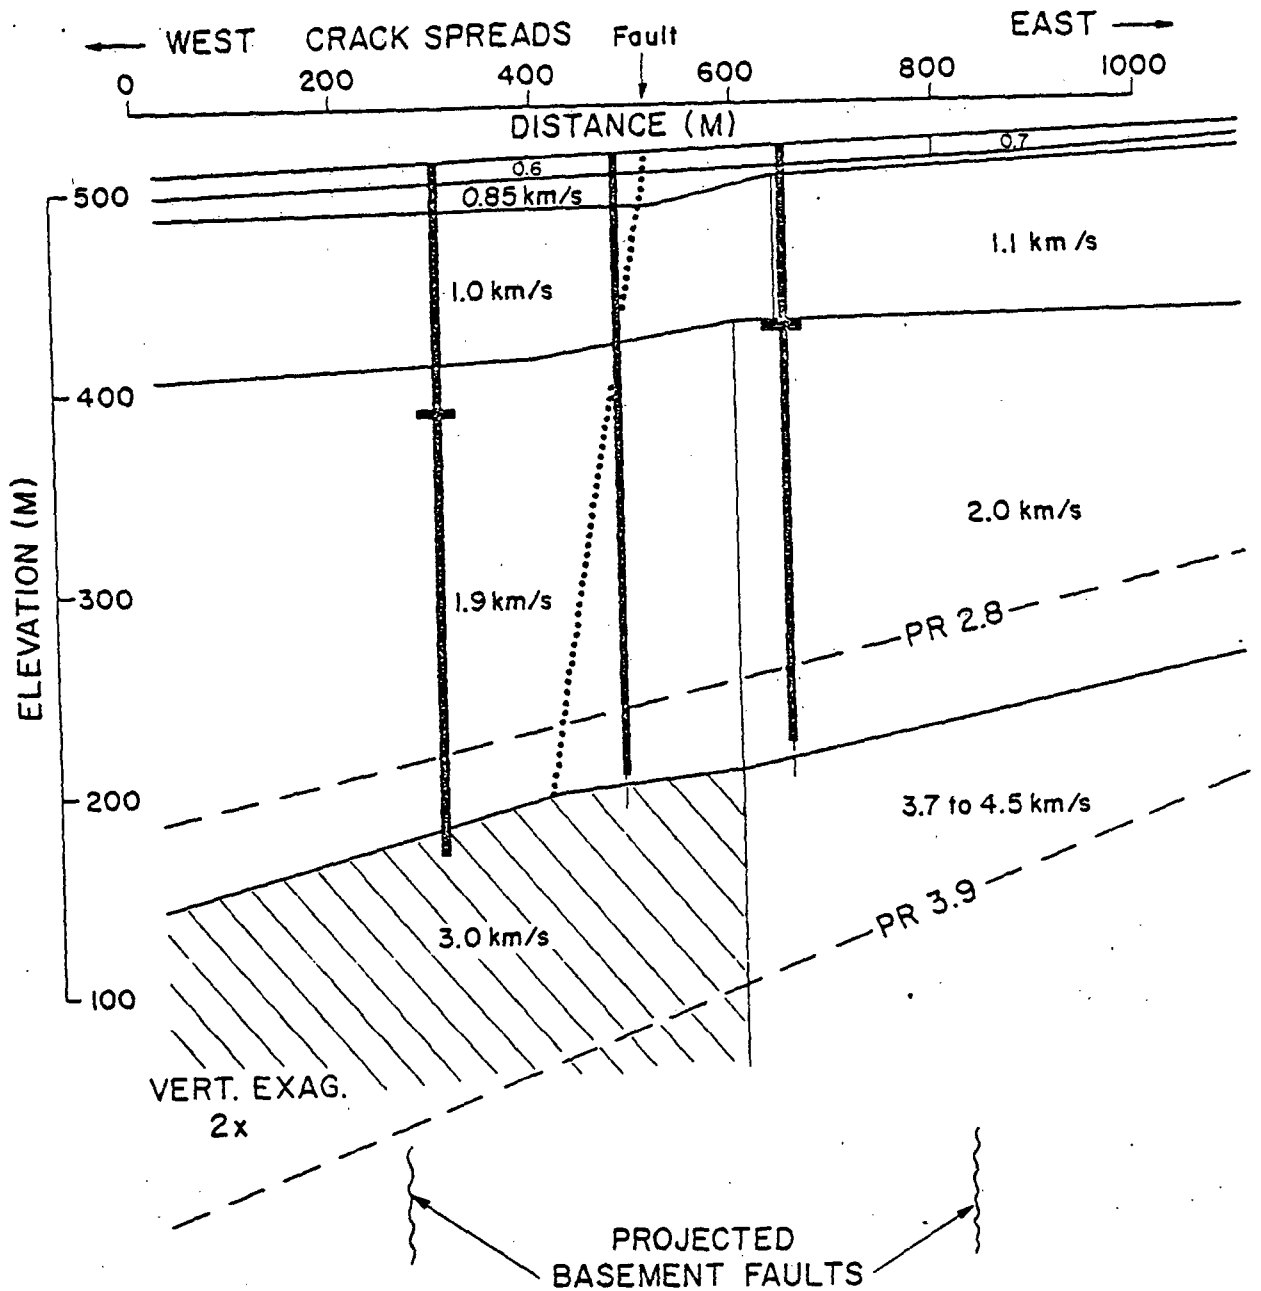
Figure 4.--Seismic velocity model derived from the Crack spreads. The vertical black lines represent the drill holes. Hard rock was encountered at the bottom of each. The horizontal bars represent the top of the zone of saturation. The fault postulated by Holzer is indicated by the dotted line. Dashed lines represent the projection of the 3.8-km/sec and 3.9-km/sec layers from Figure 3. Projection of the basement fault locations is also shown.

The interpretation of Crack-spread data resulted in good control as deep as the 3.0 km/sec layer. This layer exhibits a lateral velocity change, shown in figure 4. A number of interesting features occur near the Picacho fault

1. An abrupt change in thickness of the 0.85-km/sec layer, accompanied by an abrupt change of slope and a slight velocity change of the 1.1-km/sec layer, upslope of the Picacho fault.
2. An abrupt change of slope and a slight velocity change of the 2.0-km/sec layer. This layer is associated with the top of the zone of saturation as determined from neutron drill-hole logs (Holzer, 1973a).
3. An apparent facies change where denser compacted sediments of velocity 3.7-km/sec and greater abut more porous sediments of velocity 3.0 km/sec. The top of this layer undergoes a slope change with the inflection point just downslope from the Picacho fault.

The apparent facies change (fig. 4) in the 3.0- km/sec layer overlies the westernmost basement fault, and hence it may represent the projection of this fault into the overlying sedimentary beds. Furthermore, this faulting may extend upward to within 20 m of the surface, as manifested by the lateral changes in the 0.85-km/sec to 2.0-km/sec layers. Such a fault, if present, would not coincide with the fault interpreted by Holzer (1973a) from the drilling information, but is several hundred meters upslope.

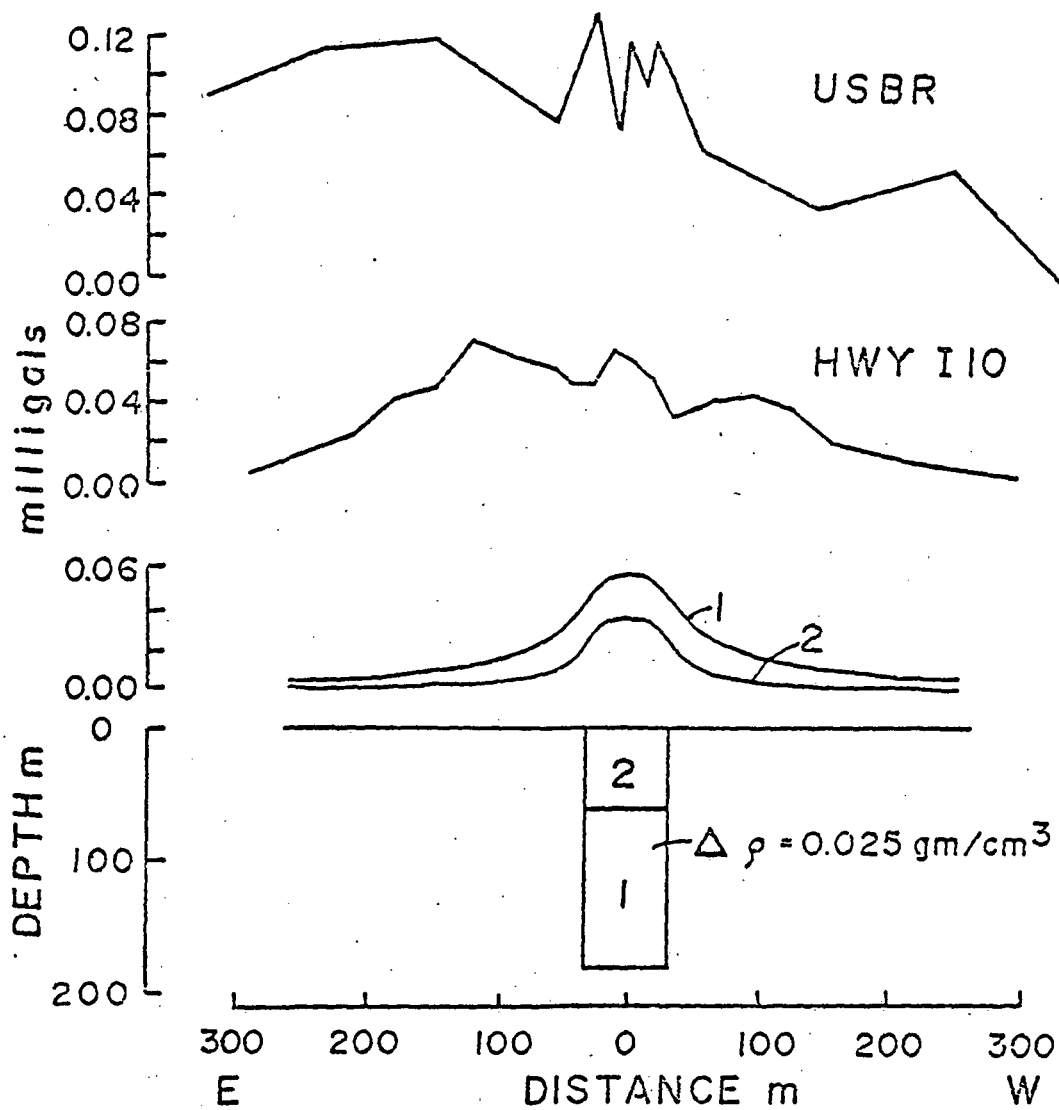
DETAILED BOUGUER ANOMALY PROFILES ACROSS FISSURE ZONE

Figure 5.--Detailed Bouguer anomaly profiles across the fissure zone with two possible models. The upper profile extends along CC in Figure 2 to I-10. The lower is along I-10.

Detailed Bouguer gravity profiles across the Picacho fault are shown in figure 5. The two profiles show a hint of a very small local gravity high over the fault zone. Two models which would satisfy the gravity high are shown as a dike-like feature (body 2) and a square body (body 1) in the lower panel. We conclude that the gravity shows no pronounced indication of the fault zone and that the apparent anomaly can be attributed to noise.

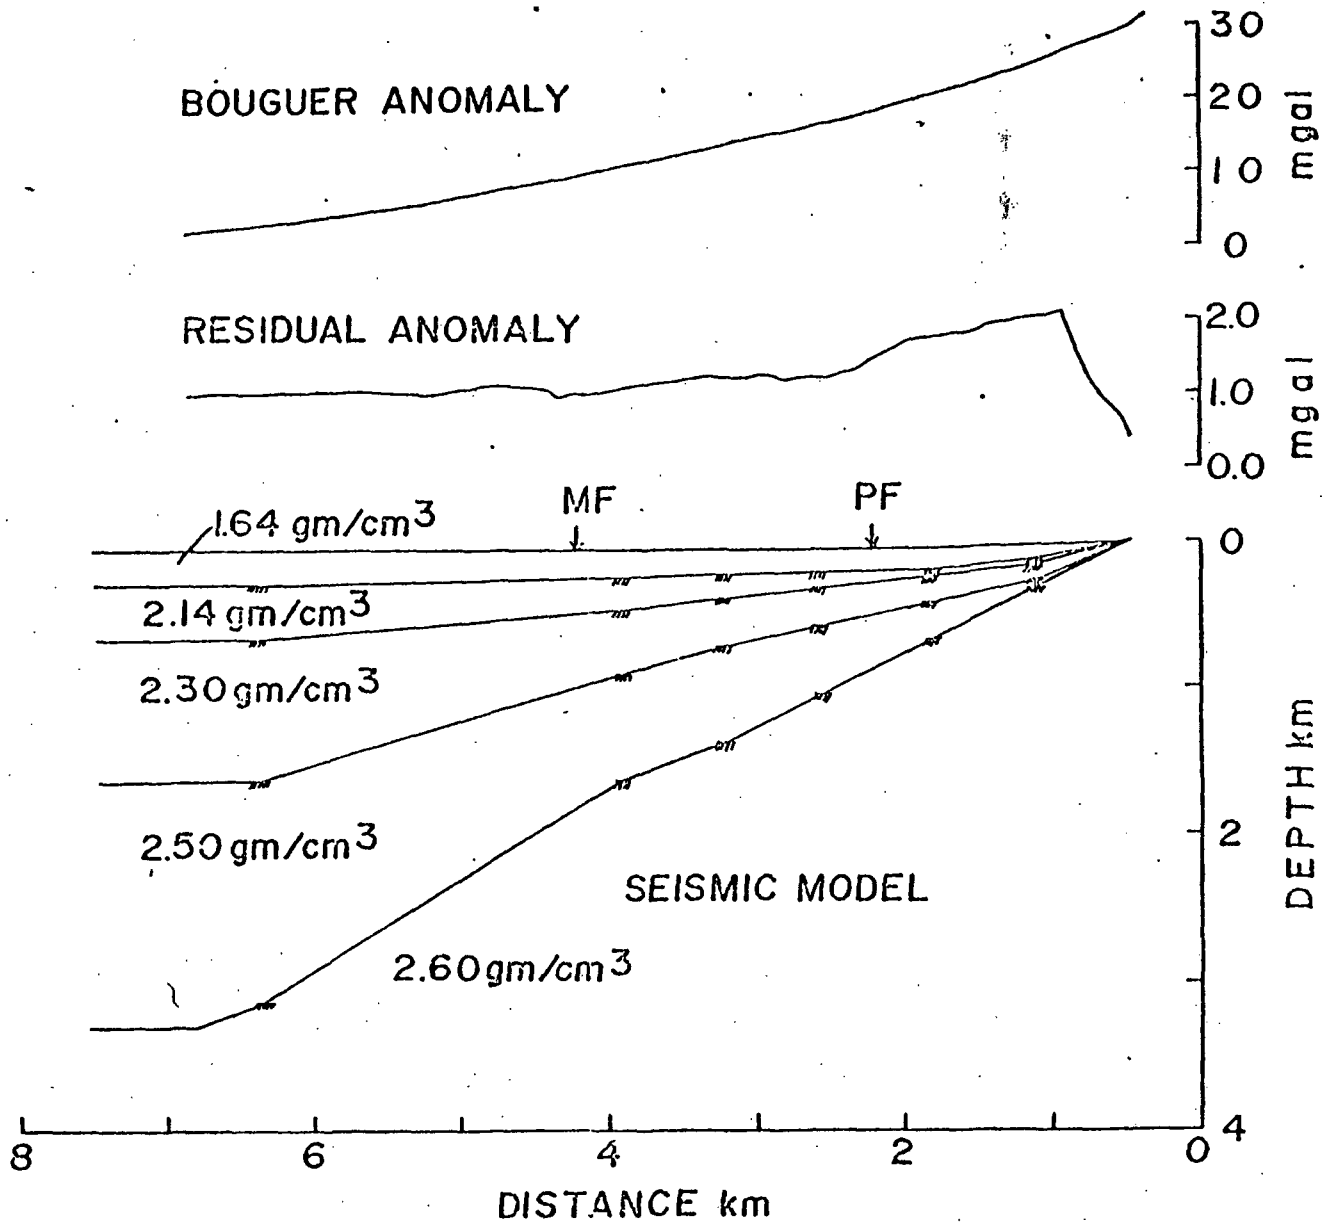
Figure 6.--Complete Bouguer anomaly and the residual calculated by subtracting the effect of the 2-D model shown. Densities of the top two layers and the basement were obtained from measured samples. Other densities were calculated from seismic velocities using the Nape-Drake curve (Grant and West, 1965).

Figure 6 shows the gravity derived along the USBR line from the Picacho Mountains to I-10. The flat residual curve west of the Picacho fault indicates excellent agreement between the seismic and gravity models. However, the increase in magnitude of the residual gravity curve east of the Picacho fault may be interpreted as indicating a step, a gradual offset, or a basinward decrease in the density of some lower layer. The velocity change of 3.0 km/sec to 3.7 km/sec in layer 5 (not used in calculating the gravity model) may account for some or all of this discrepancy. The abrupt drop of the residual curve at the far right end of the profile can be interpreted to being caused by a basement shelf extending westward under sedimentary cover as far as 500 m from its nearest outcrop. This shelf is beyond the eastern end of the seismic spreads.
