TREE-1114

**ASBESTOS-CEMENT PIPELINE EXPERIENCE  
AT THE  
RAFT RIVER GEOTHERMAL PROJECT**

April 1977

**EG&G** Idaho, Inc.

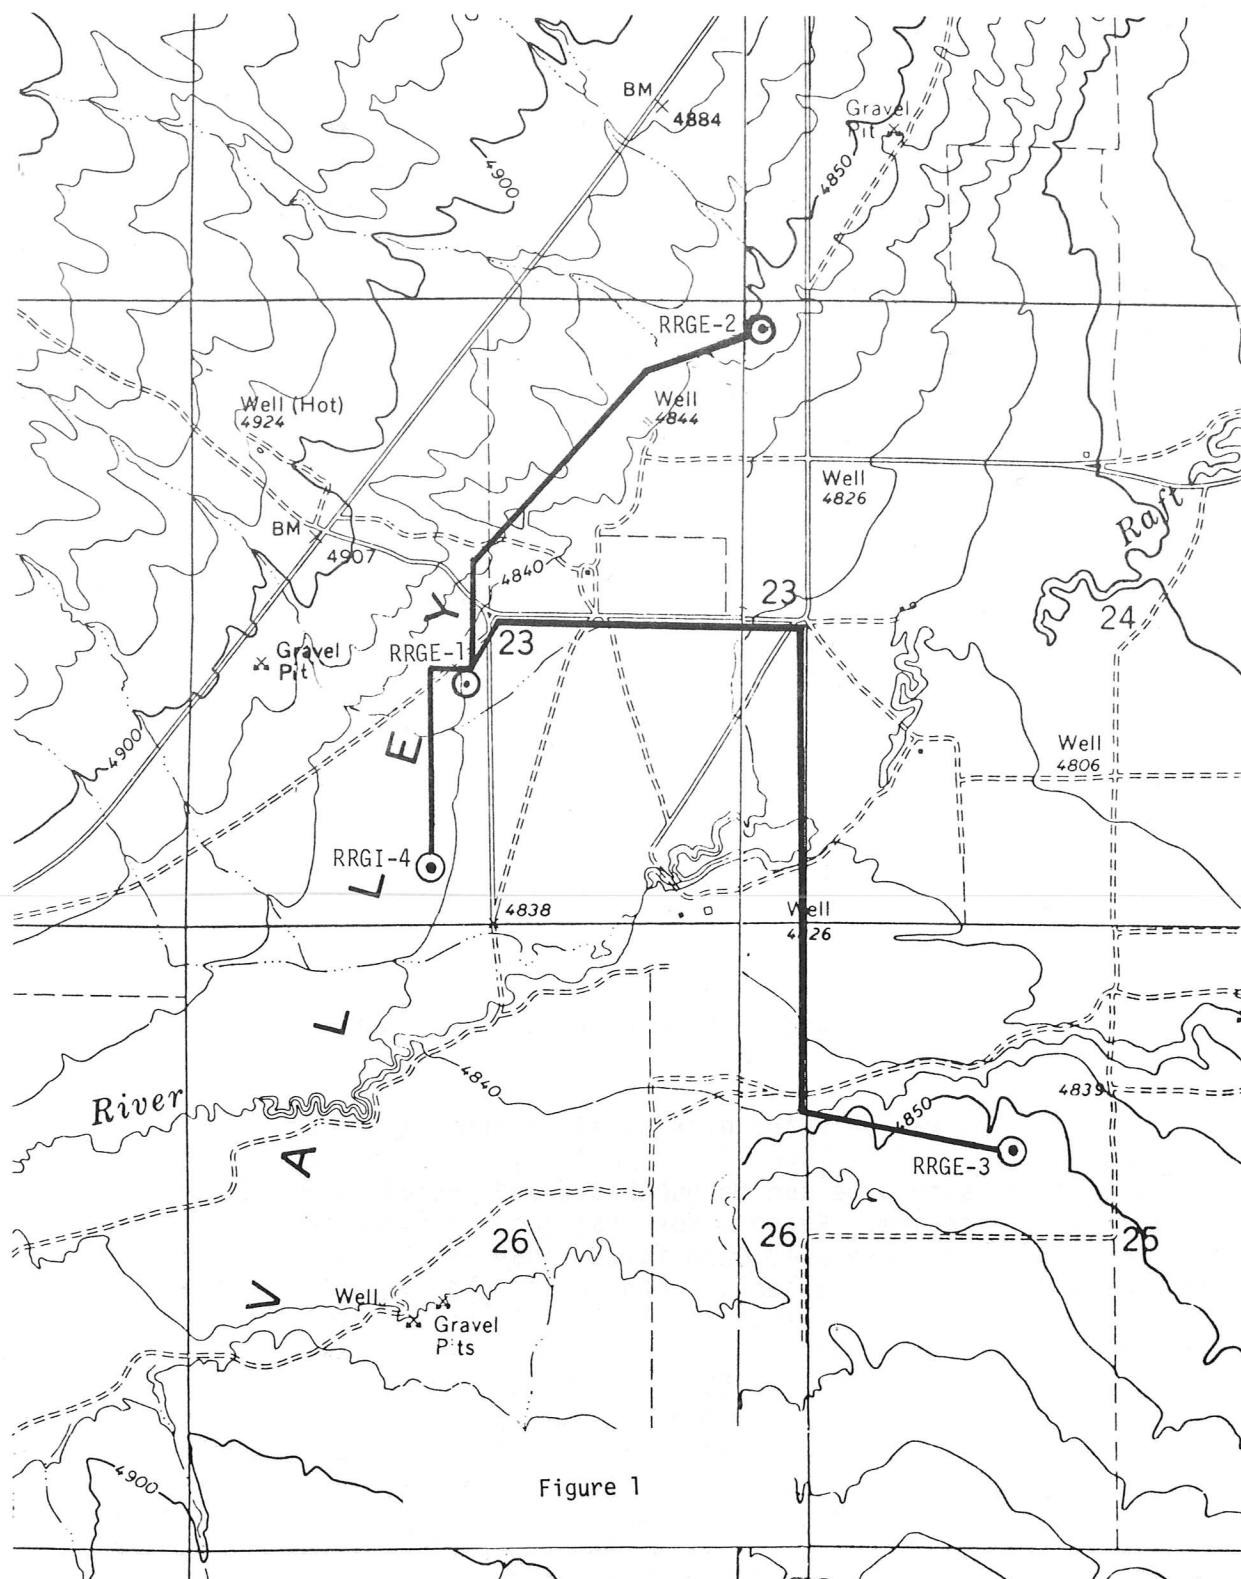
Asbestos-cement (\*Transite) pipe was installed at Raft River between well sites No. 1 and No. 2 for the purpose of transferring water from site No. 1 well and test trailers to site No. 2 for either reinjection into RRGE-2 well or into the site No. 2 reserve pit. The pipeline was designed to take the 300°F water at 150 psi over a period of time for the present testing program, and later, the power plant. A number of unexpected line failures occurred which were readily corrected. All but one failure can be attributed to design deficiencies and thermal shock. Cause of one of the failures is unknown, but most likely due to thermal shock. Figure 1 shows the well locations, the existing pipeline between wells No. 1 and No. 2, and the planned two new pipelines.

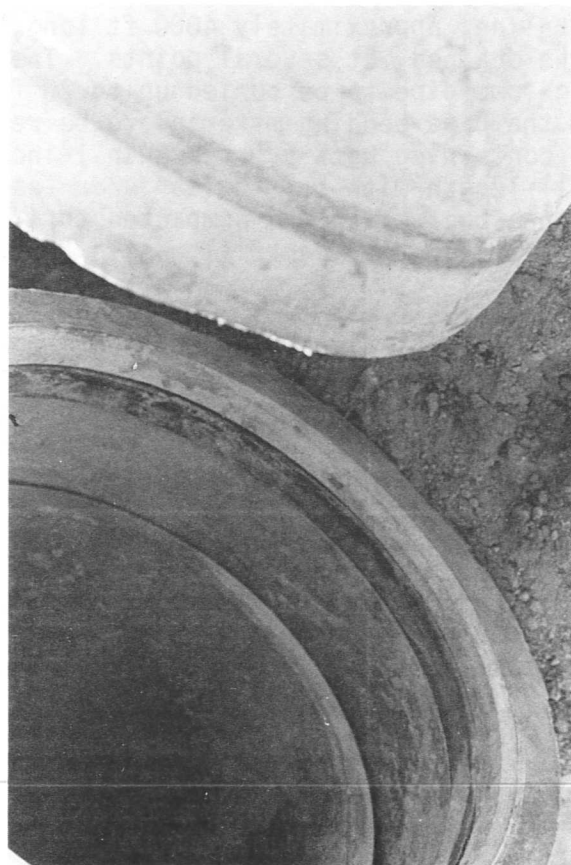
Coupling gasket (seal ring) material was a special heat resistant elastomer, EPDM (Ethylene-Propylene Terpolymer). The 1977 Materials engineering Materials Selector lists a 350°F continuous service temperature for this compound. Figure 2 shows the gasket installed in a coupling.

Fig. 2 View of coupling gasket between pipe sections

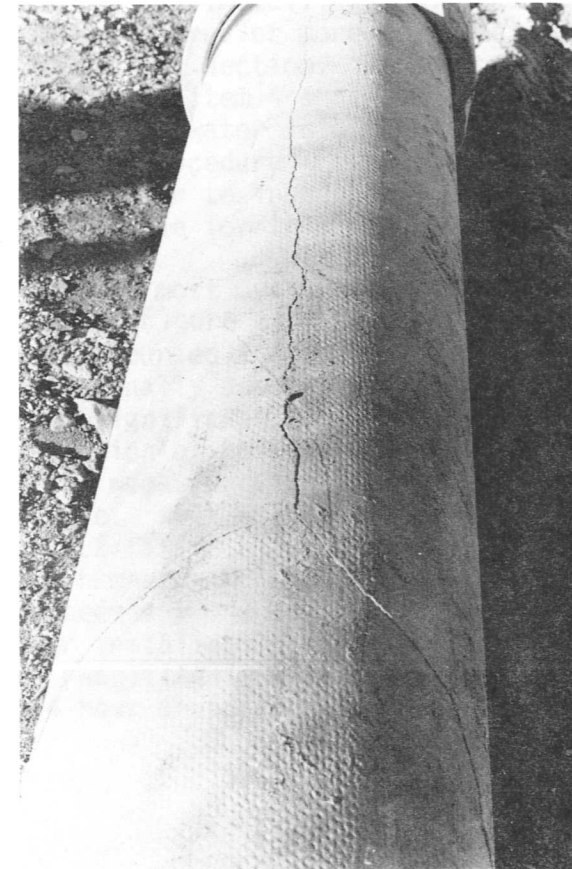
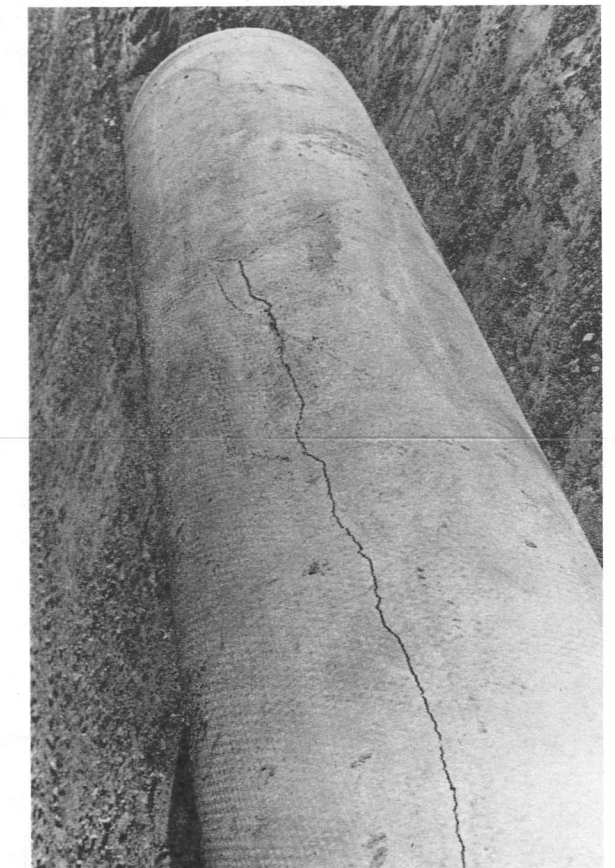
1. Thermal or mechanical shocking of the Transite pipe causing wall fracture (generally longitudinal cracks). See Fig. 3
2. Use of improper Dresser couplings (steel-to-Transite couplings) which could move under thermal cycling, resulting in ratcheting and ultimately detaching itself from the Transite pipes,
3. Installation of low temperature gaskets in the Dresser couplings.
4. Rolling the gaskets when replacing a broken section allowing the coupling to leak.
5. Unknown reasons for failure.

The other fractures that have occurred in the pipe are believed to be the result of thermal shocks, but the possibility of one or more being the result of mechanical shocking cannot be excluded. The most likely cause of mechanical shock during operation is believed to be the result of "water hammer." Air or steam bubbles, collapsing or moving past a high spot in the line could possibly result in a significant change in momentum of the flowing water, giving an impulse to the pipe wall. The current procedures for operating the pipeline are designed to minimize the possibilities of both thermal and impulse fractures.

Fig. 3 Close-up pictures of longitudinal fractures in pipeline, probably the result of thermal shock or water hammer mechanical shock

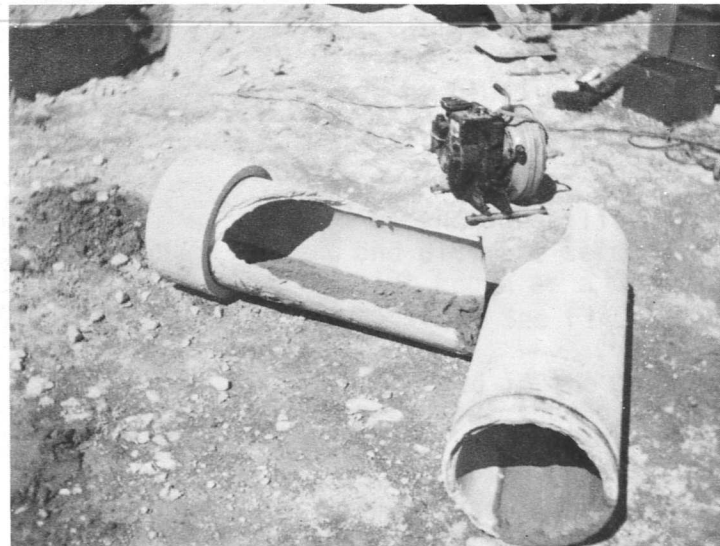
Appendix A chronologically lists the failures and the apparent reasons for the failures. The first failure occurred when the mud pumps from the drill rig accidentally, but briefly, injected cold water into the still hot Transite line near site 2. (See Fig. 4) The failure could have been caused by a mechanical shock, such as from a pressure transient, the thermal shock or both. The magnitude of the pressure transient is unknown. The thermal shock potential is known, however, from thermocouple measurements made on the pipe and in the soil. The pipeline will cool very, very slowly from merely natural conduction, taking about one week to cool to within 25°F of the outside air temperature. Therefore, the procedure has been to slowly cool the inlet water by bleeding in cold water, if a change from hot to cold water pumping is demanded over a short period of time.

Fig. 4 Transite line failure at site No. 2 when cold water was inadvertently pumped into hot line by drill rig mud pumps.

* 3-9-76	12-inch Transite pipe ruptured at No. 2 while flowing from No. 1 to No. 2. An inadvertent slug of cold water was pumped into the hot line from the drill rig.
3-29-76	Ruptured section replaced (delayed because of drill rig moving off site).
6-18-76	Valley Utilities replaced gaskets on both Dresser couplings with correct materials.
7-2-76	Transite leak at No. 2 - collar shifted - recentered collar.
7-4-76	Transite leak at No. 2 - collar shifted - recentered collar.
7-7-76	Dresser coupling blow-off at No. 1 - recentered collar.

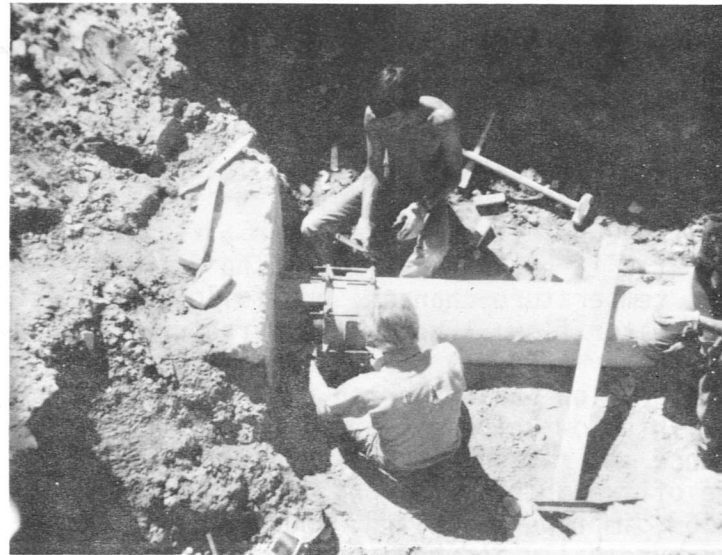
A problem not directly related to the durability of asbestos-cement pipe, involved the ratcheting and ultimate separation of the pipe from the steel end pieces, the joint known as a Dresser coupling. Improved design has eliminated this problem. See Fig. 5.

Fig. 5 Blocking Dresser coupling so that thermal cycling could not cause it to move and leak.

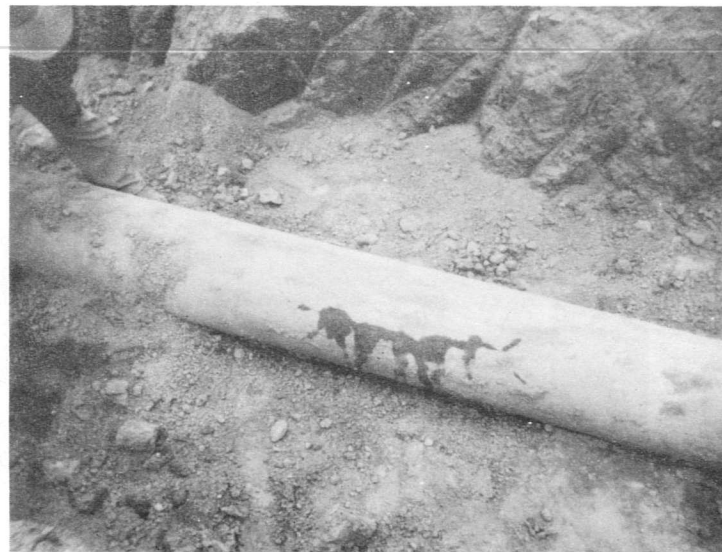
The most mysterious failure was an isolated Transite fracture (shown in Figure 6) 2100 ft from site No. 2 at a point where the line was buried 9 ft deep. It consisted of a 6 ft section fracturing longitudinally about 4 ft between collars. The failure did not occur during significant temperature changes, but followed a brief 4 hour termination of hot water flow. The initial fracture could have occurred several weeks previously and only gradually enlarged until it was detectable. When water flow was restarted, it was only 55 gal/min, less than 0.2 ft/sec. This low velocity is unlikely to result in significant water hammer. Hence the reason for the failure is unknown. It could have been any one of a number of reasons such as defective pipe, improper installation, improper handling, and unusual drainage in the area resulting in externally induced thermal shock (i.e., cooled off in the 4 hour shutdown, then shocked with hot water).

Fig. 6 Fractured line midway between sites. Reason for failure is unknown.

* 11-11-76	Transite broke mid-distance between No. 1 and No. 2 with cause unknown.

- 11-13-76 Transite section replaced - still leaking.
- 11-15-76 Air bleed valve in next section broken - leaking; also joints leaking from rolled gaskets.
- 11-17-76 Rolled gaskets still leaking.
- 11-18-76 Replaced gaskets.

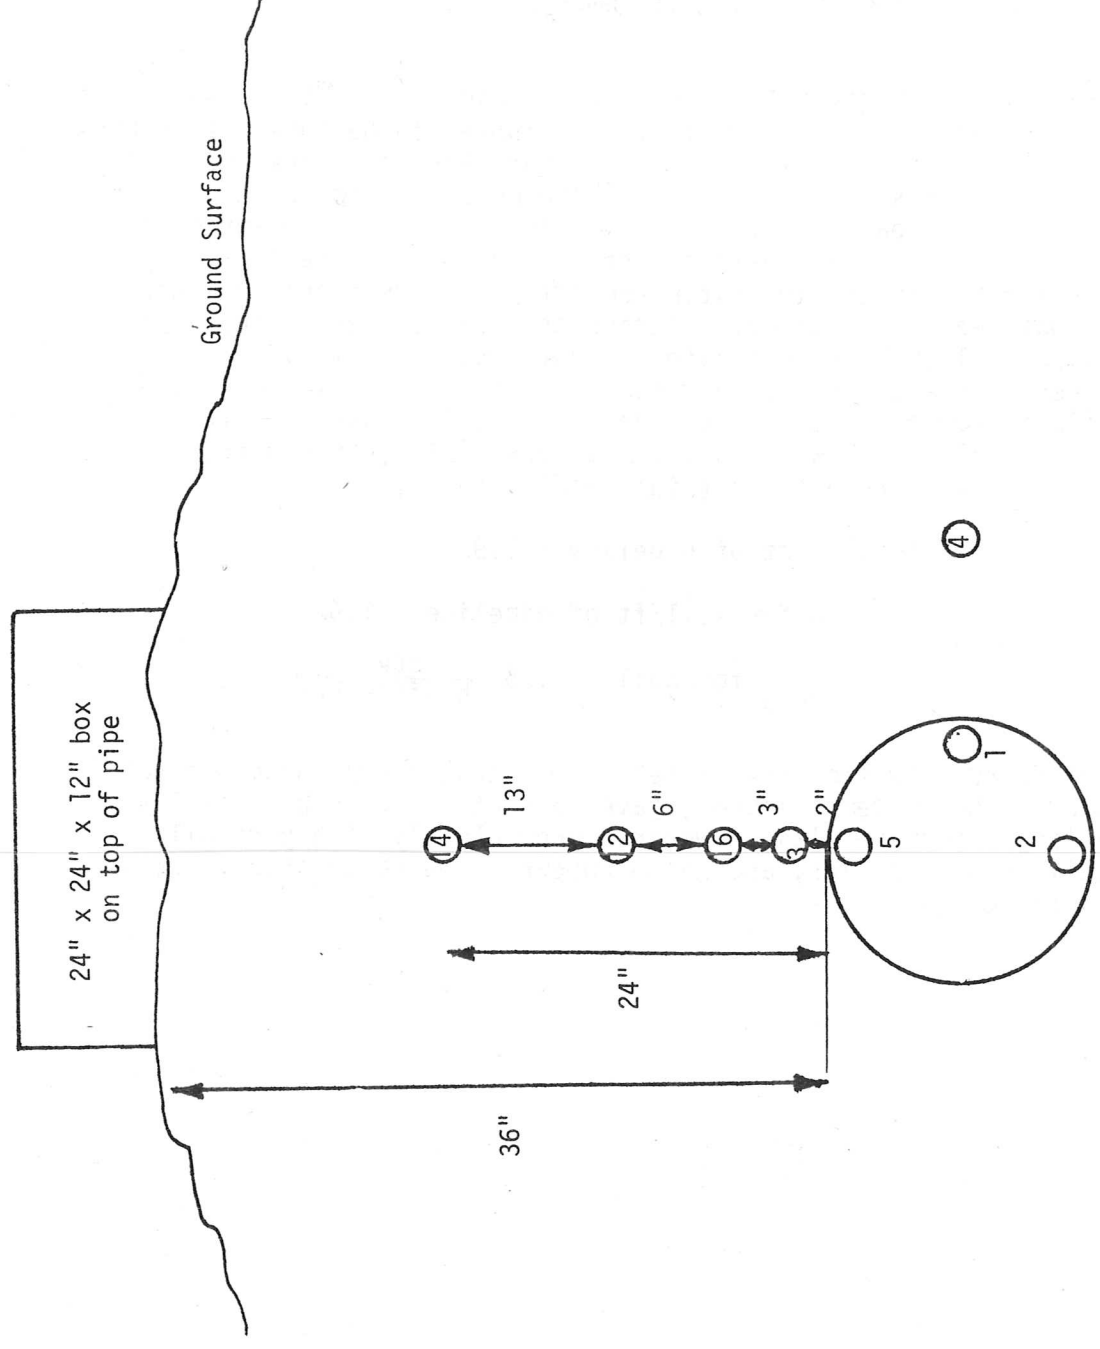
The pipeline was instrumented, as shown in Figure B-1, in a region of typical Raft River region soil, with thermocouples to measure the temperature gradient in the soil. The fluid temperature loss from one end to the other of the pipeline was also measured. These measurements began a week after cold winter weather set in. The results of these measurements are shown in Figure B-2. The pipeline carried 235 gpm for the first 2-1/2 weeks, but equilibrium temperature conditions had not been reached when the flow was reduced to 65 gpm. During the next 6 weeks, the temperatures stabilized, allowing an estimate of heat loss to be made and average soil resistance/conductivity computed. At that time temperature drop of the fluid from one end to the other end (4000 ft away) on the pipeline was 13°. For 65 gpm flow, this gives a loss of 405,000 Btu/hr, leading to the following result, in  $(\text{Btu/hr}\cdot^{\circ}\text{F})^{-1}$  for R.

Figure B-1  
Physical location of monitoring thermocouples placed in soil around 12-inch dia Transite pipeline. Measurement location was near the RRG No. 1 security force.

Experience with the present pipeline between wells No. 1 and No. 2 for heat loss and soil temperature measurements is summarized in Appendix B. Measured heat loss compares closely with the above listed thermal conductivities and resistances. The results indicate that the average thermal resistance for the pipeline, buried a minimum of 5 ft, is  $1.9 (\text{Btu/hr-ft-}^\circ\text{F})^{-1}$  (+5%, -40%) for each foot of pipe. This result corresponds to an average thermal conductivity for the soil of 0.25 Btu/hr-ft-°F (+40%, -5%).
